DOVER HIGH SCHOOL AND CAREER TECHNICAL CENTER Site & Building Assessment Report

Dover, New Hampshire

February 2015

HMFH Architects, Inc.

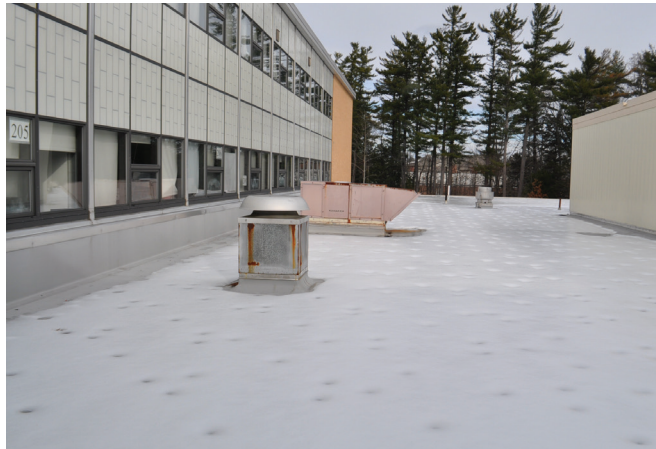
View of Roof with snow cover

In 2008, a new white Thermoplastic Polyolefin (TPO) roof was installed over the entire school. These roofs generally carry a 20 year prorated warranty, so the roof is 7 years old, and in generally good condition. When walking the site, the roof was covered in 3" to 4" of snow. When viewing the roof in this condition, the melting pattern of the snow on the roof indicated areas where heat was escaping due to the thermal breaks at the roof fasteners. This melting pattern might imply the installation of the mechanical fasteners was directly connected to the metal deck. Further investigation into this melting pattern is recommended should the building be renovated.

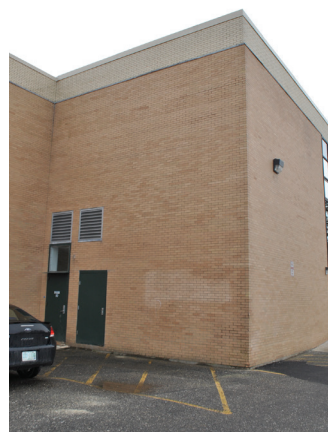
Visible Efflorescence

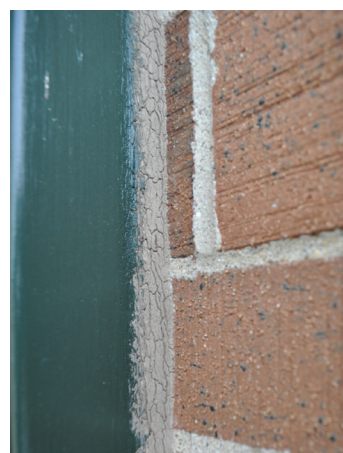
Cracked Sealant

The sealant around windows, doors, and control joints is showing signs of cracking, and some of the visible loose lintels are rusting with decay. There are various corners around the building where brick has been damaged and requires replacement. Although the masonry wall system does not meet today's code, the overall condition appears to be good, and with minimal work, new sealant, selective repointing, selective brick replacement, and a thorough cleaning, further investigation to its reuse should the building be renovated is recommended.

Brick Veener – Exterior wall not compliant with IECC, seek alternate compliance methods or upgrade wall to be compliant. Recommend recaulking at all control joints, doors, windows and inside masonry corners, selective repointing and replacement brick

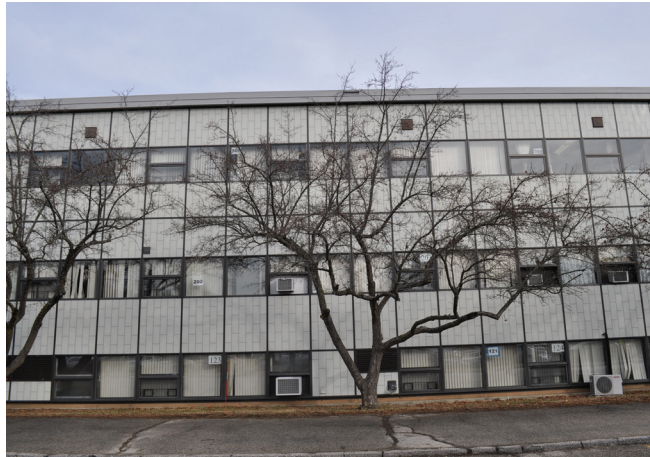
Exterior Wall System 2 - Curtain Wall with Kalwall Infill

The windows at the 1967 building are original to the building. They are aluminum with a single pane 1/4" tempered glass. There are a variety of fixed and operating windows. The windows are still functioning, but have exceeded their useful life and complete replacement is recommended if a renovation option is selected. As noted in the summary, many of the interior spaces do not have any windows; in fact 21 out of 52 classrooms are interior with no views to the exterior. The current configurations of windows would not qualify for the prerequisite access to views or the day lighting credits for LEED, which is one rating system for high performance buildings. The 2002 addition have aluminum frame windows with double glazing. These windows are approaching their half life, and have been reported to have significant drafts. Overall the window construction is in good condition. The exterior doors are constructed of aluminum with aluminum frames and have 1/4" tempered glass similar to the windows. There are 9 roll up garage doors, 7 of which are used for CTC, and two at the loading docks. The roll up doors are functioning and in fair condition, replacement is recommended. The windows on the lower level of the north side are located almost at grade, and have to be shoveled out when it snows, creating a maintenance nightmare, and increase risk for leaking.

Aluminum Curtain Wall System – Full replacement of Exterior Kalwall Insulated Panel system and windows. See structural report for required structural upgrades with any replacement

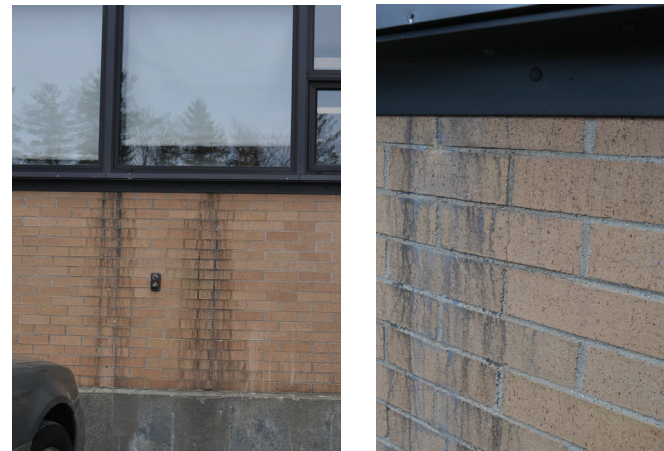
Stained Brick Under Curtain Wall System

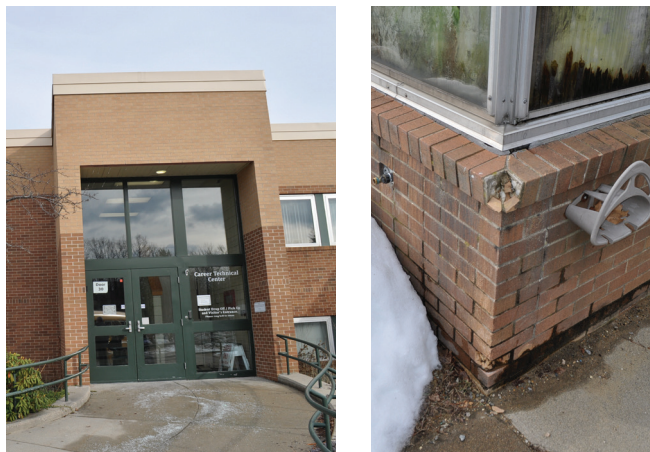
CTC Entrance & Brick in Disrepair

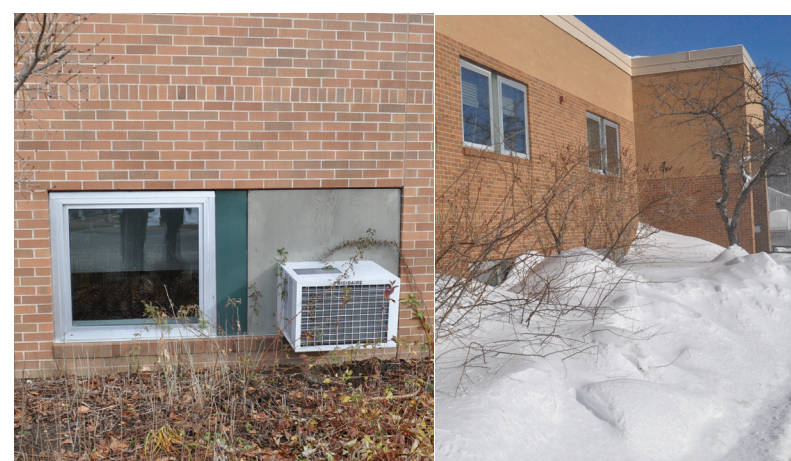
Windows Located at Grade, same window after snow storm

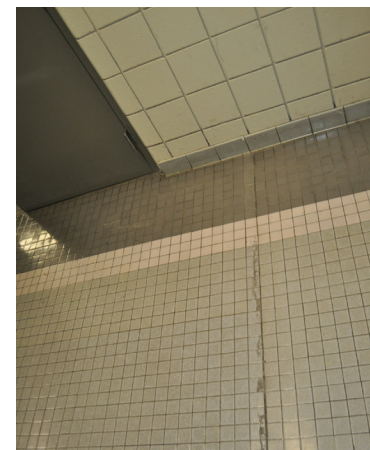
Cracked Tile Floor

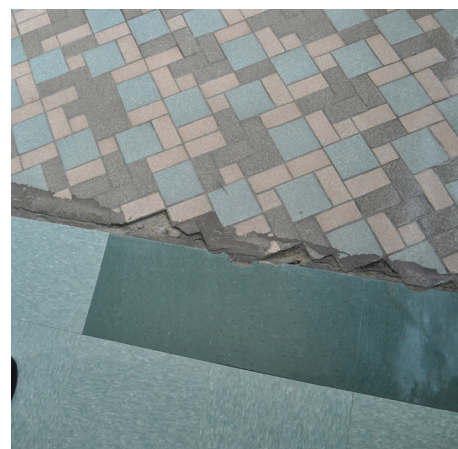
Missing Expansion Joint at 2002 Addition

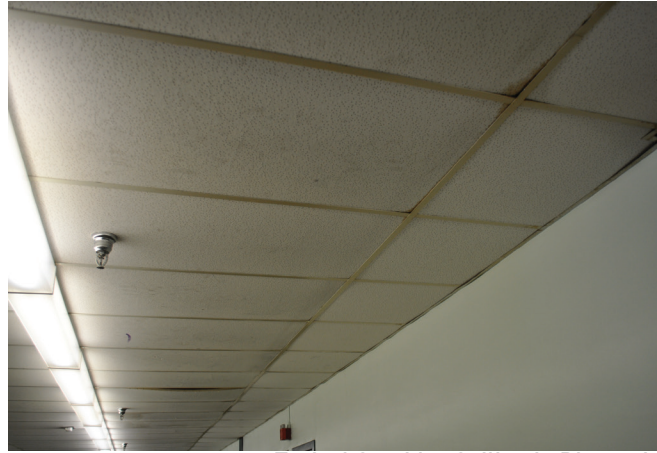
Typical Corridor Ceiling in Disrepair

Acoustic Ceiling Tile (ACT) is installed throughout the school, and is in complete disrepair. Much of the ceiling tile and grid is warped, stained, or painted. None of the existing ceiling tile and grid is salvageable and will require full replacement with any renovation.

- a. Replace all ceiling tile and grid

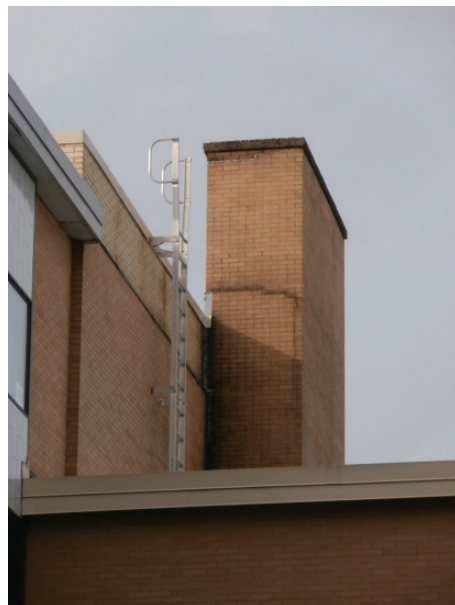
6. Masonry chimney – note step crack near upper roof line.

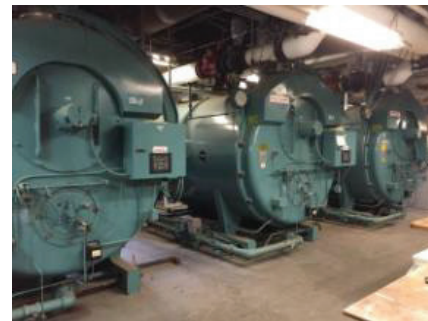
The building is primarily heated by gas fired hot water boiler plant. There are three (3) gas-fired hot water boilers located in the lower level boiler room. The boilers were manufactured by Cleaver Brooks (Model CBLE-700 240 125, Serial Nos. 0L102065, 0L102066, 0L102067) with 9,900 MBH gas input. The boilers are equipped with CB Hawk boiler controls. The boilers were installed circa 2002 and are approximately 12 years old. The boilers appear to be in good physical condition.

Existing Boilers

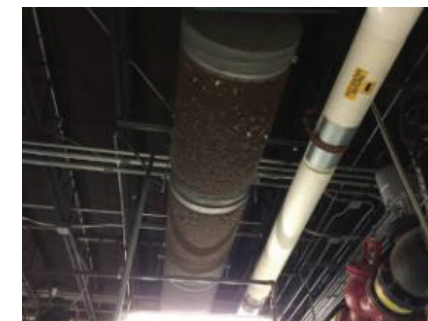
Combustion Air Perforated Supply Diffuser

Combustion air for the boilers is provided by two (2) inline combustion air fan systems. Combustion air is distributed to the boilers via galvanized sheetmetal ductwork and perforated supply diffusers that are located between the boilers. The perforated supply diffusers were observed to be dirty and clogged.

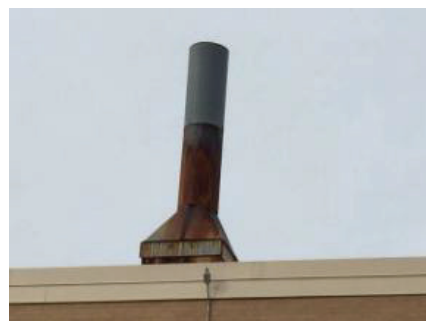
The boilers are vented by a common steel breeching system that terminates through the roof to the outdoors. The steel breeching is uninsulated, and the exterior breeching shows visible signs of rust and corrosion.

Exterior Boiler Breeching Stack

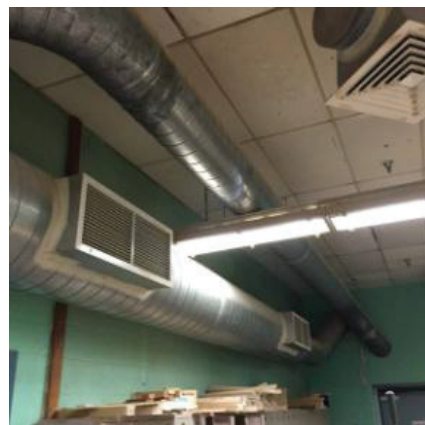
The Wood Shop is primarily heated and ventilated by a hot water unit ventilator, and supplemental ventilation air is provided by a central station air handling unit. There is an outdoor grade mounted dust collector installed that is ducted to wood-working saws and equipment via galvanized sheetmetal ductwork. The unit ventilator, dust collector and associated ductwork appears to be in poor condition.

Wood Shop - Ventilation Ductwork

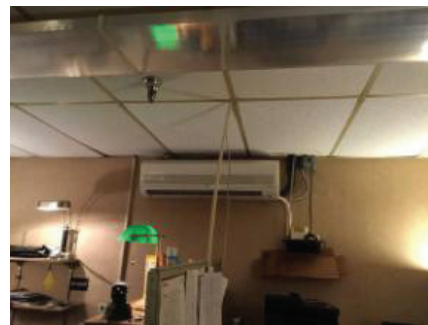
The IT Server and Office room is air conditioned by a ductless AC unit. It was reported that the room is consistently warm and experiences inadequate airflow and temperature control.

IT Room - Ductless AC Unit

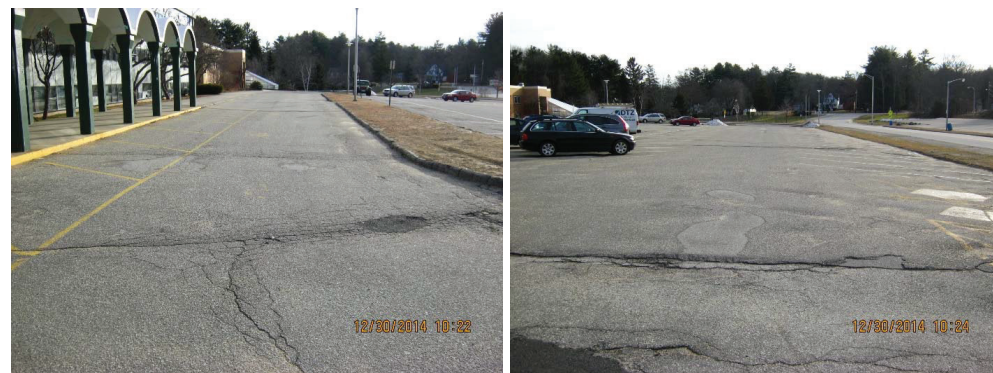
- Upon visual inspection the condition of the existing pavement is generally less than satisfactory. Numerous cracks (longitudinal, traverse, alligator) were observed in both the bus-drop off loop and the A Lot. Few of the cracks observed in the pavement have been sealed using asphalt crack sealant while the majority of the cracks have been left untreated.
- Some patch work and pavement overlays have been done over the years presumably to address the worst sections of pavement.
- Some raveling and aging (pavement surface deterioration/loss of aggregate) of the pavement is evident throughout but is the worst in the visitor parking spaces.
- The pavement overlays at the entrance and exit from Alumni Drive are in good condition.

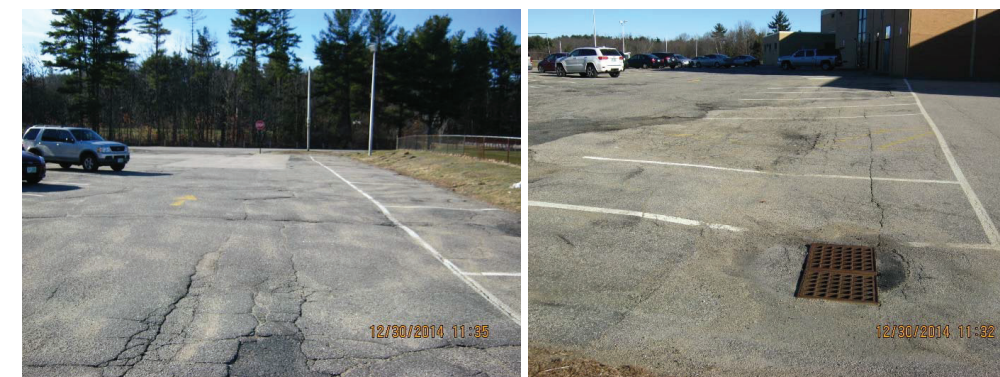
B Lot

- Upon visual inspection the condition of the existing pavement is generally poor. Numerous cracks (longitudinal, traverse, alligator) were observed in both the B lot and the portion of the lot associated with the 2002 addition. Few of the cracks observed in the pavement have been sealed using asphalt crack sealant while the majority of the cracks have been left untreated.
- Some patch work and pavement overlays have been done over the years presumably to address the worst sections of pavement.
- Some raveling and aging (pavement surface deterioration/loss of aggregate) of the pavement is evident throughout.
- The pavement overlay at the entrance and exit from Alumni Drive is in good condition.
- The entrance and exit from Alumni Drive is in less than satisfactory condition.

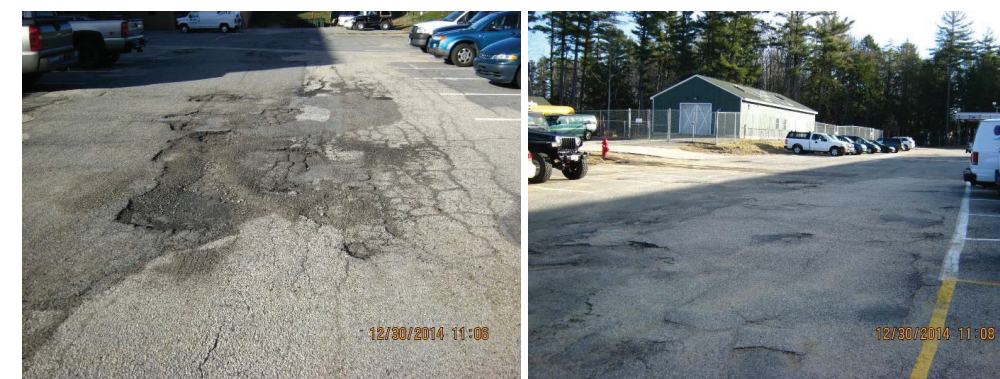
C Lot

- Upon visual inspection the condition of the existing pavement is generally very poor. Numerous cracks (longitudinal, traverse, alligator) were observed in the C lot. A few of the cracks observed in the pavement have been sealed using asphalt crack sealant while the majority of the cracks have been left untreated.
- Some patch work and pavement overlays have been done over the years presumably to address the worst sections of pavement.
- Serious raveling and aging (pavement surface deterioration/loss of aggregate) of the pavement is evident throughout sections of the C lot. This likely results in surface ponding during/following rain events.
- The entrance and exit road from Alumni Drive is in less than satisfactory condition.

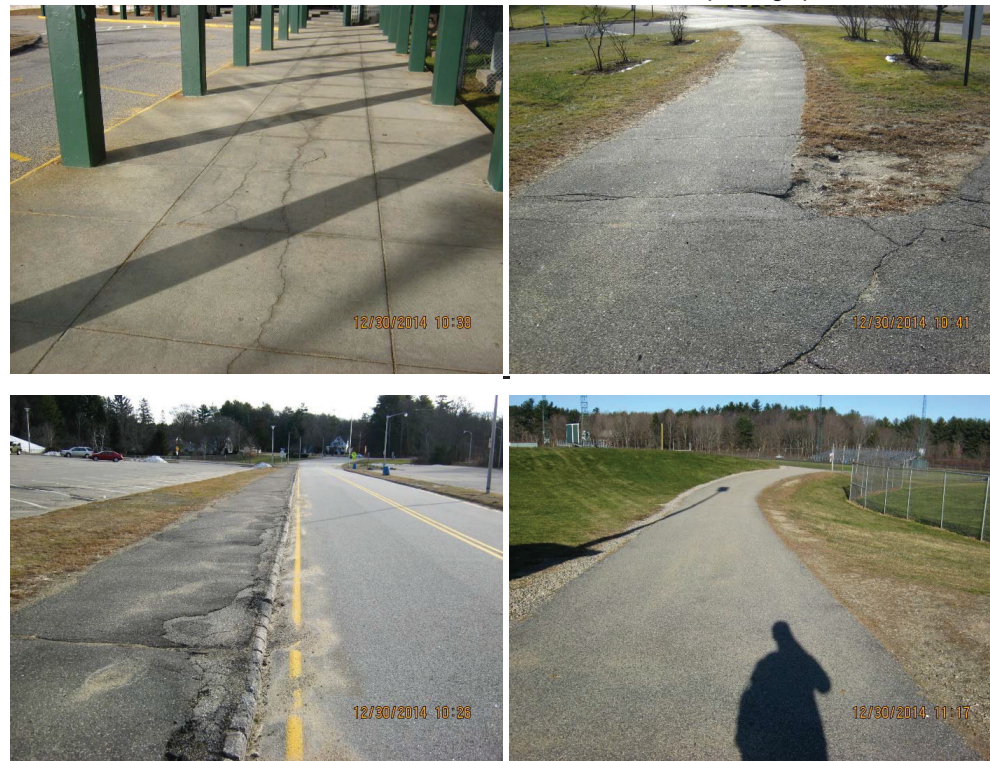
- The sidewalk along the edge of Alumni Drive is in poor condition. Numerous cracks (longitudinal, traverse, alligator) were observed in the asphalt. Raveling and aging (pavement surface deterioration/loss of aggregate) of the asphalt was also observed, most notably at the sidewalk edges. Appeared that the sidewalk has been overlain in the past.
- The walkways to the building at 50 Alumni Drive are in good condition.
- The walkway from the B Lot to the ball fields was in good condition.
- The walkway from the B Lot to the doors at the front of the 2002 addition (Door #3 & Door #4) are in good condition.
- The concrete sidewalk leading to Door 28 at the east side of the 1989 addition is in poor condition. The concrete has deteriorated next to the accessible parking space.
