CITY OF DOVER
TRANSPORTATION COMPONENT - MASTER PLAN

FINAL REPORT
TECHNICAL MEMORANDUM NO. 1
PROBLEM INTERSECTION LOCATIONS

THE CITY OF DOVER, N.H.
DEPARTMENT OF PLANNING
AND COMMUNITY DEVELOPMENT

JULY, 1988

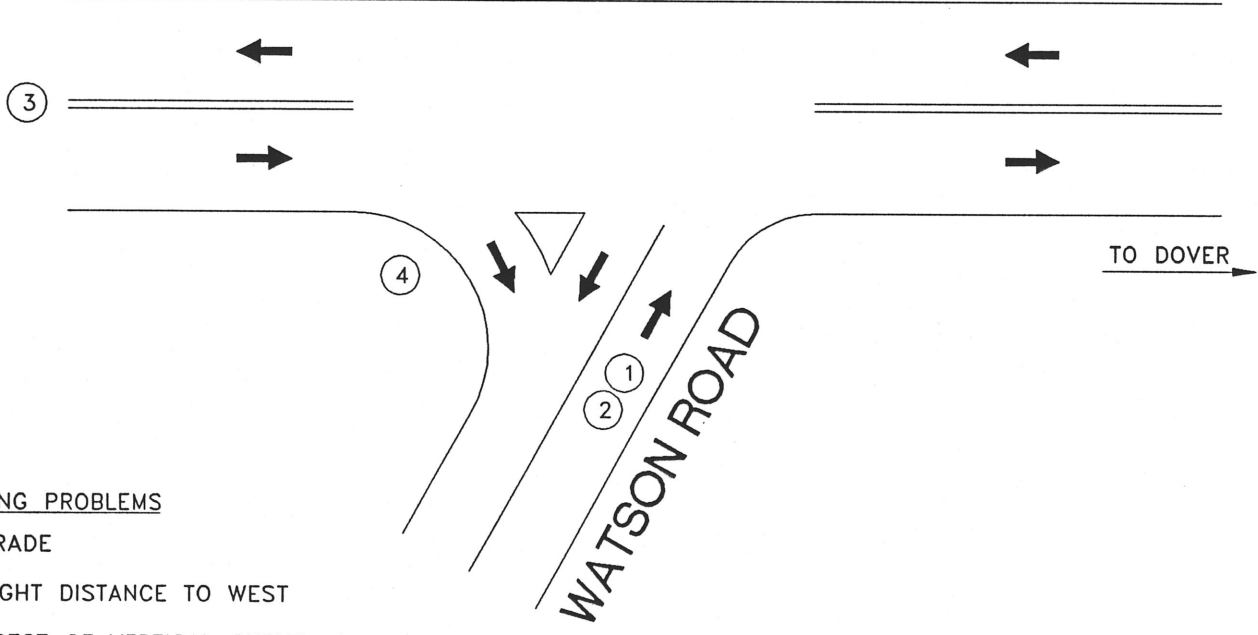
EXISTING CONDITIONS
Watson Road at County Farm Road

- ① GRADE
- ② SIGHT DISTANCE TO WEST
- ③ CREST OF VERTICAL CURVE
- ④ ROADSIDE VEGETATION

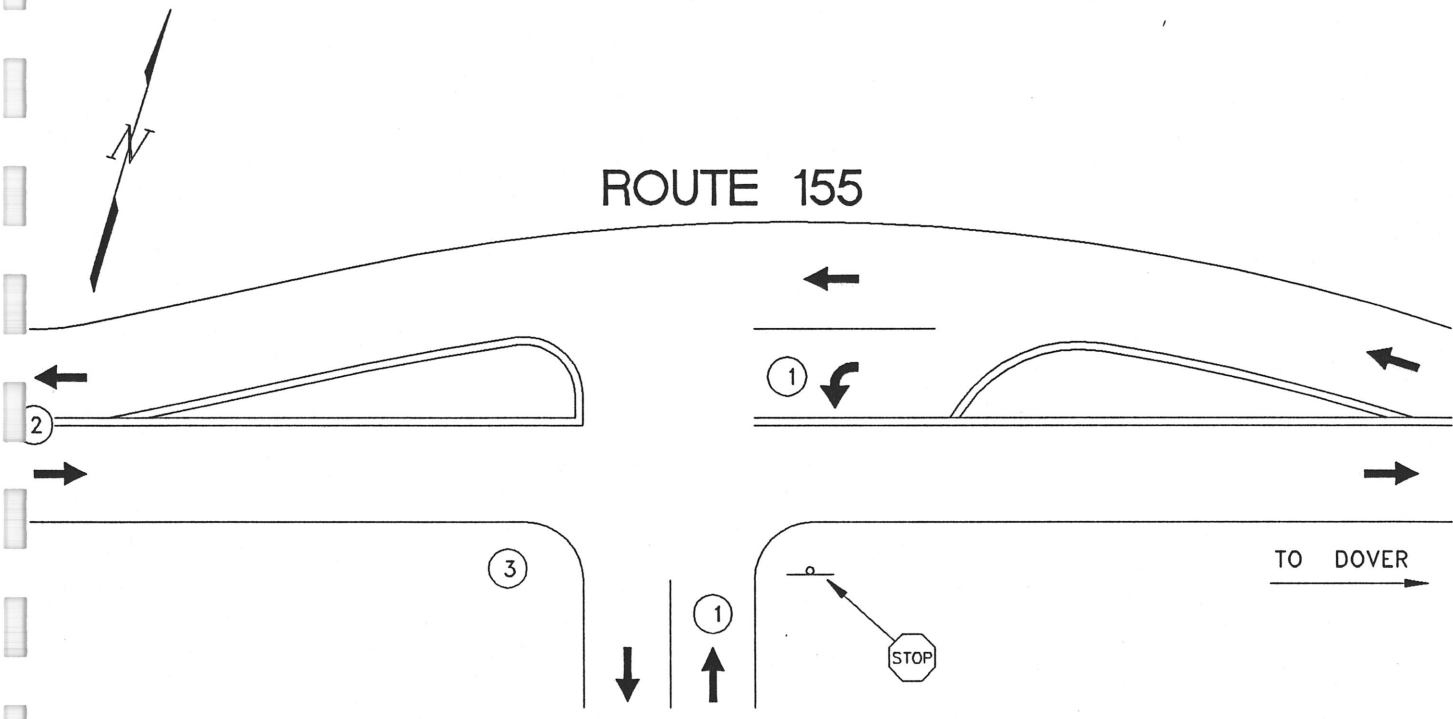
EXISTING CONDITIONS
Route 155 at Westgate Apartments

- ① SIGHT DISTANCE TO WEST
- ② CREST OF VERTICAL CURVE
- ③ RAISED FILL AREA BEHIND CURB

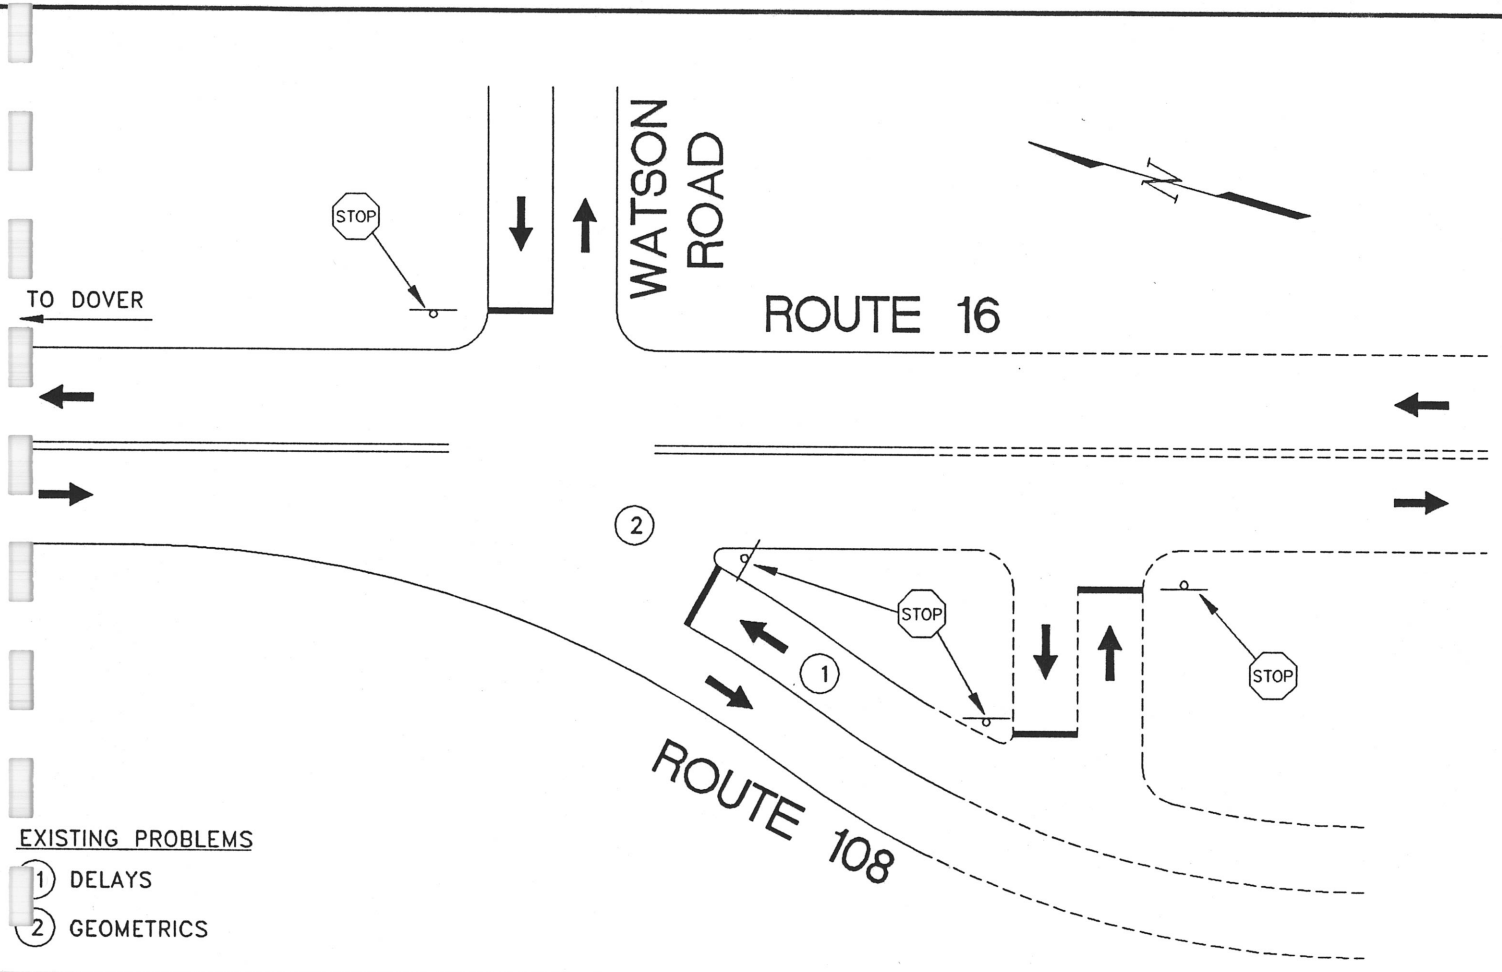
EXISTING CONDITIONS
Route 108 at Route 16

- ① DELAYS
- ② GEOMETRICS

A problem observed at this intersection is the extreme skew of the Route 108 northbound approach to Route 16. This skew complicates a driver's sight distance, and coupled with heavy flows of peak period traffic, creates a difficult intersection approach to negotiate.

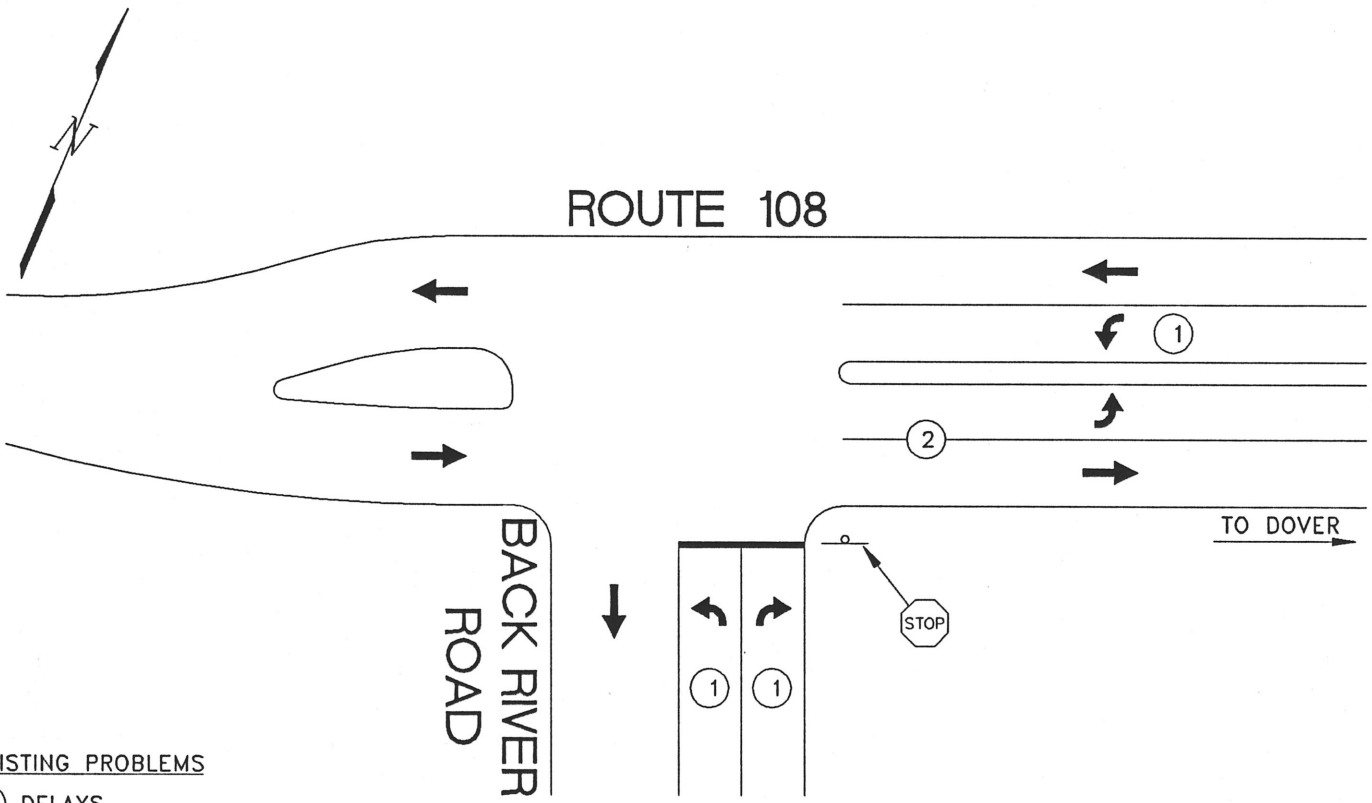
EXISTING CONDITIONS
Route 108 at Back River Road

- ① DELAYS
- ② QUEUEING FROM TRAFFIC SIGNAL AT MILL STREET

A problem observed at this intersection is the difficulty in Back River Road traffic entering Route 108 during peak traffic periods. The near proximity at the Mill Street/Spaulding Turnpike Ramps, with its signalized operation, results in queueing of northbound Route 108 traffic across the Back River Road approach, thereby blocking Back River Road traffic movement.

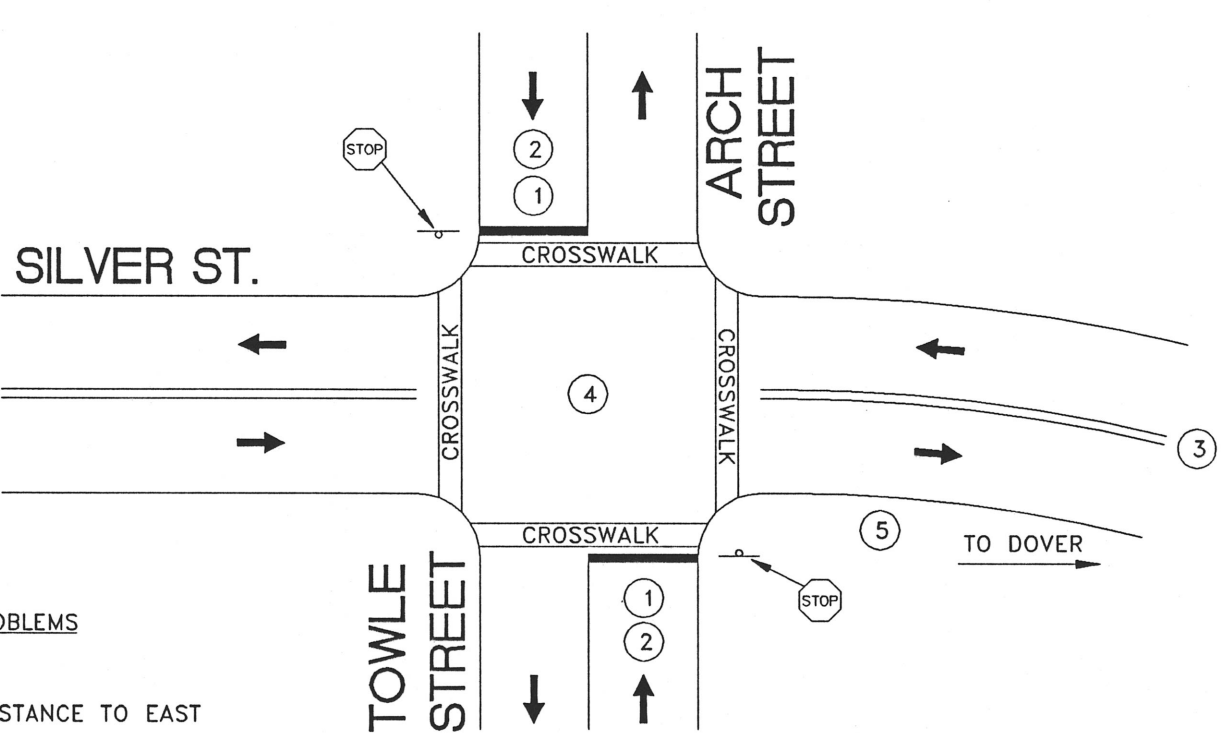
EXISTING CONDITIONS
Silver Street at Arch Street

- ① DELAYS
- ② SIGHT DISTANCE TO EAST
- ③ CREST OF VERTICAL CURVE
- ④ SCHOOL CROSSING
- ⑤ TREES

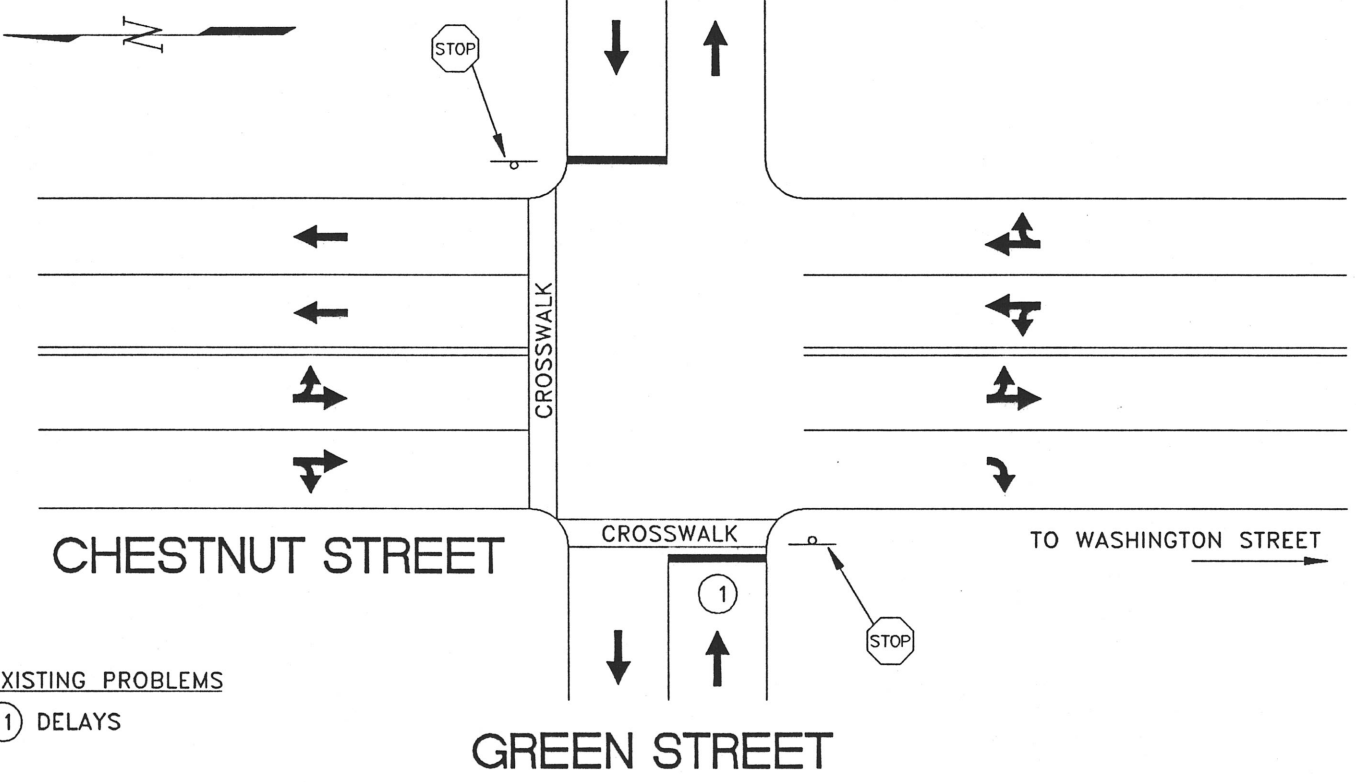
EXISTING CONDITIONS Chestnut Street at Green Street

- ① DELAYS

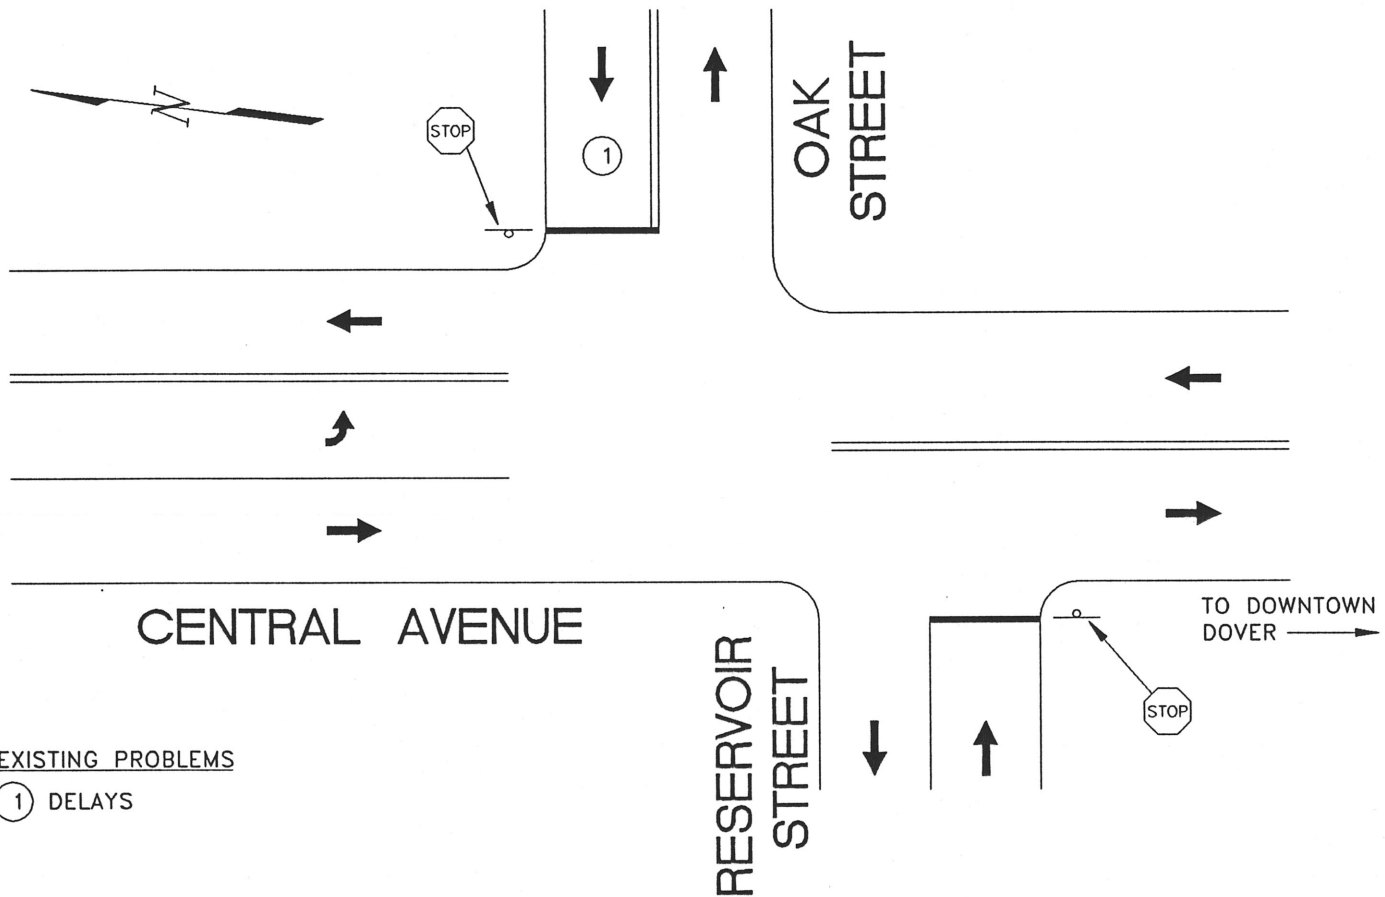
EXISTING CONDITIONS
Central Avenue at Oak Street

- ① DELAYS

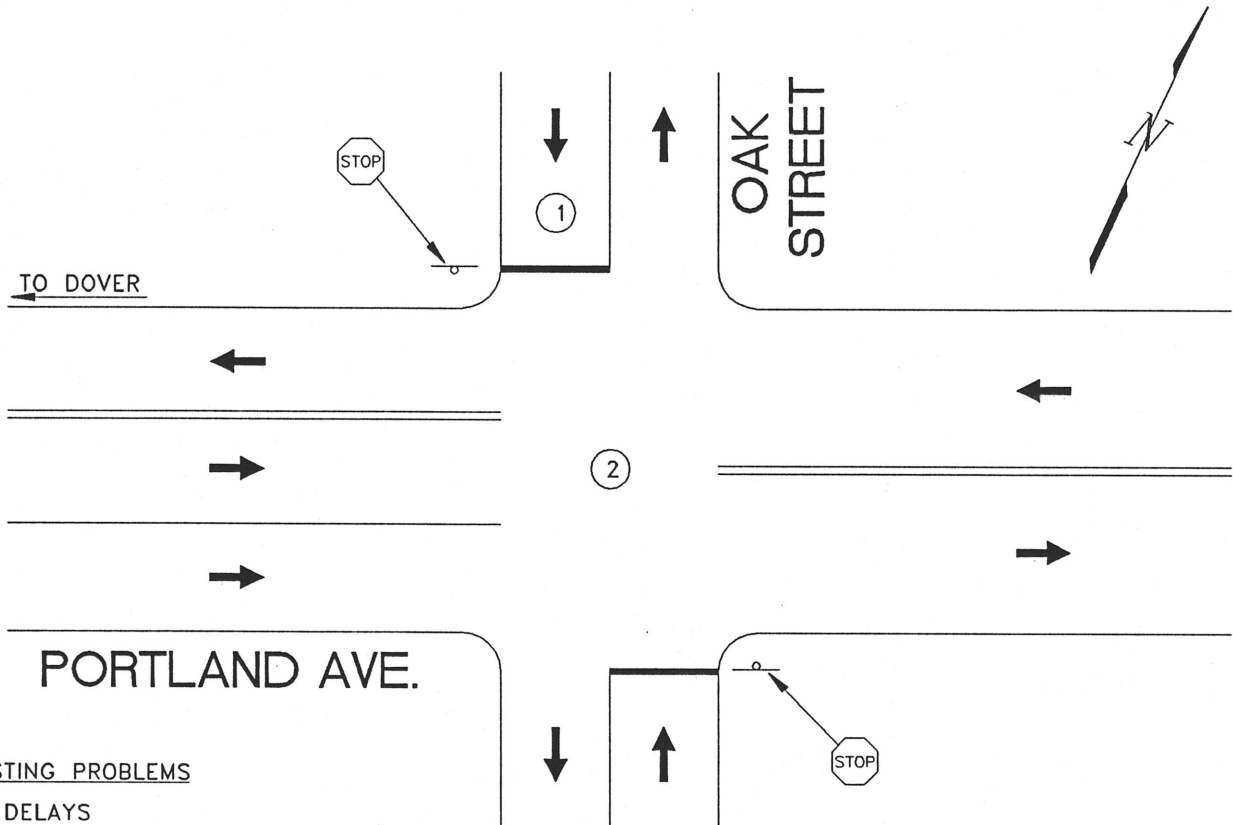
EXISTING CONDITIONS
 Portland Avenue at Oak Street

- EXISTING PROBLEMS
- ① DELAYS
 - ② HIGH SPEEDS

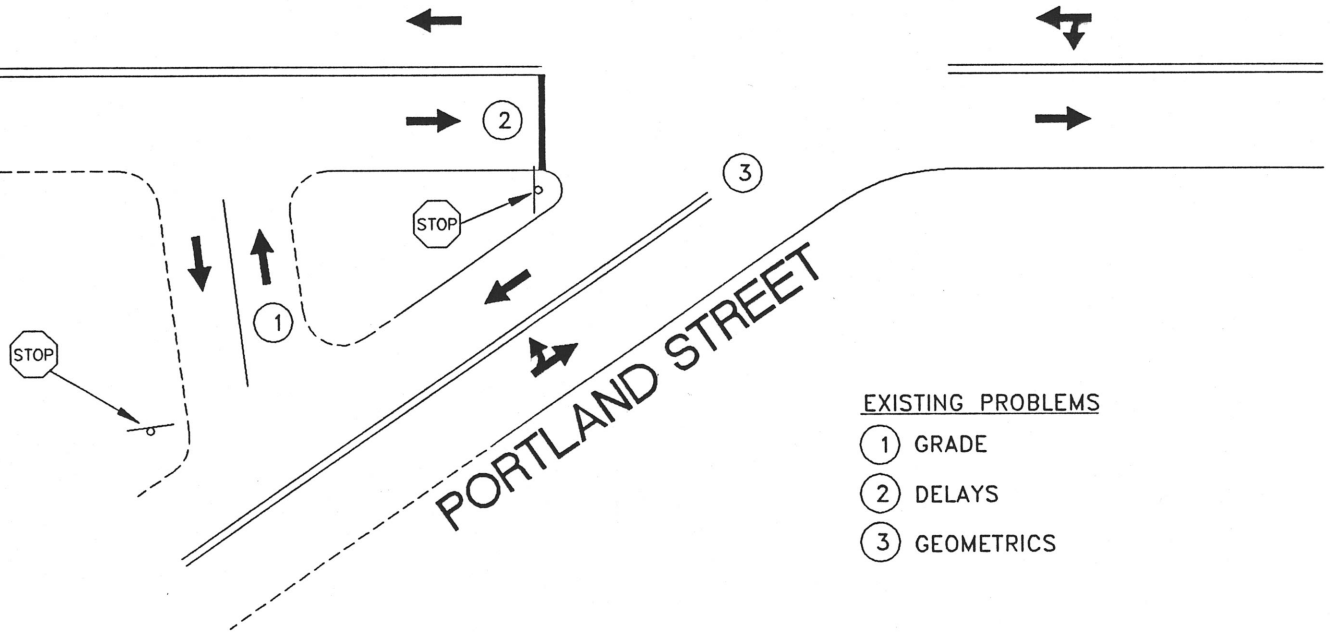
EXISTING CONDITIONS Portland Avenue at Portland Street

- ① GRADE
- ② DELAYS
- ③ GEOMETRICS

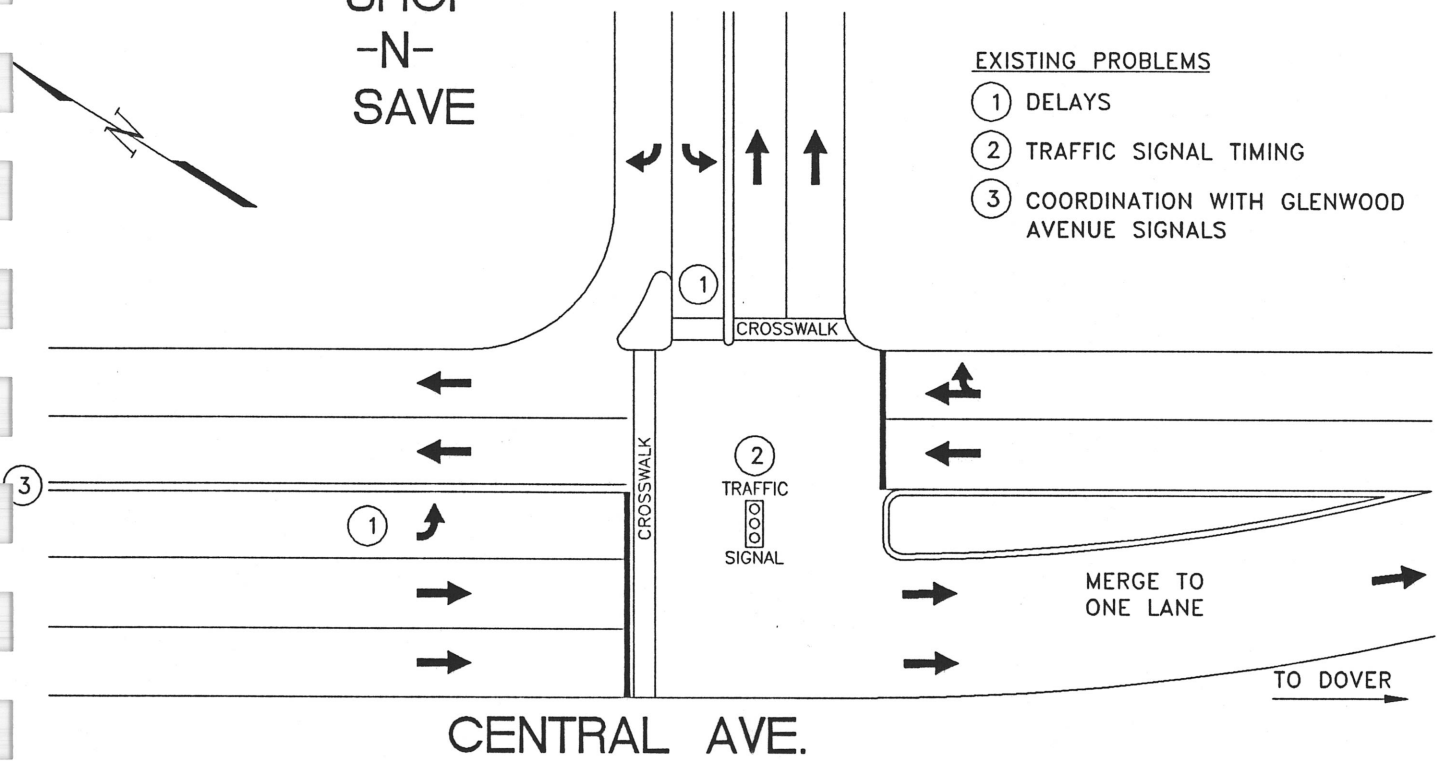
EXISTING CONDITIONS
Central Avenue at Shop'n Save

- ① DELAYS
- ② TRAFFIC SIGNAL TIMING
- ③ COORDINATION WITH GLENWOOD AVENUE SIGNALS

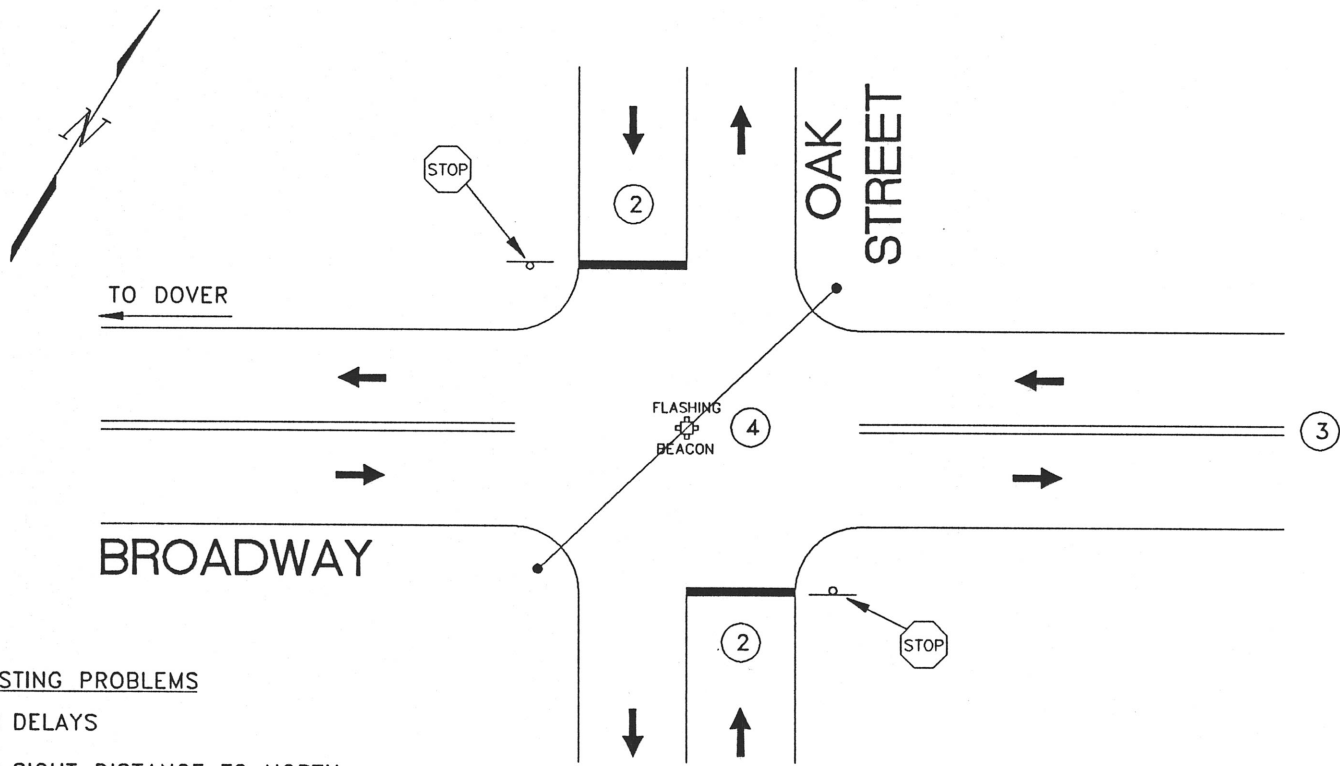
EXISTING CONDITIONS
Broadway at Oak Street

- ① DELAYS
- ② SIGHT DISTANCE TO NORTH
- ③ CREST OF VERTICAL CURVE
- ④ ACCIDENTS
