CITY OF DOVER
TRANSPORTATION COMPONENT - MASTER PLAN

FINAL REPORT
TECHNICAL MEMORANDUM NO. 1
PROBLEM INTERSECTION LOCATIONS

THE CITY OF DOVER, N.H.
DEPARTMENT OF PLANNING
AND COMMUNITY DEVELOPMENT

JULY, 1988

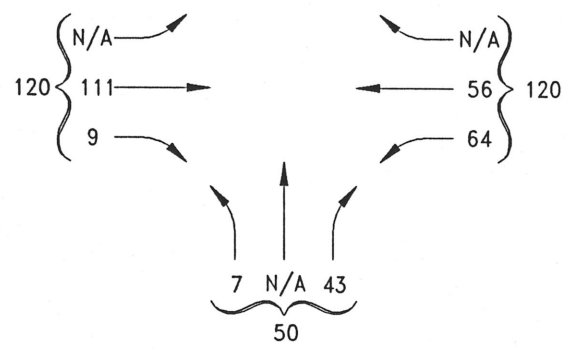
EXISTING CONDITIONS
Watson Road at County Farm Road

- ① GRADE
- ② SIGHT DISTANCE TO WEST
- ③ CREST OF VERTICAL CURVE
- ④ ROADSIDE VEGETATION

TOTAL ENTERING VOLUME: 290

MINOR STREET
LEVEL OF SERVICE: A

PROPERTY DAMAGE ACCIDENTS: 2
PERSONAL INJURY ACCIDENTS: 2

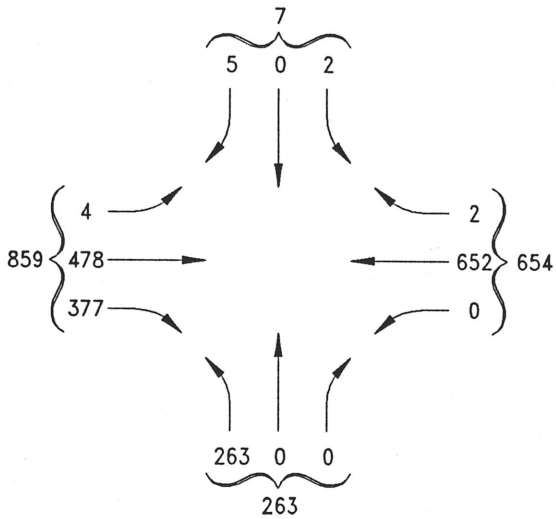
EXISTING CONDITIONS
Route 108 at Route 16

- ① DELAYS
- ② GEOMETRICS

TOTAL ENTERING VOLUME: 1783

MINOR STREET
LEVEL OF SERVICE: F

PROPERTY DAMAGE ACCIDENTS: 23
PERSONAL INJURY ACCIDENTS: 3

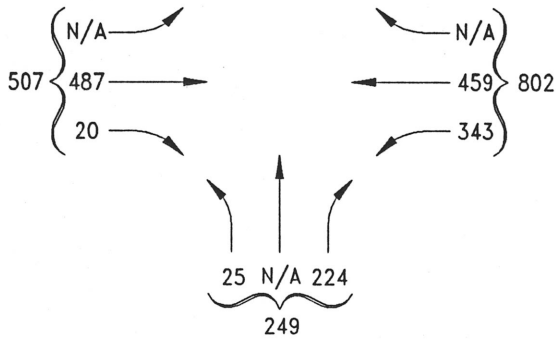
EXISTING CONDITIONS
Route 108 at Back River Road

- ① DELAYS
- ② QUEUEING FROM TRAFFIC SIGNAL AT MILL STREET

TOTAL ENTERING VOLUME: 1558

MINOR STREET
LEVEL OF SERVICE: E

PROPERTY DAMAGE ACCIDENTS: 18
PERSONAL INJURY ACCIDENTS: 2

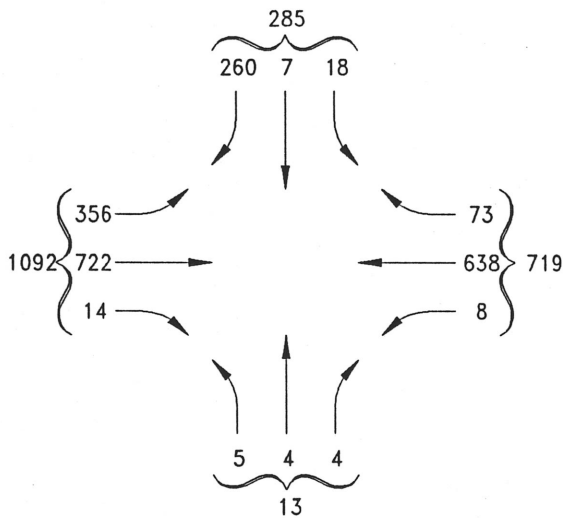
EXISTING CONDITIONS
Silver Street at Arch Street

- ① DELAYS
- ② SIGHT DISTANCE TO EAST
- ③ CREST OF VERTICAL CURVE
- ④ SCHOOL CROSSING
- ⑤ TREES

TOTAL ENTERING VOLUME: 2109

MINOR STREET
LEVEL OF SERVICE: F

PROPERTY DAMAGE ACCIDENTS: 11
PERSONAL INJURY ACCIDENTS: 4

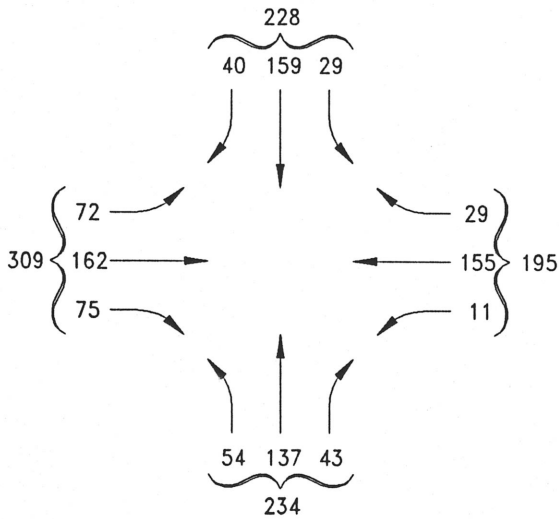
EXISTING CONDITIONS
Broadway at Oak Street

- ① DELAYS
- ② SIGHT DISTANCE TO NORTH
- ③ CREST OF VERTICAL CURVE
- ④ ACCIDENTS

TOTAL ENTERING VOLUME: 966

MINOR STREET
LEVEL OF SERVICE: F

PROPERTY DAMAGE ACCIDENTS: 30
PERSONAL INJURY ACCIDENTS: 6

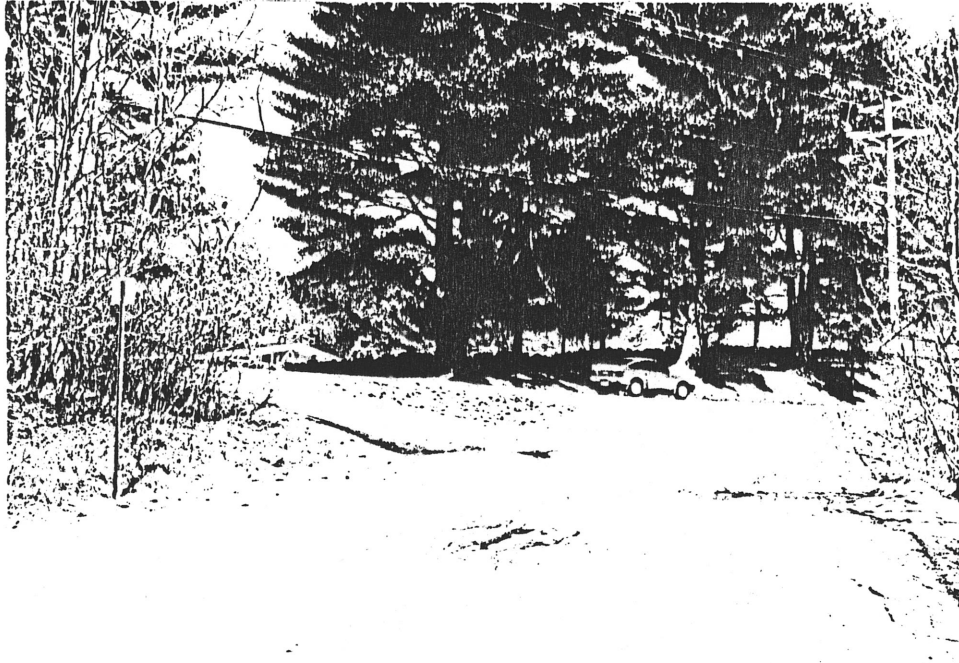
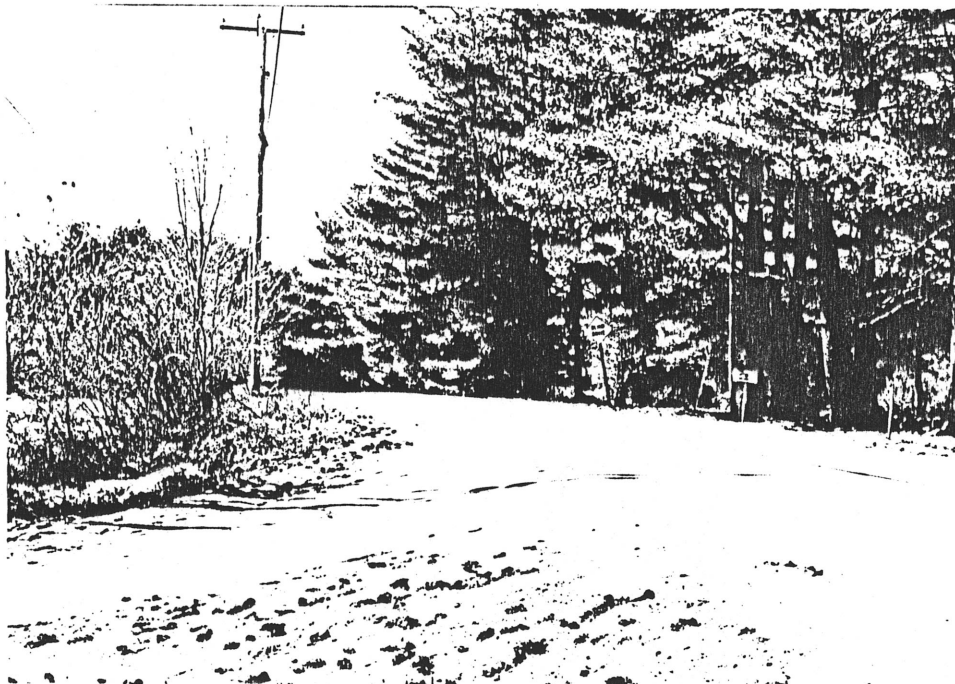
INTERSECTION 1: COUNTY FARM ROAD/WATSON ROAD

County Farm Road is a rural two-lane roadway that extends from 6th Street to points east in the City of Dover. Its pavement width is approximately 22 feet with 1-2 foot shoulders. Pavement markings in the vicinity of its intersection with Watson Road consist of a double yellow centerline. No posted speed limits were noted along County Farm Road. Due to its general curvilinear alignment, design speeds are estimated to be 40 mph.

Watson Road is a rural two-lane roadway with a pavement width of approximately 20 feet. No pavement markings or stop control was noted at its "T" intersection with County Farm Road.

Watson Road Northbound Approach To Intersection

Drivers View Looking West Along
County Farm Road At Intersection

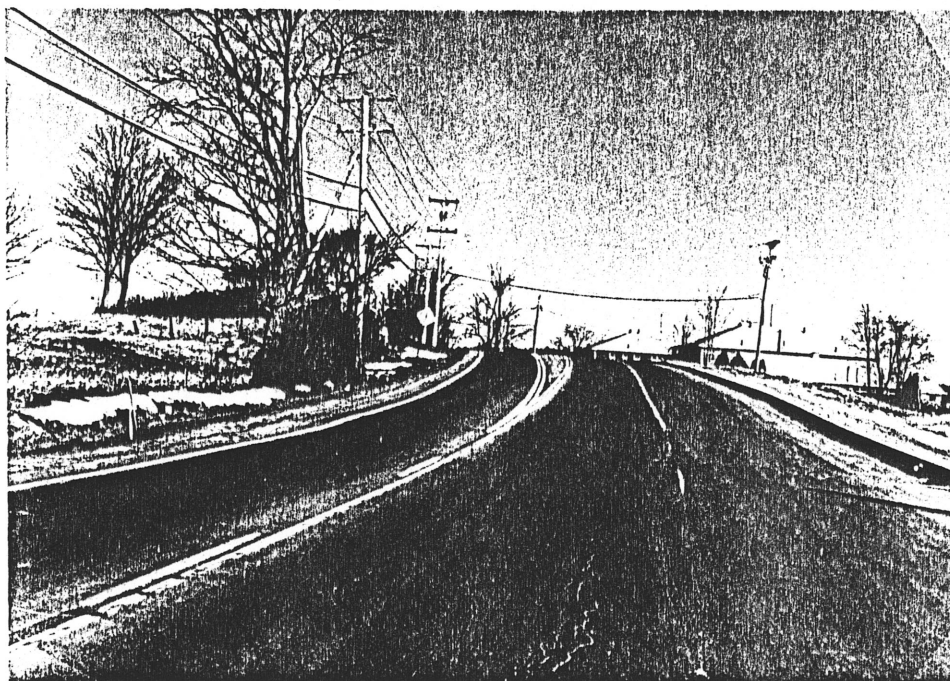
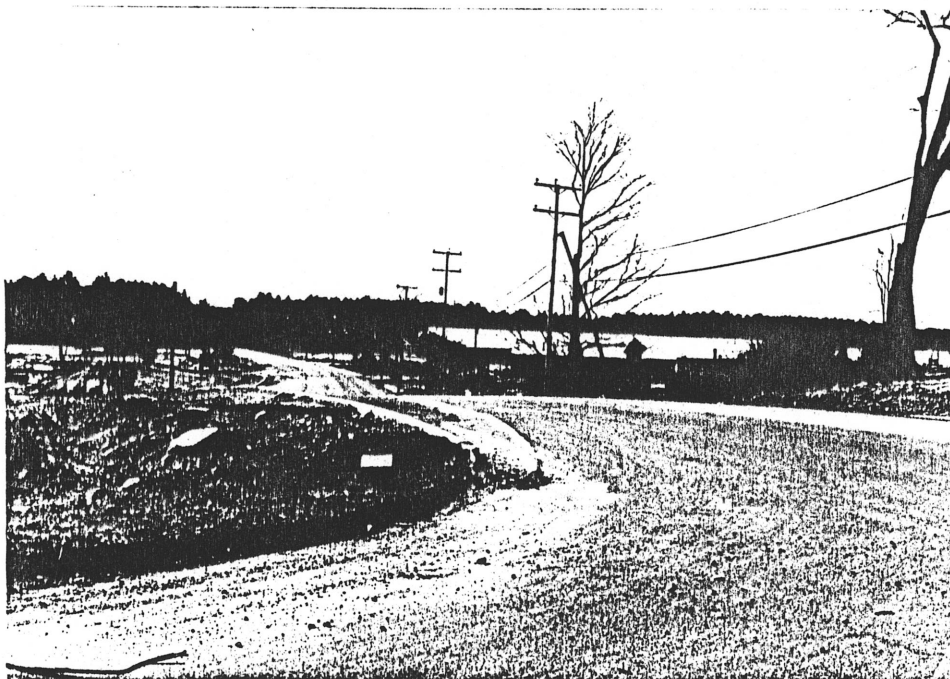
INTERSECTION 2: ROUTE 155/WEST GATE DRIVE

Route 155 Eastbound Approach To Intersection

**Drivers View Looking West Along
Route 155 At Intersection**

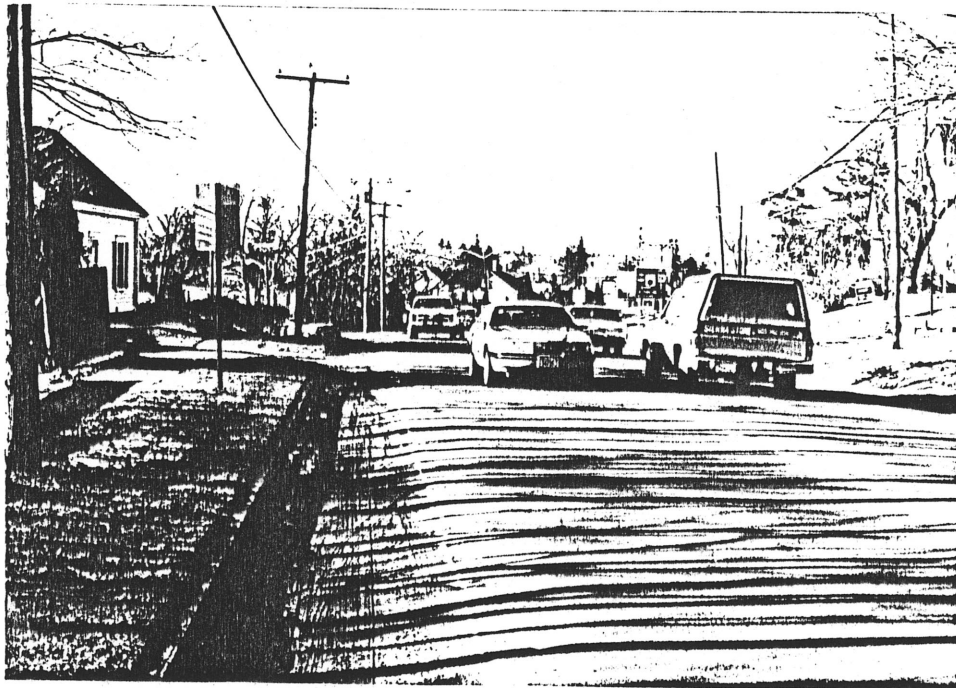
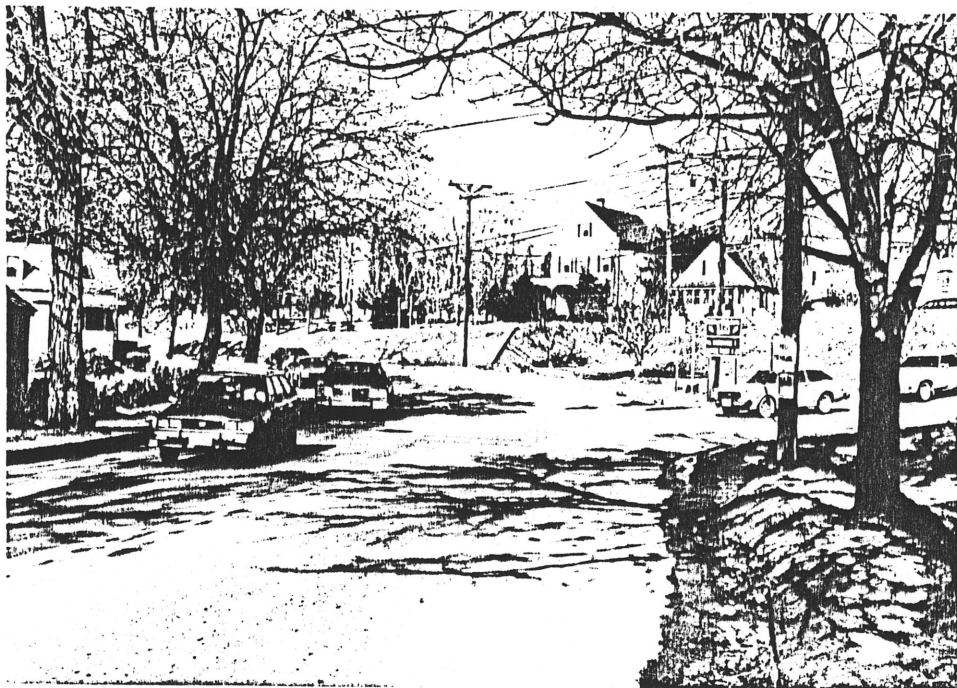
INTERSECTION 3: ROUTE 108/ROUTE 16

A problem observed at this intersection is the extreme skew of the Route 108 northbound approach to Route 16. This skew complicates a driver's sight distance, and coupled with heavy flows of peak period traffic, creates a difficult intersection approach to negotiate.

Route 16 Northbound Approach To Intersection

Route 108 Eastbound Approach To Intersection

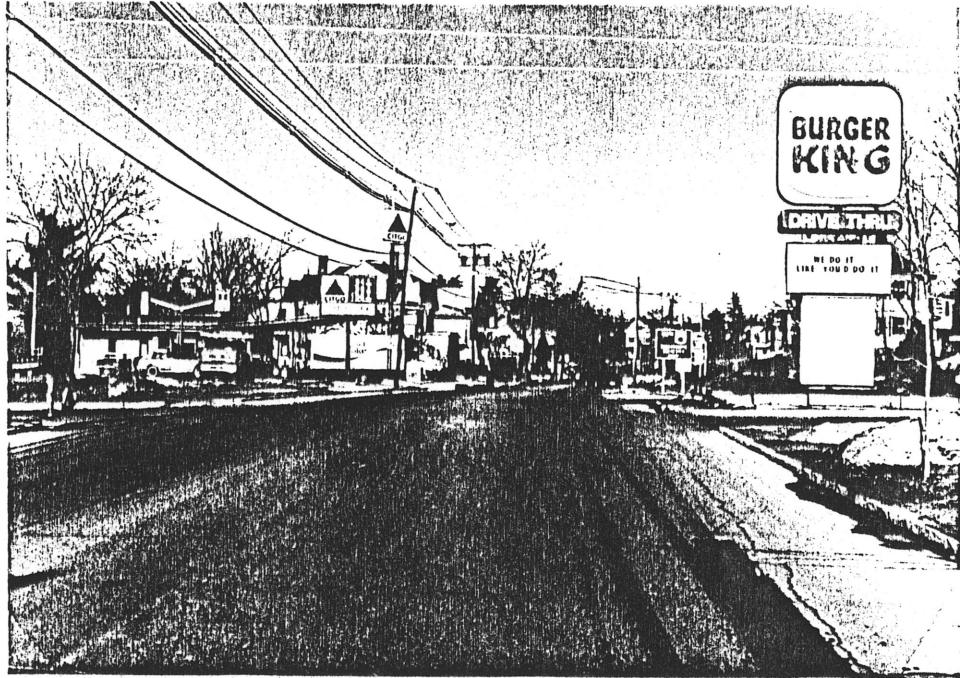
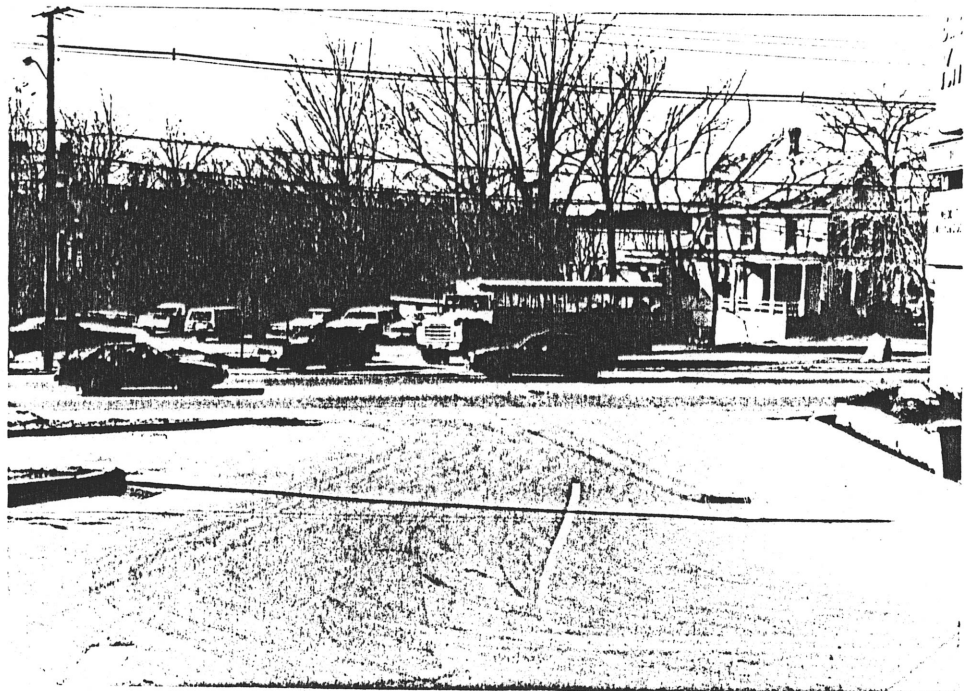
INTERSECTION 4: ROUTE 108/LOCUST STREET

A problem observed at this intersection is the skewed Locust Street approach to Route 108, coupled with the near proximity of the Burger King entrance and the ramps to the Spaulding Turnpike. Multiple uncontrolled traffic movements to and from Route 108 occur with the 100 to 200 foot segment bounded by these two intersections.

Route 108 Eastbound Approach Through Intersection

Looking North At Locust Street Intersection
From Burger King Driveway

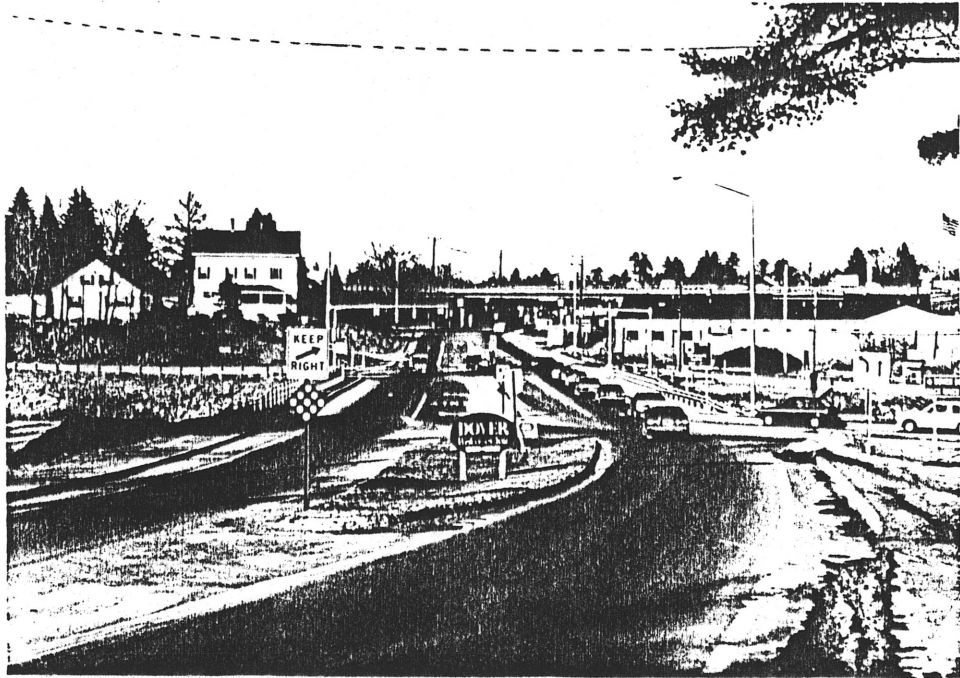
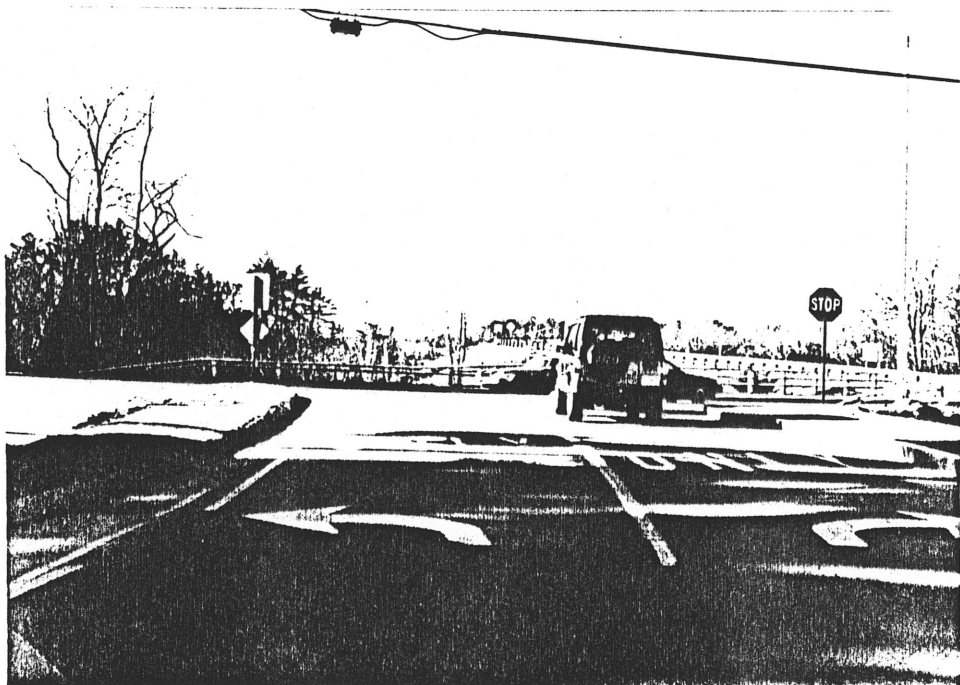
INTERSECTION 5: ROUTE 108/BACK RIVER ROAD

A problem observed at this intersection is the difficulty in Back River Road traffic entering Route 108 during peak traffic periods. The near proximity at the Mill Street/Spaulding Turnpike Ramps, with its signalized operation, results in queueing of northbound Route 108 traffic across the Back River Road approach, thereby blocking Back River Road traffic movement.

Route 108 Eastbound Approach Through Intersection

Back River Road Northbound Approach To Intersection

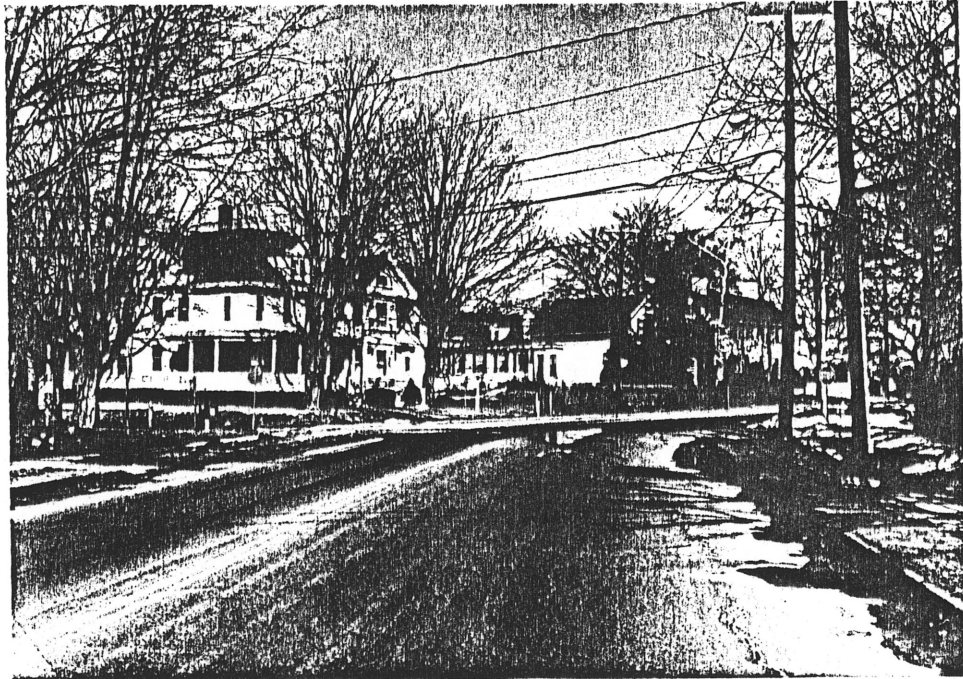
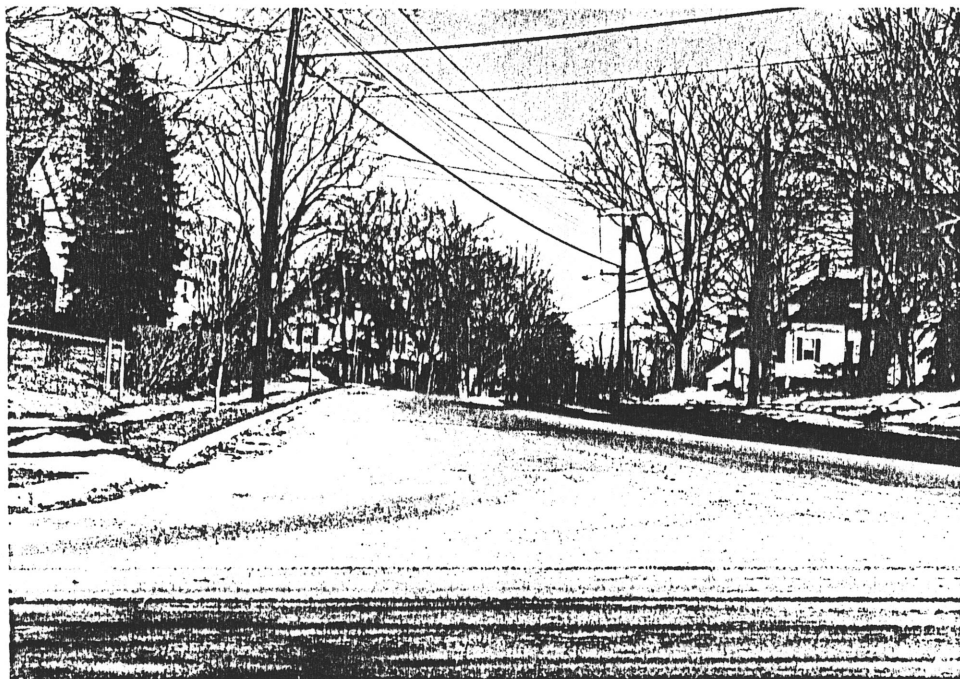
INTERSECTION 6: SILVER STREET/ARCH STREET

Silver Street is a two-lane urban arterial providing a primary connection between Central Avenue in downtown Dover to the Spaulding Turnpike. In the vicinity of its intersection with Arch Street and Towle Drive the roadway is marked as a school zone with 20 mph advisory speed limits. General vehicle speeds were observed to be approximately 35 mph. Pavement markings consist of a double yellow centerline and faded school/pedestrian crosswalks. Advance 'Dangerous Intersection' signing is also posted.

Silver Street Eastbound Approach To Intersection

**Drivers View Looking East Along
Silver Street At Intersection**

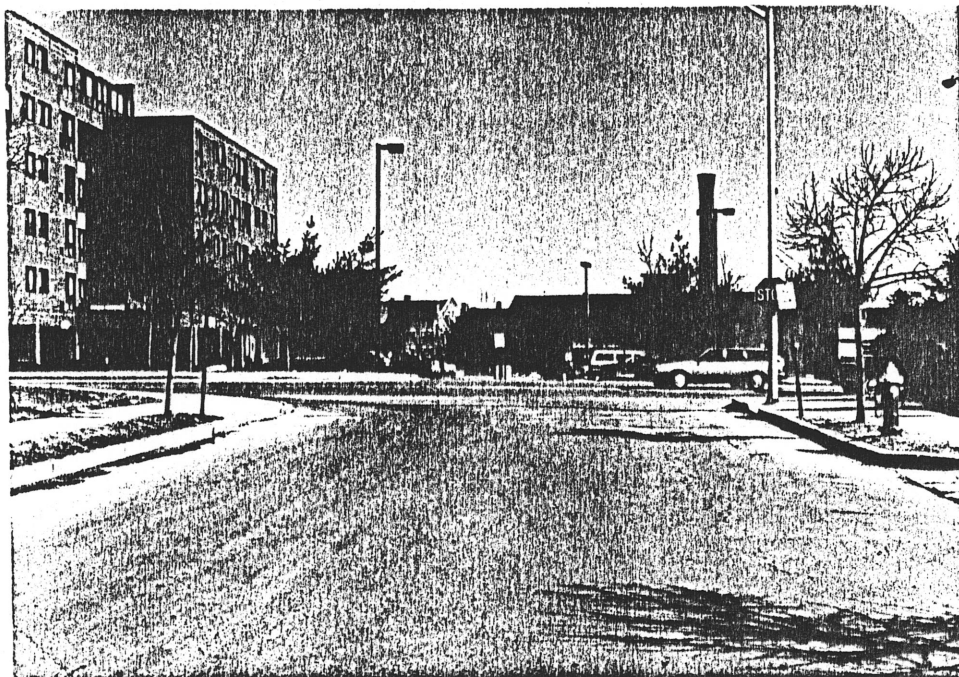
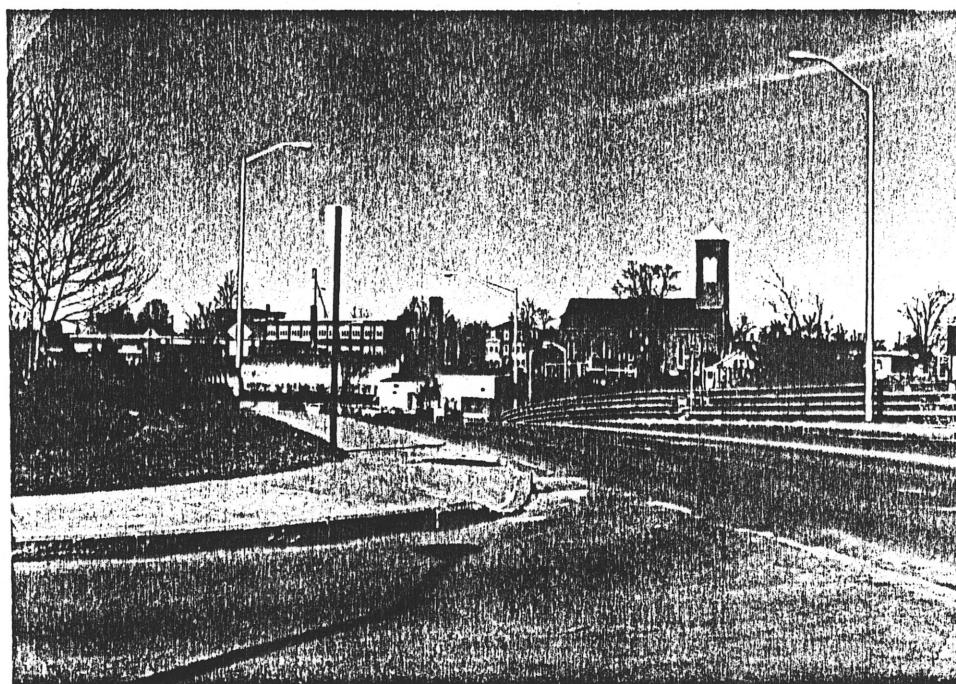
INTERSECTION 7: CHESNUT STREET/GREEN STREET

Chestnut Street is a downtown collector arterial route that extends from Central Avenue north of 6th Street to Washington Street. In the vicinity of its intersection with Green Street the roadway is approximately 44 feet wide providing for two thru lanes in each direction. General vehicle speeds were observed to be 30-35 mph. Pavement markings consist of a double yellow centerline, broken white lane lines and solid white lines outlying the outer edge of the travelled lanes.

Faded pavement markings were noted for two pedestrian crosswalks, one on the north leg and one on the west leg of the intersection.

Green Street Approach To Intersection

**Drivers View Looking North Along
Chesnut Street At Intersection**

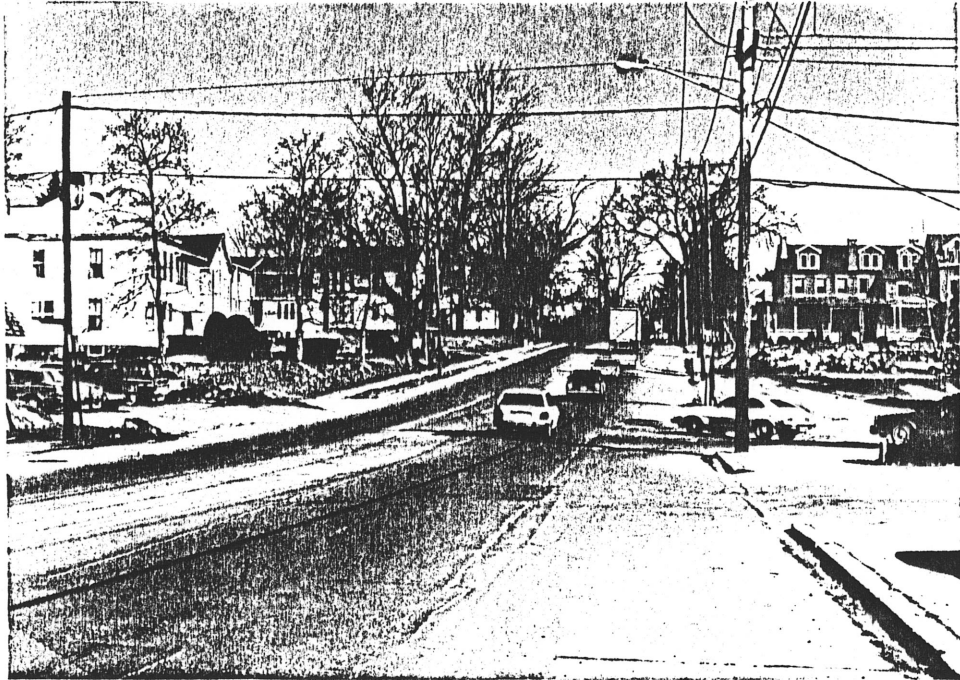
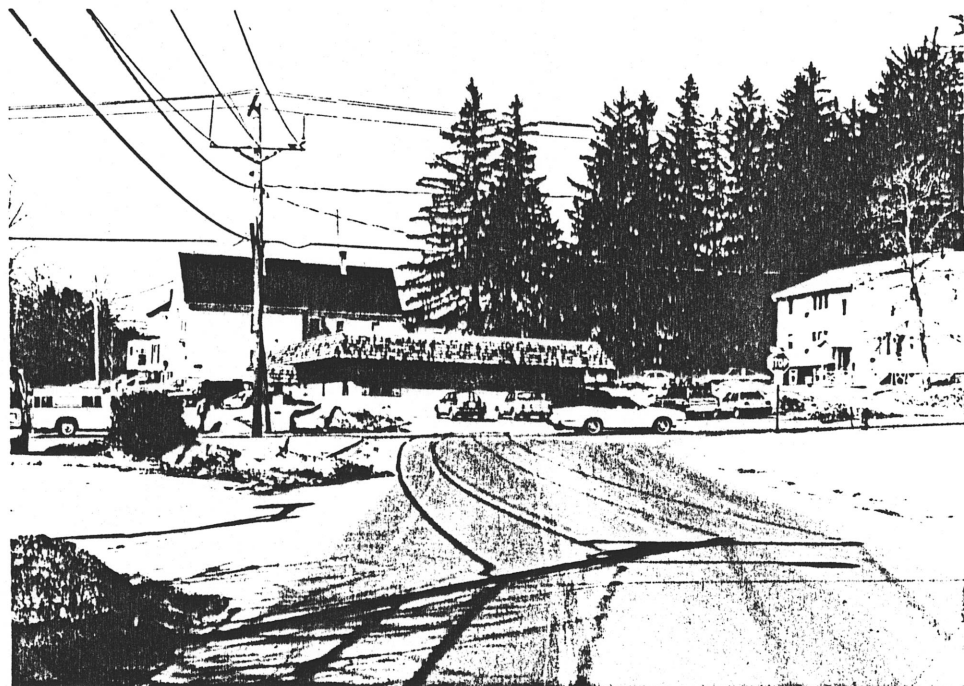
INTERSECTION 8: CENTRAL AVENUE/OAK STREET

Reservoir Street is a local 22 foot wide two-way street that intersects with Central Avenue approximately 35 feet to the south opposite Oak Street. Posted stop control is provided. Corner sight distance was observed to be greater than 350 feet.

Central Avenue Northbound Approach Through Intersection

Oak Street Westbound Approach To Intersection
