DOVER HIGH SCHOOL AND CAREER TECHNICAL CENTER Site & Building Assessment Report

Dover, New Hampshire

February 2015

HMFH Architects, Inc.

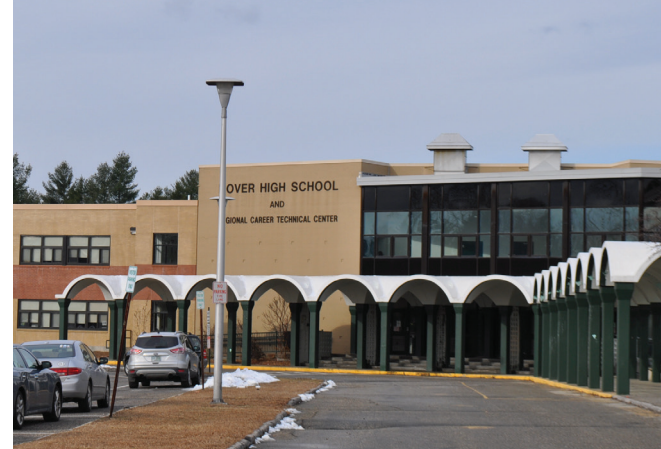
View of Entrance Canopy

At the main entrance a large double barrel vaulted canopy covers the walkway approach to the school. The canopy is held up by painted concrete columns, and the roof structure is concrete with painted plaster. The structure itself is sound, however the plaster is continuously flaking, requiring yearly maintenance repairs. (See Structural Report for further information)

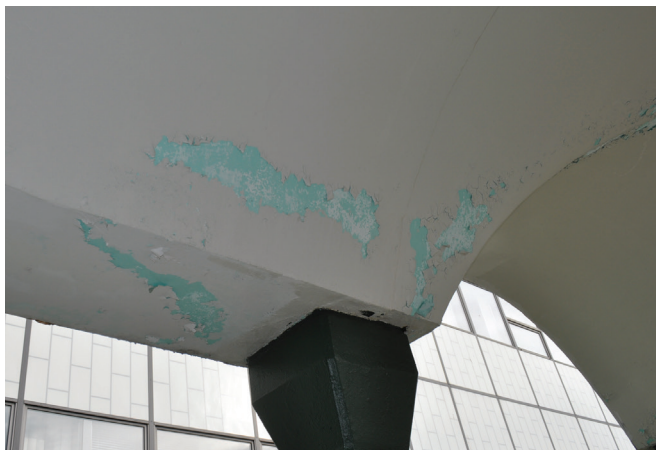
Flaking Plaster at Entrance Canopy

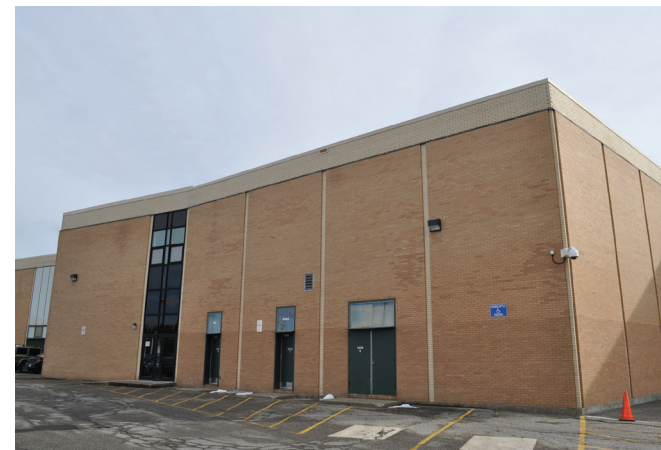
Exterior Wall System 1 - Brick Veneer

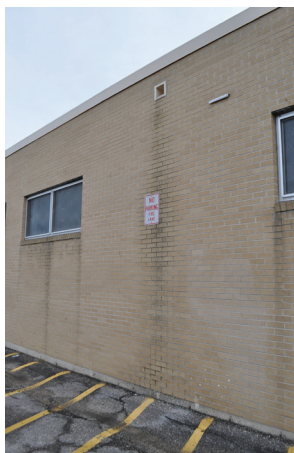
Stained Brick

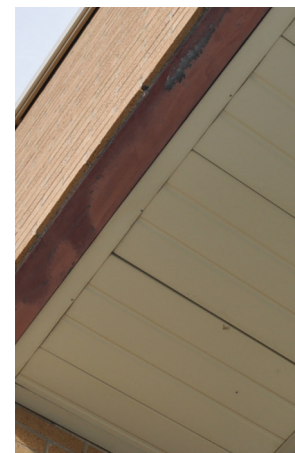
Rusted Lintels

The sealant around windows, doors, and control joints is showing signs of cracking, and some of the visible loose lintels are rusting with decay. There are various corners around the building where brick has been damaged and requires replacement. Although the masonry wall system does not meet today's code, the overall condition appears to be good, and with minimal work, new sealant, selective repointing, selective brick replacement, and a thorough cleaning, further investigation to its reuse should the building be renovated is recommended.

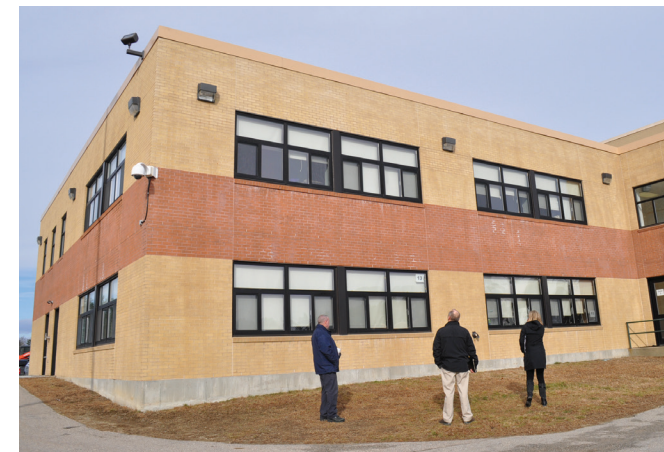
CTC Entrance & Brick in Disrepair

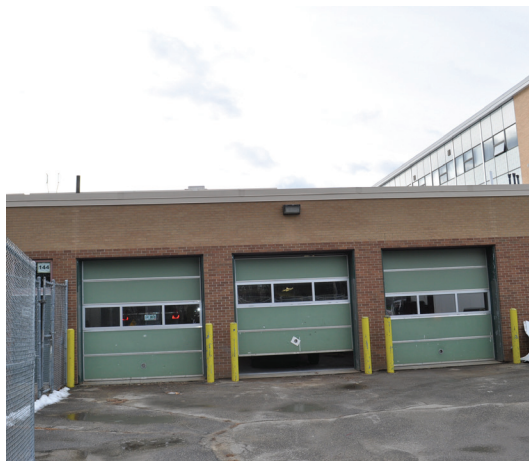
2002 Addition with Visible Efflorescence

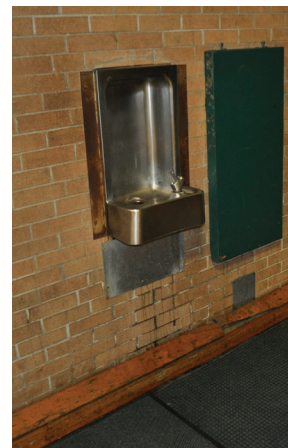
Drinking Fountain, Aged Base Board & Cracking CMU

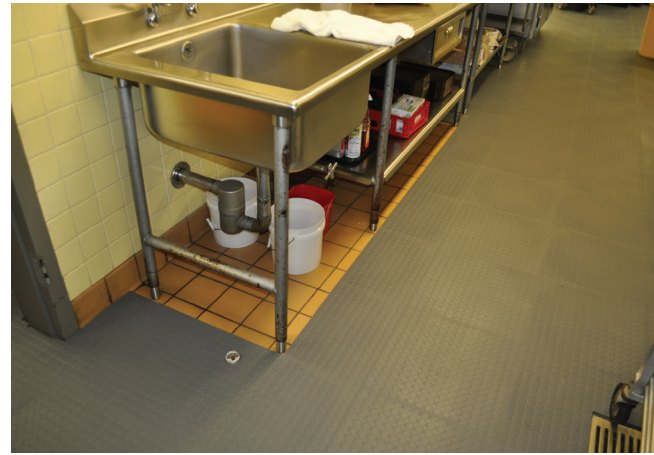
Kitchen Rubber Floor

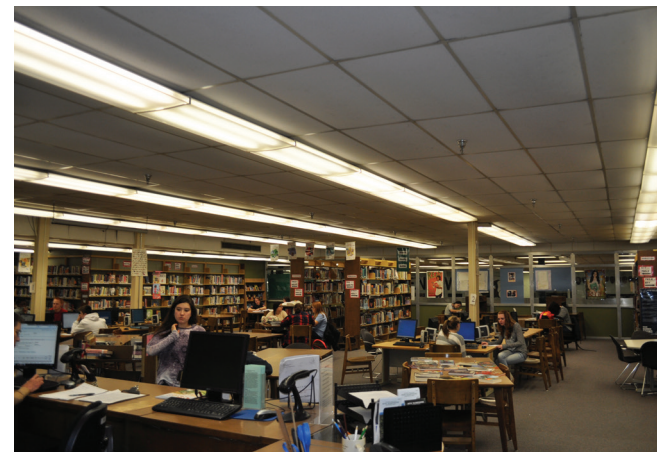
Library, No Natural Daylight

The Library is located central to the school on the main level. There are no exterior windows or natural light, and the interior lighting is poor. This interior space is furnished with aged tables, chairs and book shelves. The wall paper is original to the school, and shows visible tears and repairs with duct tape. The space requires a complete renovation, and all finishes should be replaced. This space would benefit greatly from natural light.

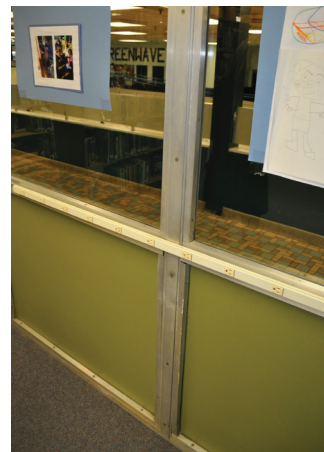
Interior Aluminum Wall System & Aged Bookshelves

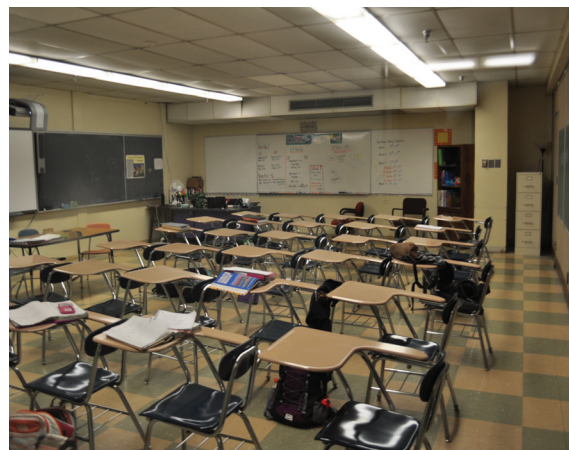
Typical Classroom - Asbestos Tile Floor

The 1966 portion of DHS has a variety of floor types throughout the school. The corridors, kitchen, bathrooms, and lockers rooms are ceramic tile, the classrooms and cafeteria are Vinyl Coated Tile (VCT), the auditorium, library, computer room, administration areas and select other spaces have carpet, the gymnasium is athletic wood flooring. All of the flooring in the 1966 portion of the school is beyond its useful life and would require full replacement. The 2012 AHERA report as attached in the appendix, indicates that all of the flooring listed above with the exception of the gym floor is assumed to have asbestos containing material, and would need full remediation prior with any renovation, demolition or addition.

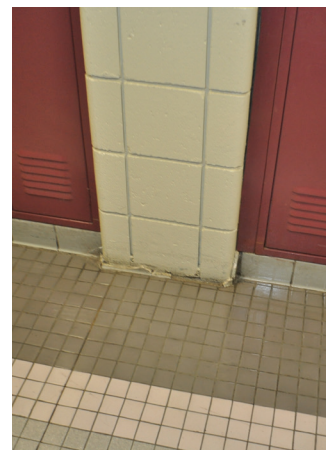
Base in Disrepair

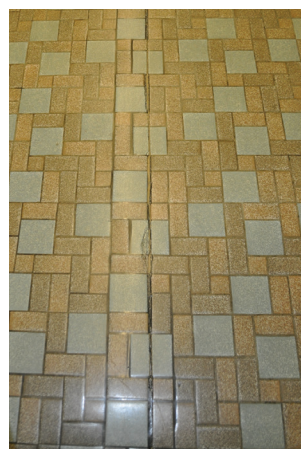
Cracked Tile Floor

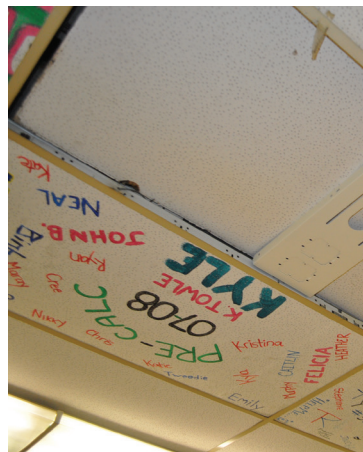
Typical, Painted Ceiling Tiles

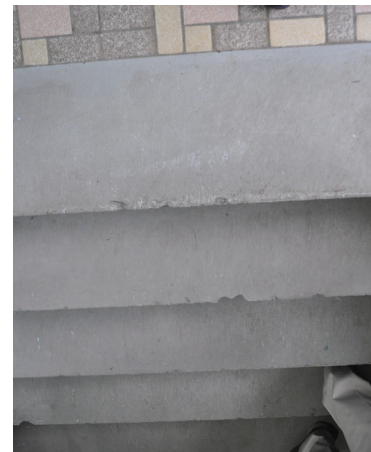
Chipped Blue Stone Treads

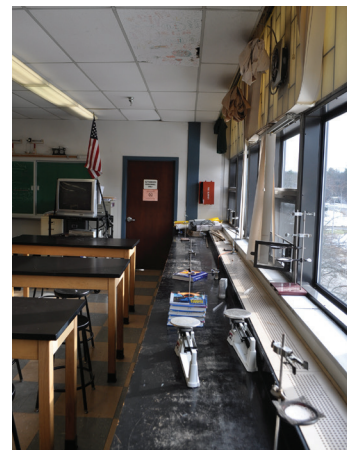
Counter Tops in Disrepair

All of the interior built in furnishing are original to the school, and in poor condition. The majority of built in casework is located in the science classrooms and labs. Full replacement is recommended with any renovation.

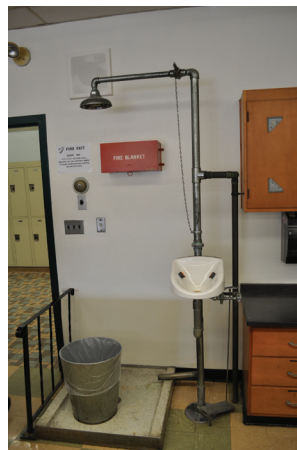
Original Chemical Shower

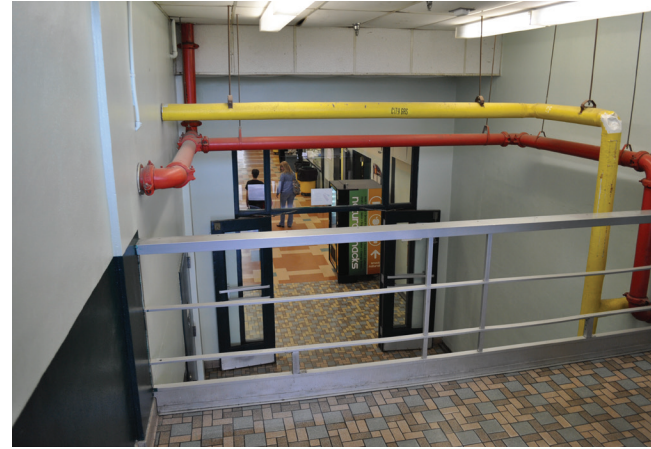
Multiple Levels

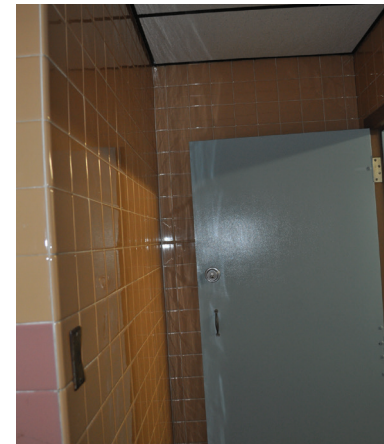
Inaccessible Toilet Stalls

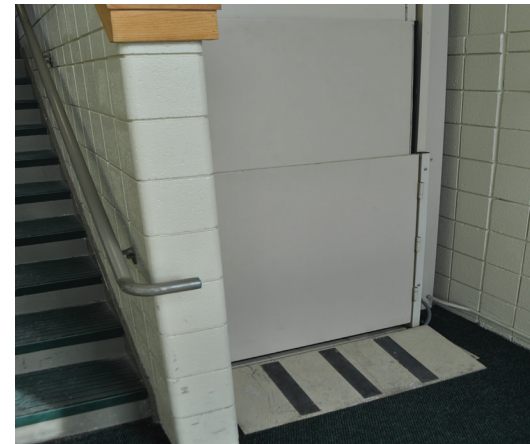
Hardware Issues

- Door hardware must be upgraded or replaced to meet ADA regulations including, but not limited to, door handles, closers and panic devices, as previously noted

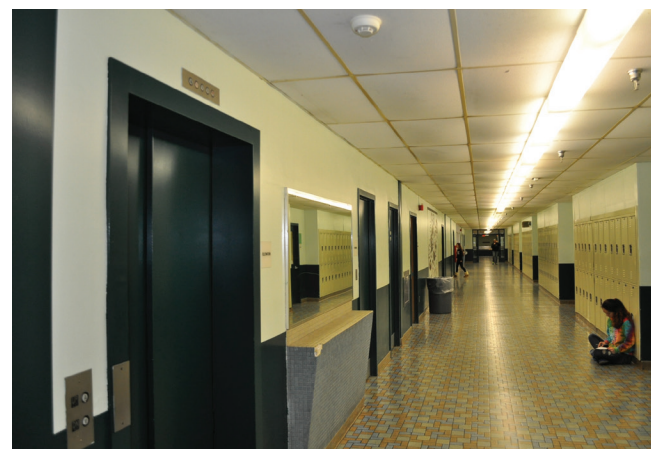
Inaccessible Water Fountain

- Currently the drinking fountains lack appropriate clear floor space and height requirements ADA.
- Many of the doors do not provide the required push/ pull clearances and must be replaced or relocated to meet the ADA requirements. This condition occurs throughout the building including several of the classroom entrances, and secondary egress doors.

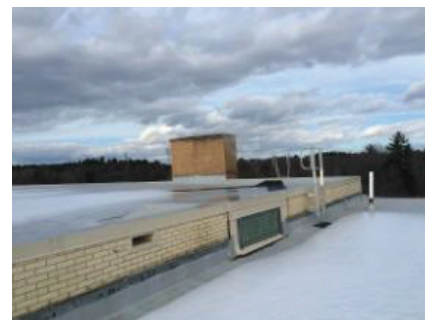
Boiler Chimney

The boilers are vented by a common manifold double wall steel breeching system that terminates through a masonry chimney to the outdoors. There are some visible cracks at the top of the chimney. The condition of the interior liner was not inspected during the site visit.

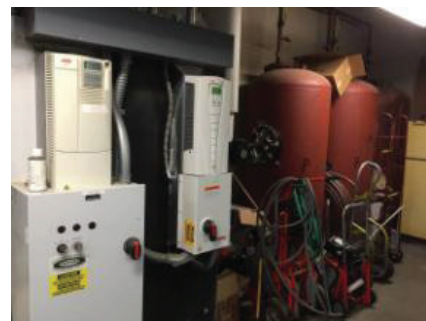
Existing HW Pump VFDs (left) and Expansion Tanks (right)

There are three (3) hot water expansion tanks that appear to be in good condition.

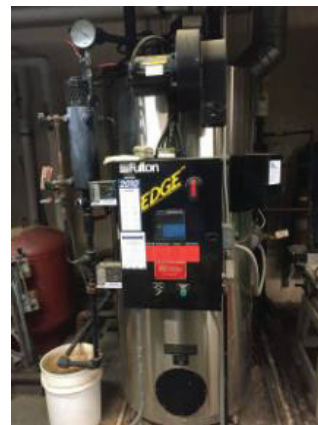
Steam Boiler

There is a steam boiler system installed in the mechanical room. The steam boiler is a Fulton Edge boiler. The steam boiler provides steam for the Kitchen dishwasher and steam cooking kettles. The steam boiler appears to be in good condition.

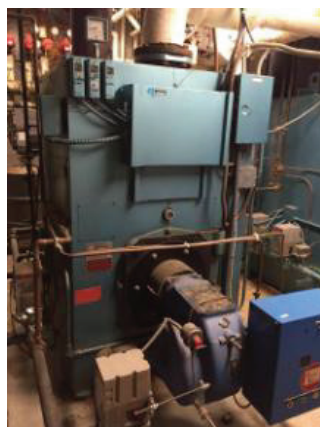
Existing Boiler (Johnson Burner)

The 1989 Addition building is primarily heated by a gas fired hot water boiler plant. There are two gas-fired cast iron sectional hot water boilers located in the boiler room. The boilers were manufactured by Cleaver Brooks. One boiler is equipped with a S.T. Johnson Co, burner and the other boiler has a Cleaver Brooks burner. The boiler equipped with Johnson burner has an input capacity of 2,520 MBH. The boiler equipped with a Cleaver Brooks Burner (Model I-506 Series 200, Serial No. CI-1296) has a capacity of 2,237 MBH gas input and 1,786 MBH output (I=B=R). The boilers were installed circa 1989 and are approximately 26 years old and nearing the end of their useful service life. The boilers appear to be in fair physical condition. One boiler has recently had a damaged control board replaced.

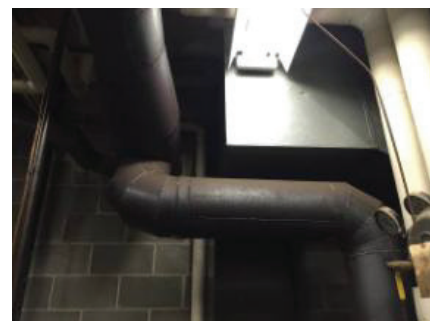
Interior Boiler Breeching

The boilers are vented by a common steel breeching system that terminates through the roof to the outdoors. The steel breeching is uninsulated, and the exterior breeching shows visible signs of rust and corrosion.

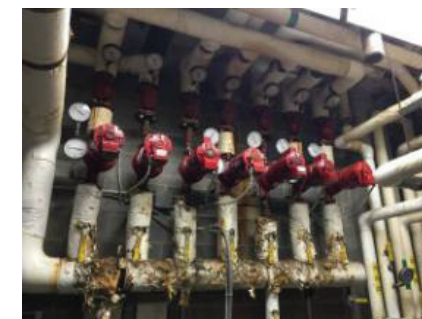
Existing Hot Water Pumps

Hot water is distributed from the Boilers to terminal heating equipment located throughout the building by six (6) inline zone circulator pumps. The pumps appear to have been installed in 1989. In general, the pumps appear to range from fair to poor physical condition. Much of the adjacent piping insulation is damaged. There is a hot water expansion tank which appears to be in good condition.

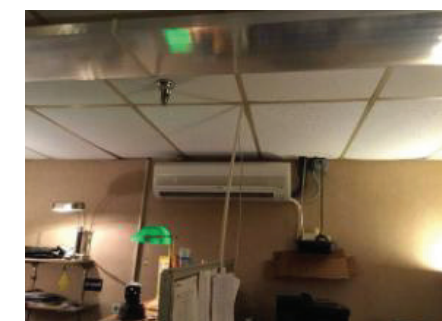
Ductless Cooling Unit – IT Server and Office

The IT Server and Office room is air conditioned by a ductless AC unit. It was reported that the room is consistently warm and experiences inadequate airflow and temperature control.

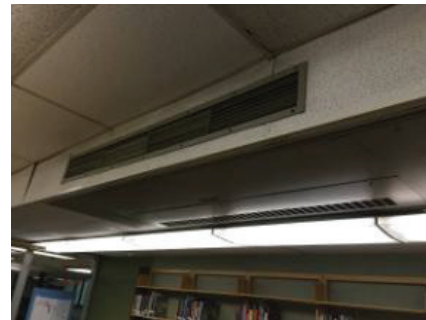
The Library/Media Center is heated and ventilated by indoor ceiling suspended heating and ventilation unit ventilators. The units were installed circa 1967, and are approximately 48 years old and past their expected service life. The Library/Media Center is also heated by supplemental fin tube radiation that is located along the perimeter exterior walls.

Library Heating & Ventilation Unit

- Library: Existing hot water unit ventilators should be replaced and new energy efficient HVAC system should installed to serve this area.
- **Air Handling Unit Systems:**

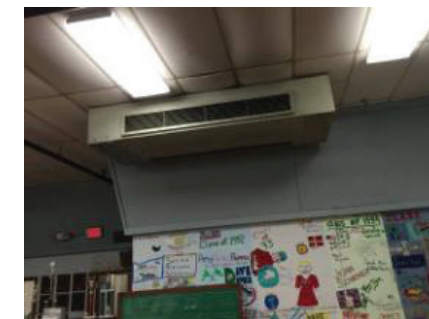
The Music classrooms are heated and ventilated by horizontal type classroom unit ventilators, and are exhausted by exhaust air fan systems. The unit ventilators and ductwork distribution systems appear to be originally installed equipment, installed circa 1967, and past their expected service life. Some Music classrooms also have supplemental hot water fin tube radiation installed; the fin tube radiation also appear to be originally installed equipment.

Music Classroom – Unit Ventilator

- High School Classrooms: The existing High School Unit ventilators that serve the interior classrooms should be replaced. New HVAC systems with mechanical ventilation should be provided for exterior classrooms. New mechanical ventilation systems should be provided with energy recovery.

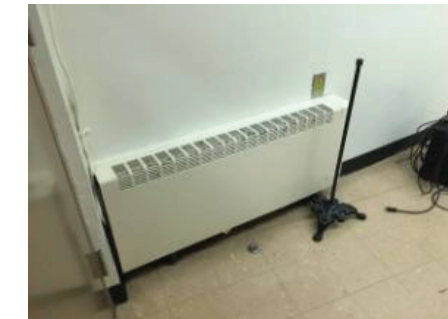
Music Classroom – Fin tube Radiation

- **Terminal Heating Equipment:**
 - General: Existing fin tube radiation, unit heaters, unit ventilators and convector heating equipment should be replaced, with exception of Language Arts Building fan coil unit and unit heater heating equipment.

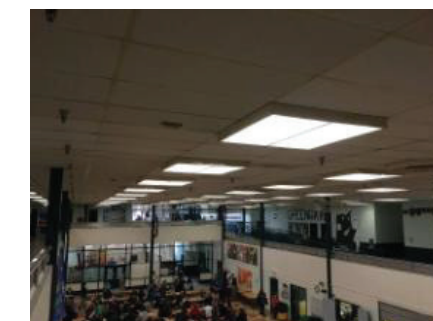
The Cafeteria is heated and ventilated by an indoor hot water air-handling unit (AHU-6) that delivers supply air to the space via a galvanized sheetmetal distribution system and ceiling mounted diffusers. Return air is primarily removed from the space by low wall return registers. The air handling unit and ductwork distribution system was installed circa 1967, and is approximately 48 years old and past its expected service life.

Cafeteria – Ceiling Diffusers

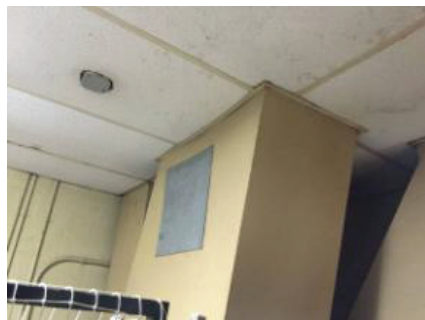
The Kitchen has a stainless steel exhaust hood that is exhausted by a centrifugal utility set exhaust fan located in the Penthouse Mechanical room. The kitchen exhaust ductwork riser does not appear to meet all current NFPA 96 code requirements as the riser is not located in a 2-hr fire rated enclosure. The Kitchen is heated by supplemental hot water unit heaters and supply air registers that are connected to a make-up heating and ventilation air-handling unit (AHU-7). There is a wall mounted propeller fan that is utilized to provide airflow movement within the space. The dishwasher is exhausted by stainless steel ductwork that is connected to an exhaust air fan. The Kitchen service corridor is heated by a unit heater.

Kitchen Exhaust Duct Riser in Storage Closet

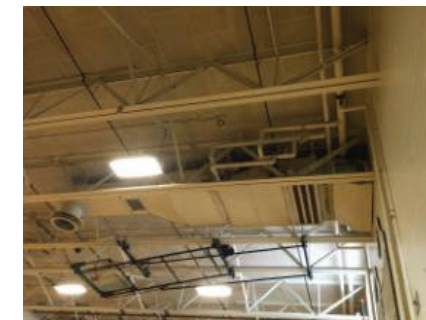
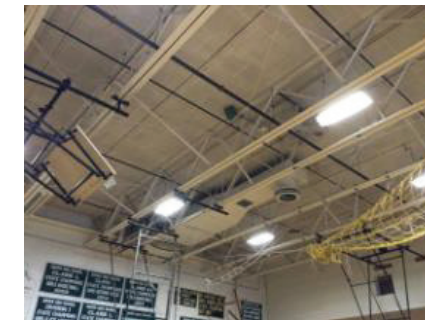
The Gymnasium is heated and ventilated by four (4) indoor, ceiling suspended, hot water heating and ventilation units (AHU-1, 2, 3 & 4). The units appear to have been installed circa 1967 and are in poor physical condition and have exceeded their expected service life. Exhaust air is removed from the gymnasium via ceiling exhaust grilles that are connected to roof exhaust fans. There are (4) four roof exhaust fans.

Gym Heating & Ventilation Units

- General: Existing indoor air handling units should be replaced.
 - CTC Shops and Classrooms: The existing hot water heating air handling unit systems should be replaced.

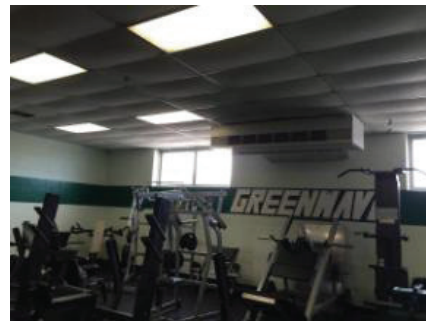
The Fitness Room is heated by a ceiling suspended hot water unit ventilator. It appears that the unit ventilator is originally installed equipment circa 1967. The heating and ventilation system appears to be in poor condition and past its expected service life.

Fitness Room Unit Ventilator

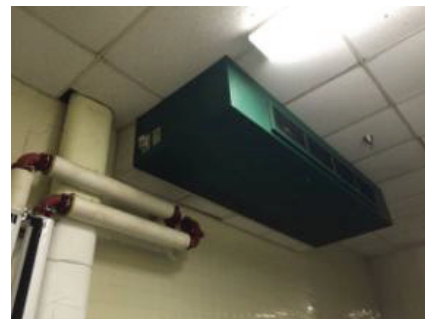
The Locker Rooms are heated by a combination of suspended hot water unit ventilators and hot water fin tube radiation heating equipment. The Girls locker room has a ducted exhaust air system that is served by two (2) inline exhaust air fans. The Boy's Locker room is exhaust by rooftop exhaust air fans. It appears that the heating and ventilation system appears to be originally installed equipment, in poor physical condition and past its expected service life. Sections of the fin tube radiation and several of the air distribution devices appear to be rusted and soiled.

Locker Room Unit Ventilator

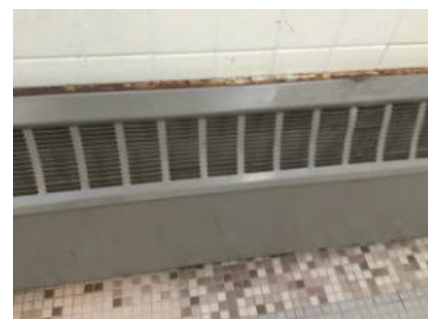
Locker Room Fin tube Radiation

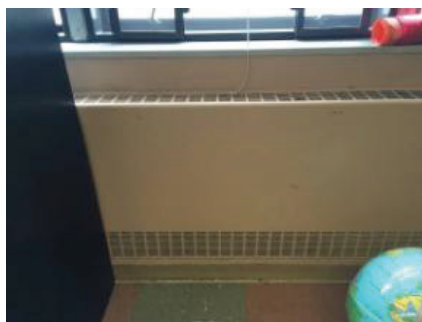
The majority of interior classrooms are heated and ventilated by horizontal type classroom unit ventilators. The exterior classrooms are typically heated by hot water fin tube radiation and ventilated through the use of operable windows. Roof mounted exhaust air fans and associated exhaust ductwork distribution systems provide exhaust air for the majority of classrooms. The unit ventilators, exhaust fans and ductwork distribution systems appear to be originally installed equipment, installed circa 1967, and past their expected service life.

Classroom – Fin tube Radiation

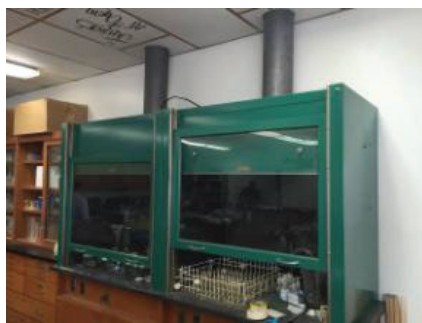
Science Classroom Fume Hoods

Some of the Science Classrooms have fume hoods and associated exhaust air fan systems. Some of the Science classrooms also have a sidewall exhaust air fan. It has been reported that the fume hood operation interferes with the heating and ventilations system’s ability to properly heat the space, as warm air is exhausted through the fume hood and sidewall exhaust air fan while they are in operation. Tempered mechanical make-up air ventilation should be provided in these Classrooms.

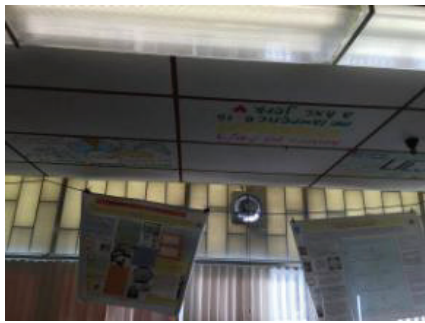
Science Classroom Sidewall Exhaust Fan

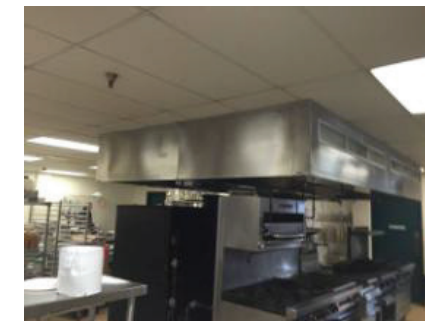
The 1989 Addition Kitchen has a main stainless steel kitchen exhaust hood and associated roof mounted exhaust air fan. There is also a stainless steel canopy dishwasher hood. There are hot water ceiling suspended unit heaters that provide heating to the kitchen. Make up air ventilation is provided by a roof top make-up air unit. The exhaust, make-up air and heating systems appears to have been installed circa 1989 and appear to be in fair to poor condition.

Kitchen Exhaust Hood

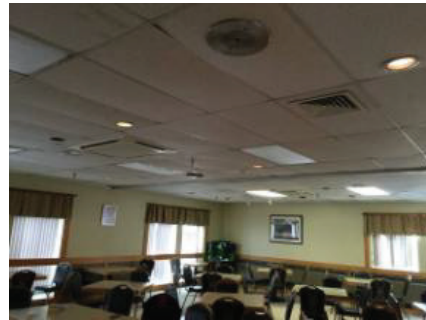
The 1989 Addition Dining room is heated and air conditioned by a ductless AC split system heat pump system. There is also perimeter hot water fin tube radiation heating. It has been reported that the heat pump AC system and hot water fin tube radiation heating operate simultaneously at certain times of the year, resulting in both excess energy usage and temperature control complaints. The ductless cassette type AC heat pump system has its own stand-alone thermostat controls which are not fully integrated into the building control system.

1989 Addition Dining Room - Cassette Type AC Unit (left)

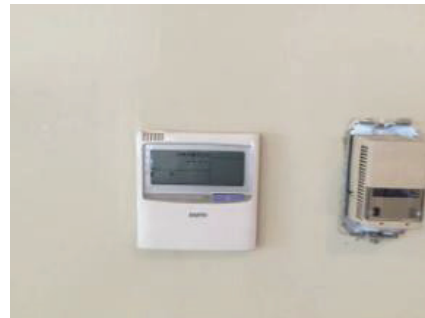
1989 Addition Dining - Thermostats

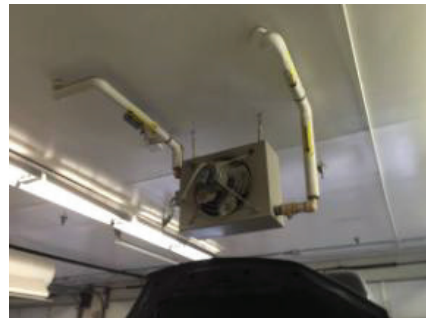
The Auto Shop is primarily heated and ventilated by a central indoor air handling unit and duct mounted hot water heating coils. Supplemental heating is provided by hot water unit heaters. There are general exhaust air, welding booth and under-slab exhaust air systems installed. The air handling unit, unit heaters, general exhaust and under slab exhaust were installed circa 1989 and are generally in poor physical condition. The welding booth exhaust and ventilation ductwork appear to be in fair condition.

Auto Shop Unit Heater

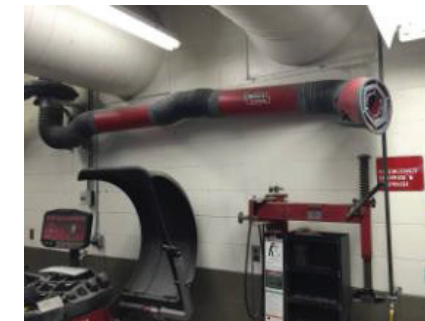
Auto Shop Welding Exhaust System

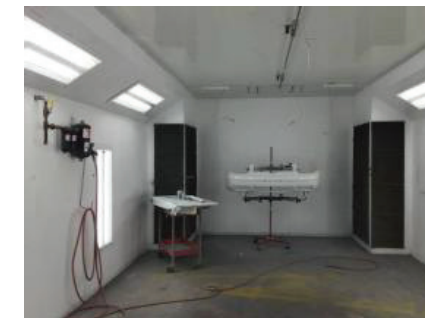
The Auto Body Shop is primarily heated and ventilated by a central indoor air handling unit and duct mounted hot water heating coils. Supplemental heating is provided by hot water unit heaters. There are general exhaust air, and paint booth exhaust welding booth systems installed. The air handling unit, unit heaters and general exhaust systems were installed circa 1989 and are generally in poor physical condition. The paint booth make-up ventilation air is provided from a rooftop unit and exhaust air is provided by an associated exhaust fan. The paint booth appears to be in fair condition.

Paint Booth

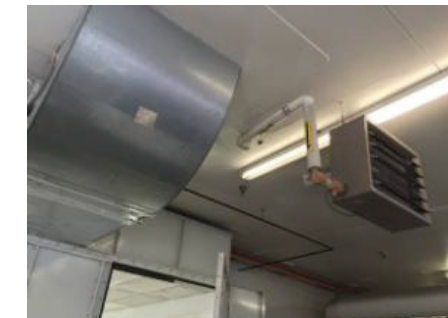
Paint Booth Ductwork and Unit Heater

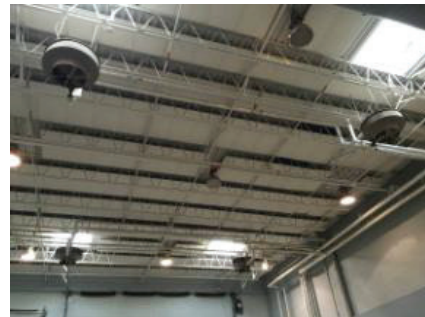
The Trades Shop is primarily heated and ventilated by a central indoor air-handling unit and duct mounted hot water heating coils, and supplemental heating is provided by ceiling suspended propeller type unit heaters. The unit heaters appear to be in good condition. There is a re-circulating filtered type dust collector installed. The dust collector appears to be in good condition.

Unit Heaters

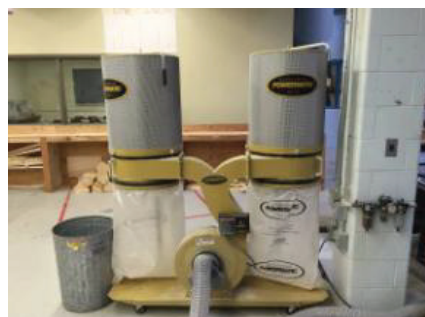
Dust Collector

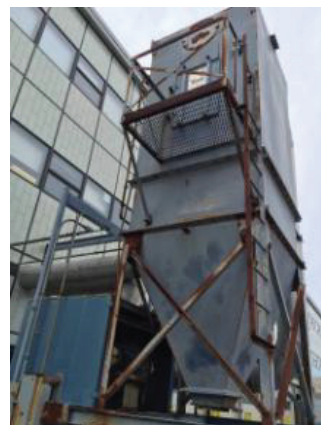
The Wood Shop is primarily heated and ventilated by a hot water unit ventilator, and supplemental ventilation air is provided by a central station air handling unit. There is an outdoor grade mounted dust collector installed that is ducted to wood-working saws and equipment via galvanized sheetmetal ductwork. The unit ventilator, dust collector and associated ductwork appears to be in poor condition.

Wood Shop - Dust Collector

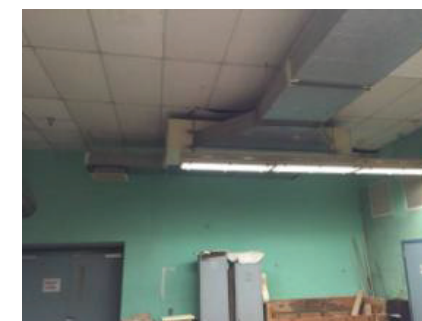
Wood Shop Unit Ventilator

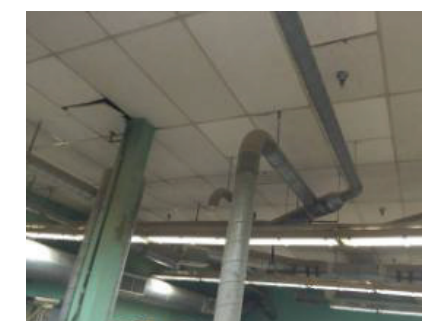
Wood Shop Dust Collector Exhaust Ductwork

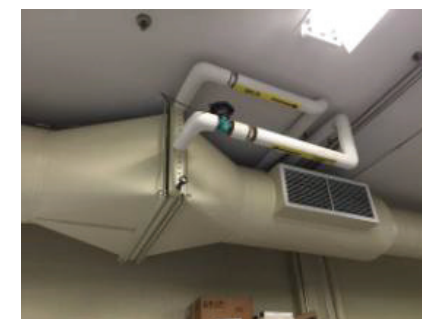
The CADD Classroom and Shop is primarily heated and ventilated by a central indoor air handling unit and duct mounted hot water heating coils. There are general exhaust air and hose-reel exhaust air systems installed. The air handling unit, general exhaust fan and hose-reel exhaust systems were installed circa 1989 and are generally in poor physical condition. The exhaust and ventilation ductwork appear to be in fair condition.

CADD Shop Heating Coil and Ventilation Ductwork

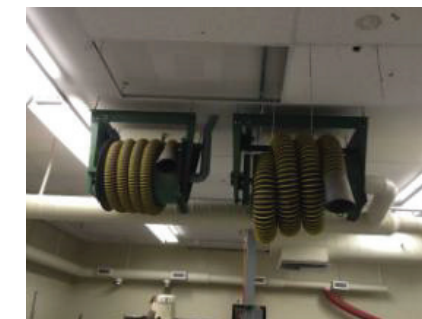
Hose-Reel Exhaust

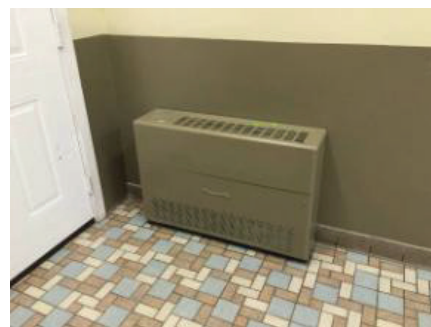
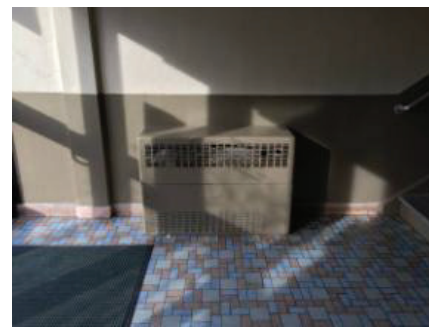
Entryways, stairwells, and corridors are typically heated by cabinet unit heaters. There are also locations where hot water fin tube radiation is installed. In general, the heating equipment is originally installed equipment, approximately 25 to 48 years old dependent upon its location and date of installation.

Existing Cabinet Unit Heater

- Corridor and Entryway Heating and Ventilation – The majority of corridor areas should be provided with improved mechanical ventilation, as many appear under ventilated*. Existing ductwork and diffusers should be replaced and existing hot water radiator/convectors/unit heaters should be replaced.

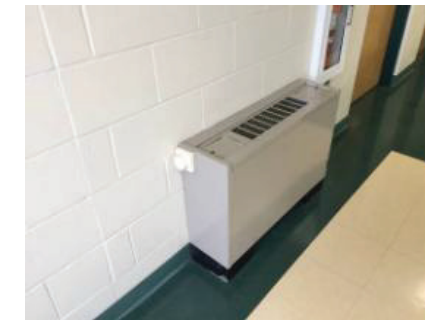
Existing Cabinet Unit Heater – World Arts Wing

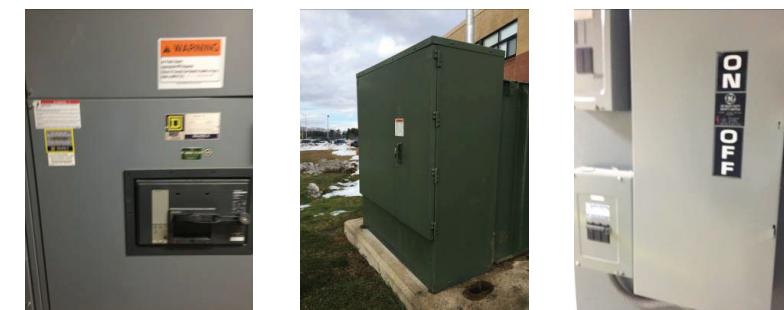
The service voltage is 120/208V rated at 2000 amps. The switch is in fair condition and within its 40 year useful life. The main switchboard does not have space for future expansion. The main switchboard is manufactured by Square D.

The power for the facility is in poor/fair condition, a new power distribution system should be provided at 277/480 volt distribution.

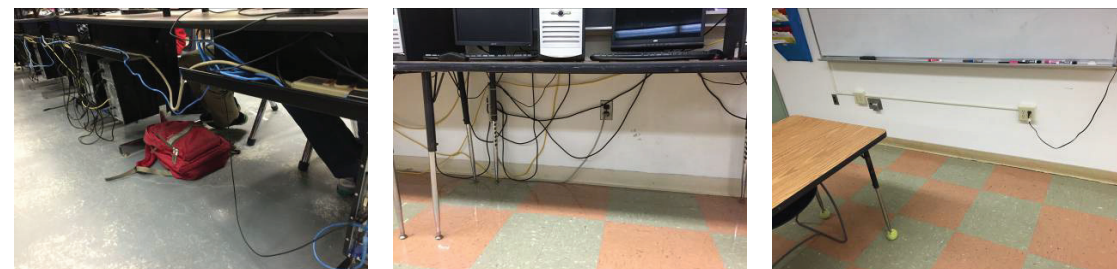
Kitchen and Science Lab receptacles are not on GFCI circuits to meet present code. Science labs do not have EPO's installed.

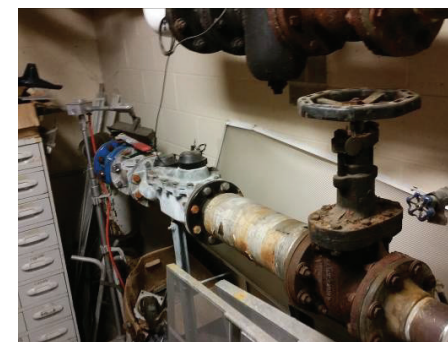
In the 1967 School there is a dedicated 4" domestic water service which enters the mechanical room. There is a 4" domestic water meter and two 2" reduced pressure backflow preventers with pressure reducing valves located in parallel. There is also two 1-1/2" pressure reducing valves piped in parallel configuration. The distribution main is 4" in size.

1967 school water service & meter

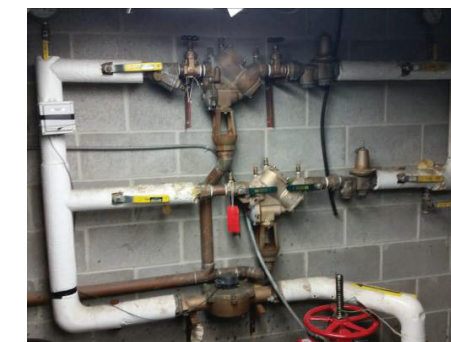
In the 1989 Addition there is a combined 8" water service which enters the lower level mechanical room. Off of this service there is a 2-1/2" domestic water supply with 2" water meter and two 1-1/2" reduced pressure backflow preventers with 1-1/2" pressure reducing valves located in parallel. The outlet water pressure is 70 PSI.

1989 addition water meter

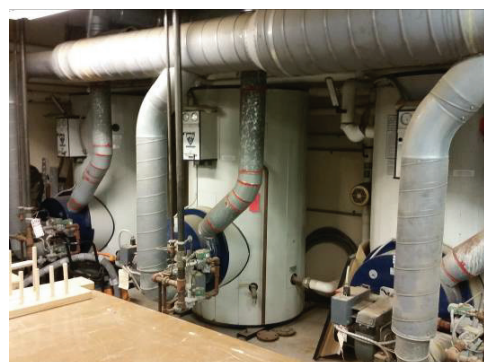
Domestic hot water in 1967 School is generated through three natural gas fired storage type water heaters. Water heaters are PVI model 750N-400A, with a natural gas input of 600,000 BTUH and 400 gallon storage capacity. The water heaters are in fair condition. The hot water systems are recirculated. There are two thermostatic mixing valves on the systems to prevent scalding, Lawler model 805 and Lawler model 802.

1967 School water heaters

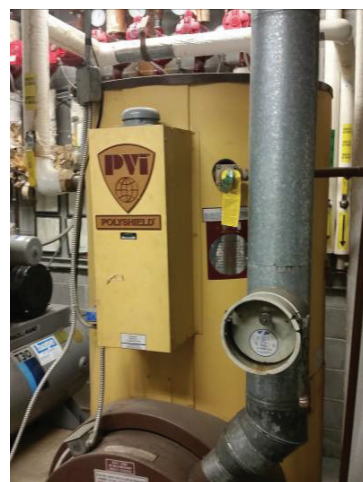
Domestic hot water in 1989 Addition is generated through a gas fired storage type water heater. Water heater are PVI model 375P-225, with a natural gas input of 300,000 BTUH and 225 gallon storage capacity. The water heater is in fair condition. The hot water system is recirculated. There are two thermostatic mixing valves on the systems to prevent scalding, both are Symmons model 5-900.

1989 Addition water heater

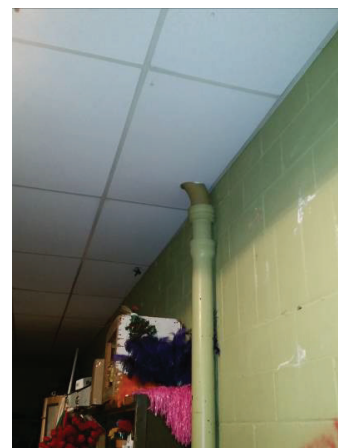
Cast iron is used for sanitary and storm drainage. Where visible, the cast iron pipe appears to be in fair condition. Smaller pipe sizes appear to be copper or PVC.

Cast iron drainage piping

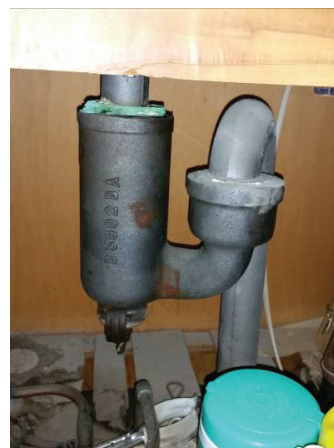
Acid waste and vent piping is hub and spigot dur-iron. The systems is not piped to an acid neutralization system

Science waste piping

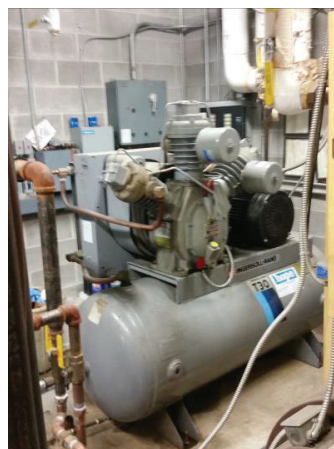
The compressed air is provided by a single 15 h.p. motor located on a horizontal receiver. Compressor is located in the 1989 Addition mechanical room. The air compressor is in good condition.

Air compressor

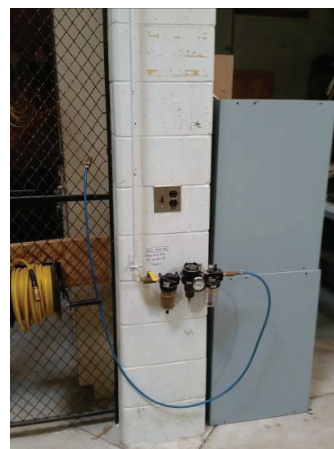
The technical shops are provided with compressed air. There are various pipe drops in each shop supplied from the piping distribution system. Typical outlets include a filter and pressure regulator.

Typical air outlet station

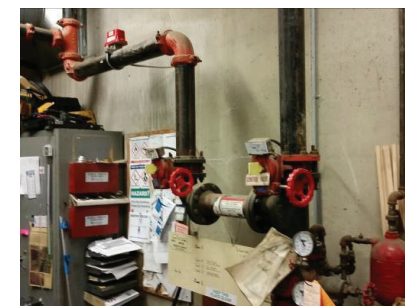
Fire service riser

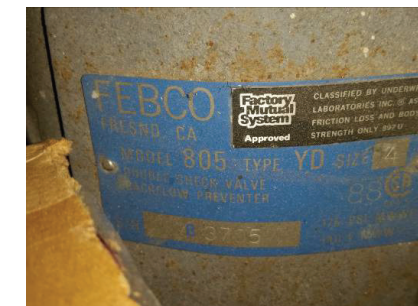
Double check valve assembly

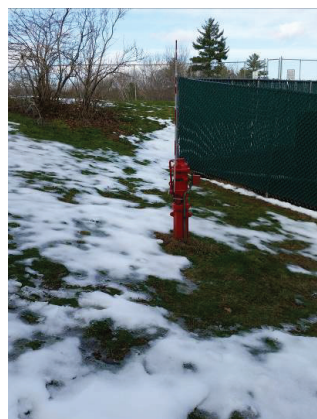
Post Indicating valve

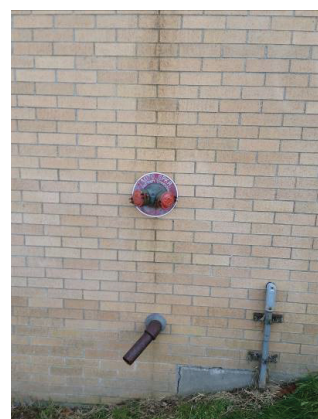
Siamese Fire Department connection

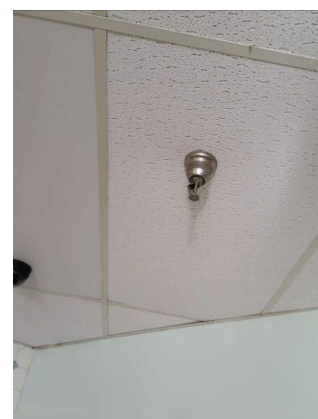
Typical pendant sprinkler

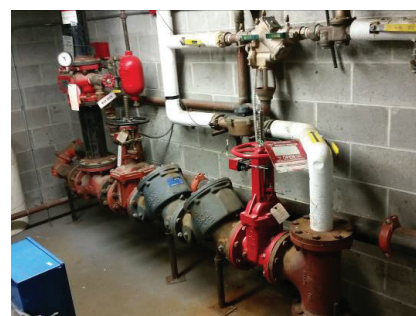
Combined water service - FP riser

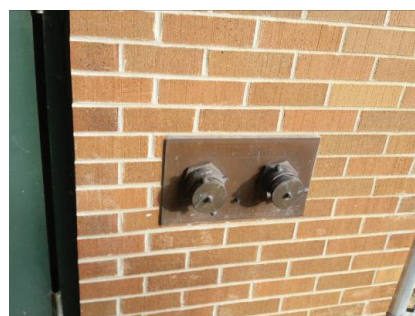
Siamese Fire Department connection

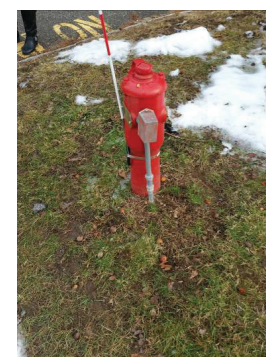
Post indicating valve

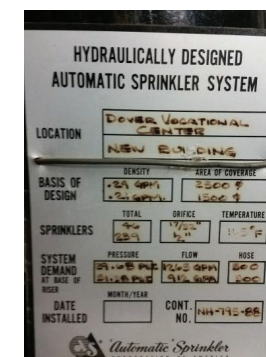
Hydraulic data card

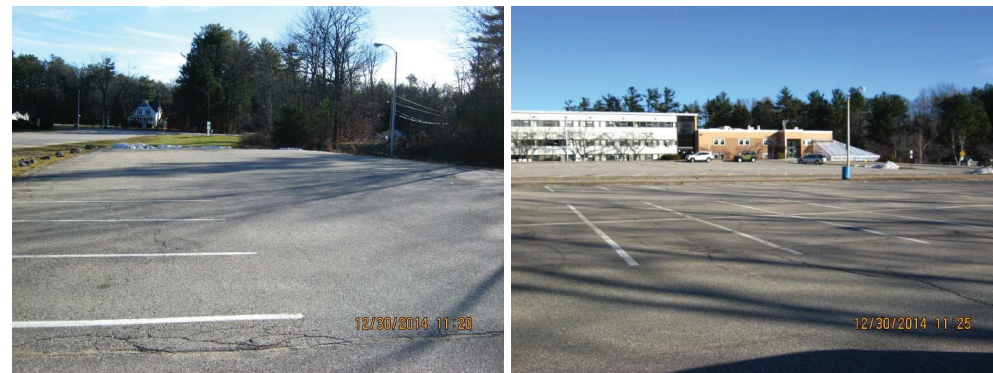
Senior Lot

- Upon visual inspection the condition of the existing pavement is generally in satisfactory to less than satisfactory condition. Longitudinal and traverse cracking is low to medium in severity while alligator cracking is minimal. None of the cracks observed in the pavement have been sealed using asphalt crack sealant.
- Raveling and aging (pavement surface deterioration/loss of aggregate) of the pavement is not evident.

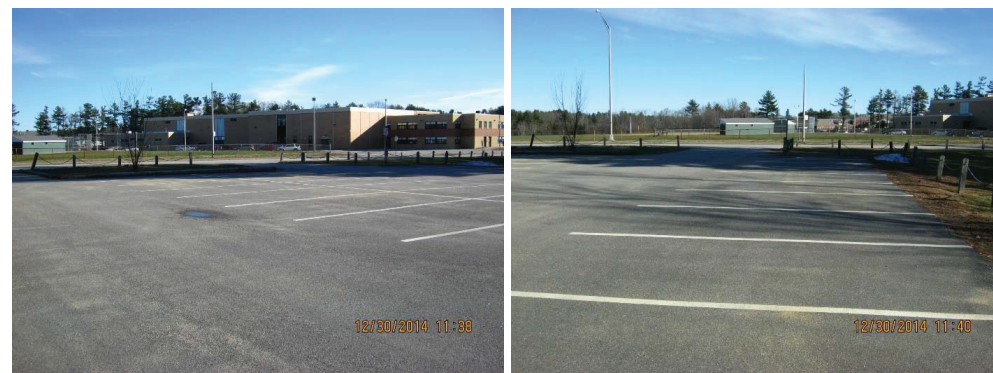
Dover Alternative Program Parking Lot (50 Alumni Drive)

- Upon visual inspection the condition of the existing pavement is generally in good condition.
- No cracking, raveling and aging (pavement surface deterioration/loss of aggregate) of the pavement is evident.
- A couple of minor puddles were observed in the parking lot.

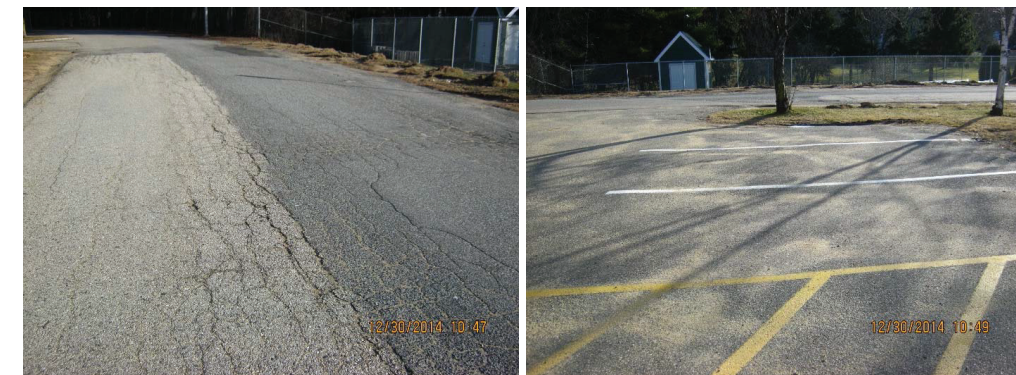
Pavement East of 1989 Addition (Including the access road from Alumni Drive)

- Upon visual inspection the condition of the existing pavement is generally satisfactory to less than satisfactory. Numerous cracks (longitudinal, traverse, alligator) were observed in the pavement. None of the cracks observed in the pavement have been sealed using asphalt crack sealant.
- There is minor raveling and aging (pavement surface deterioration/loss of aggregate) of the pavement evident throughout the area.
- The pavement overlay at the entrance and exit from Alumni Drive is in good condition.

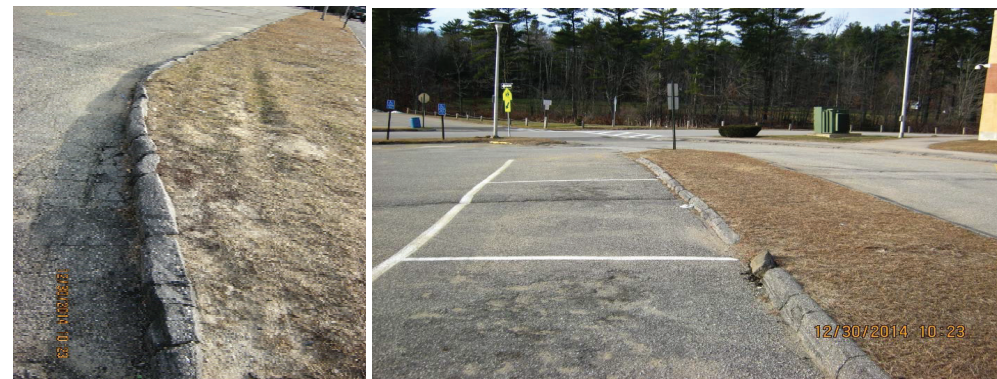
A Lot & Bus Drop-off

- The A Lot and Bus Drop-off driveway are surrounded by bituminous concrete curb (BCC) except along the face of the concrete sidewalk entering the main entrance to the building.
- Based on visual inspection most of the BCC is nearing the end of its life cycle however it still appears to be functioning as designed. The BCC is cracked into several small 1 to 2 foot sections and is deformed in areas. BCC is a cost-effective curb, however, the harsh New England winters and snow plows shorten its useful life.
- The height of BCC is generally desired to be about 4-5 inches above finished grade. Nobis observed sections of BCC less than 3 inches (likely due to pavement overlays over the years).
- Recommend replacing BCC with vertical granite curb (VGC) along sidewalk for pedestrian safety.

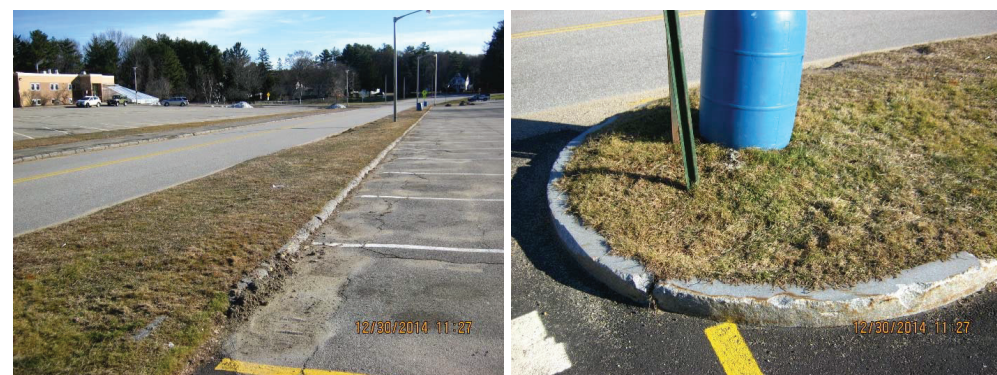
Senior Lot

- No curb except around the landscape island abutting Alumni Drive. The landscape island has BCC along both sides of the island and VGC around the radial ends.
- The condition of the VGC is satisfactory while the condition of the BCC is nearing the end of its useful life. The BCC is cracked into several small 1 to 2 foot sections but has not begun to lose its alignment.

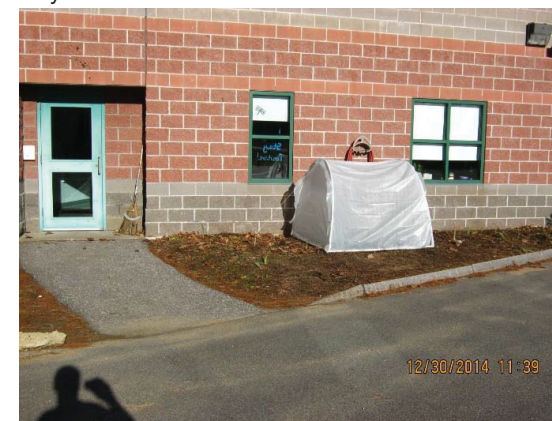
Dover Alternative Program Parking Lot (50 Alumni Drive)

- No curb except around the southeast corner of the building. The curb around the edge of the parking lot surrounding the southeast corner of the building is sloped granite curb (SGC). The SGC is in satisfactory condition.

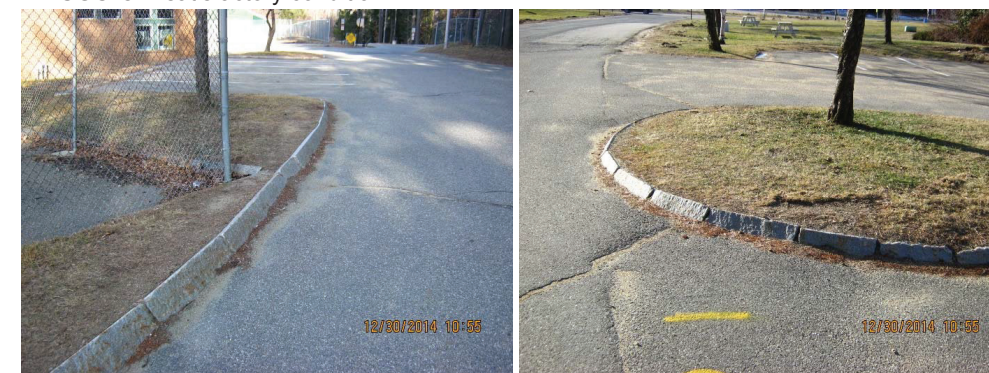
Pavement East of 1989 Addition (East Side of DHS)

- SGC around portions of the asphalt perimeter along the east side of the 1989 addition. The SGC is in satisfactory condition.

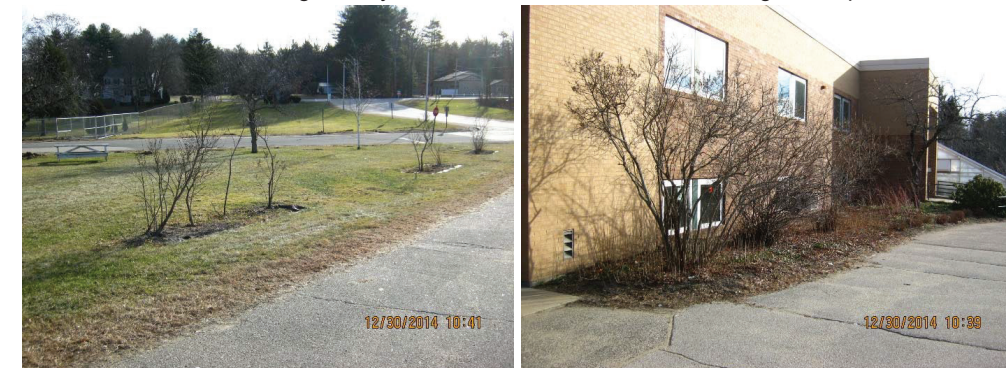
- Landscape inspection included the inspection of the trees and shrubs around the perimeter of the buildings and parking lots. The inspection did not include the landscaping and vegetation of the ball fields.
- The trees and shrubs planted around the buildings and parking lots appeared to be well established and healthy.
- The majority of the planted tree and shrubs are along the front face of the buildings and along the western edge of the driveway from Alumni Drive heading towards the C lot and middle school.
- Visible inspection of the grass appeared to be well established throughout the campus.
- The existence of an irrigation system could not be determined during the inspection.

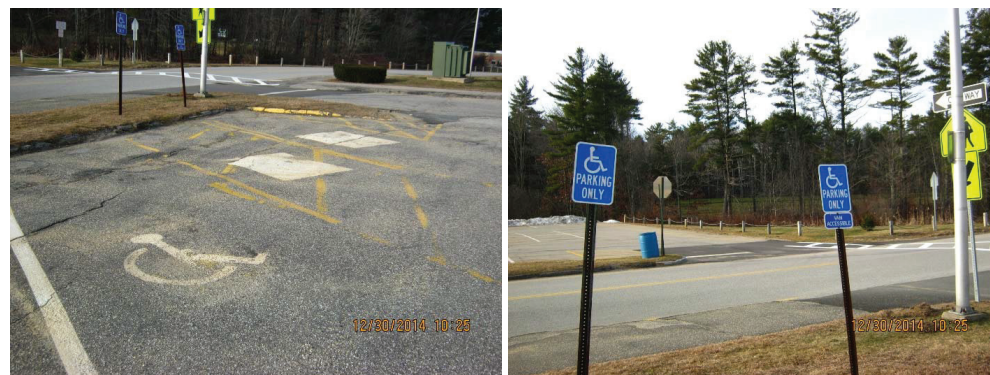
A Lot & Bus Drop-off

- Upon visual inspection there are two accessible parking spaces in the A lot and one accessible ramp into the main entrance of the building. There are approximately 87 parking spaces in the A Lot. According to state and federal ADA design standards there should be a minimum of 4 accessible parking spaces. In addition to having less than the minimum number of accessible spaces required, the access aisle striping and parking space signage are out of compliance. Also the head of the accessible aisles does not lead to an accessible path of travel as required by ADA.
