DOVER HIGH SCHOOL AND CAREER TECHNICAL CENTER Site & Building Assessment Report

Dover, New Hampshire

February 2015

HMFH Architects, Inc.

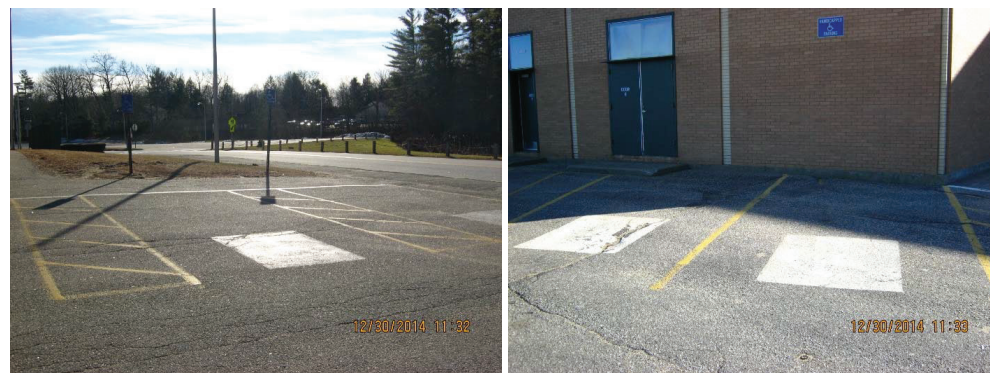
- There are two accessible parking spaces designated in the shortest accessible route to Door 5. Although the number of spaces is adequate one of the spaces should be designated as van accessible and the accessible spaces are not properly striped with an access aisle.

- There is a long concrete ramp leading to the Door 5 entrance. This ramp should have a handrail and a level landing per the ADA standards.
- No accessible parking spaces are provided to access Door 12. If this is an accessible building entrance a minimum of one van designated accessible space should be provided.

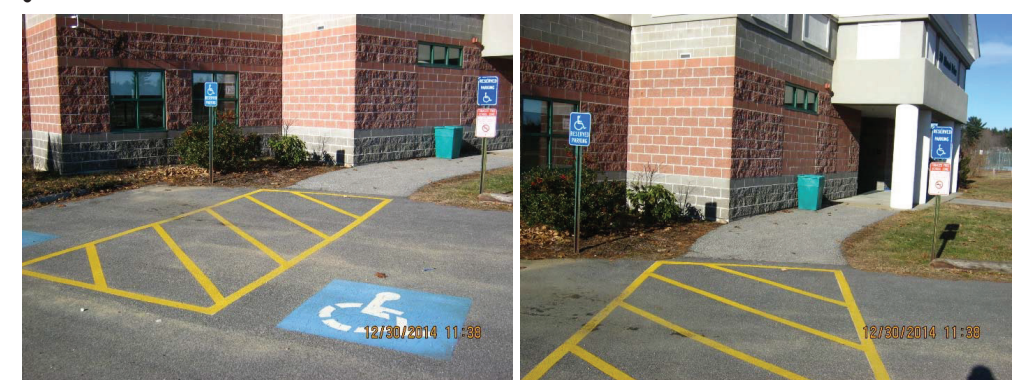
Dover Alternative Program Parking Lot (50 Alumni Drive)

- Upon visual inspection there are three accessible parking spaces in the parking lot and there appears to be one accessible entrance at the front of the building. There are approximately 76 parking spaces in the parking lot.
- Two accessible parking spaces are properly located closest to the accessible entrance although one of the spaces should be designated as van accessible. The other accessible space is located closest to the walkway to one of the ball fields. To be in accordance with ADA design standards this accessible space should be designated as van accessible and have an 8 foot wide access aisle to the right of the space.
- Based on the 76 parking spaces in the parking lot per ADA design standards 4 accessible parking spaces are required and only 3 accessible parking spaces are provided.

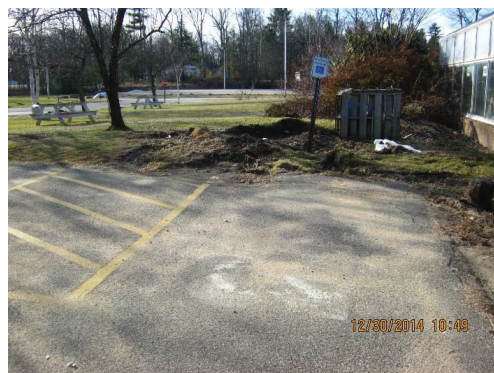
1989 Addition Parking Spaces

- Upon visual inspection there is one accessible entrance (Door 28) to the 1989 addition. There is a small 4 parking space lot accessible to this entrance. One of the four parking spaces is accessible which meets ADA design standards. However, this accessible parking space should be designated as van accessible and have an 8 foot wide access aisle to the right of the space.
