# Tidal Crossing Summary Sheet

## New Hampshire's Tidal Crossing Assessment Protocol

Crossing ID: 1

Observer(s) & Organization:	TS, JB (NHDES Coastal)
Municipality:	SEABROOK
Stream Name:	Blackwater River
Road Name:	Route 286

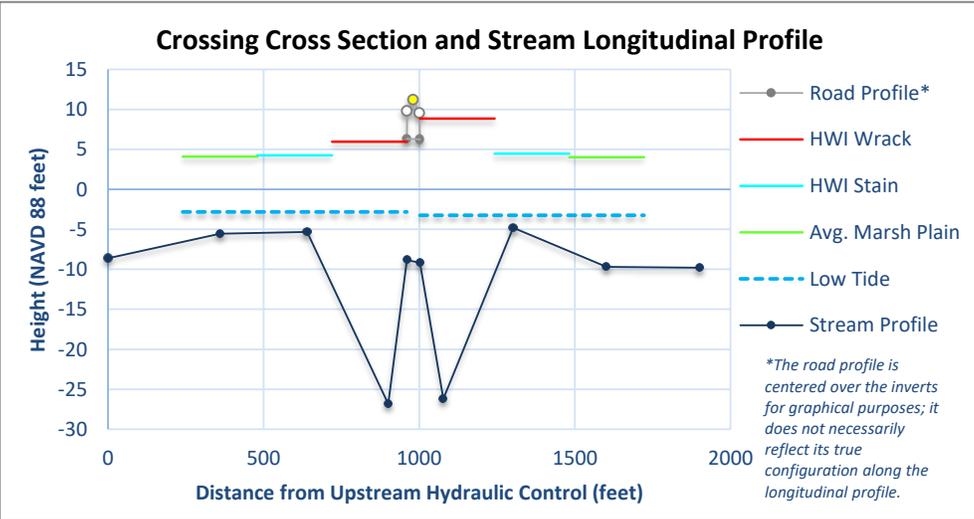
**Long. Profile**

Dist.	Hght.	Feat.	Sub.
0	-8.6323	CB	S
360	-5.5323	CB	S
640	-5.3323	HC	S
900	-26.832	P	S
960	-8.8423	I	B
1002	-9.1923	I	B
1077	-26.202	P	G
1302	-4.8023	HC	C
1602	-9.7023	P	G
1902	-9.8023	CB	C/S

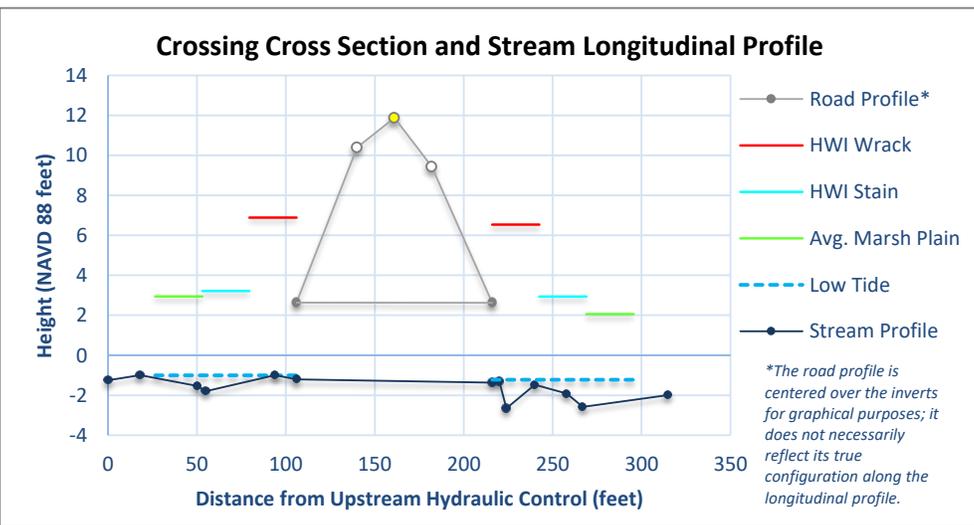
Long. Profile			
Dist.	Hght.	Feat.	Sub.
0	-1.2434	HC	G
18	-0.9934	CB	G
50	-1.5334	CB	C/S
55	-1.8034	P	C/S
94	-0.9934	HC	G
106	-1.2034	I	S
216	-1.3634	I	G
220	-1.3034	GC	B
224	-2.6534	P	G
240	-1.4734	HC	C
258	-1.9234	CB	G
267	-2.5834	P	G
315	-1.9934	HC	G

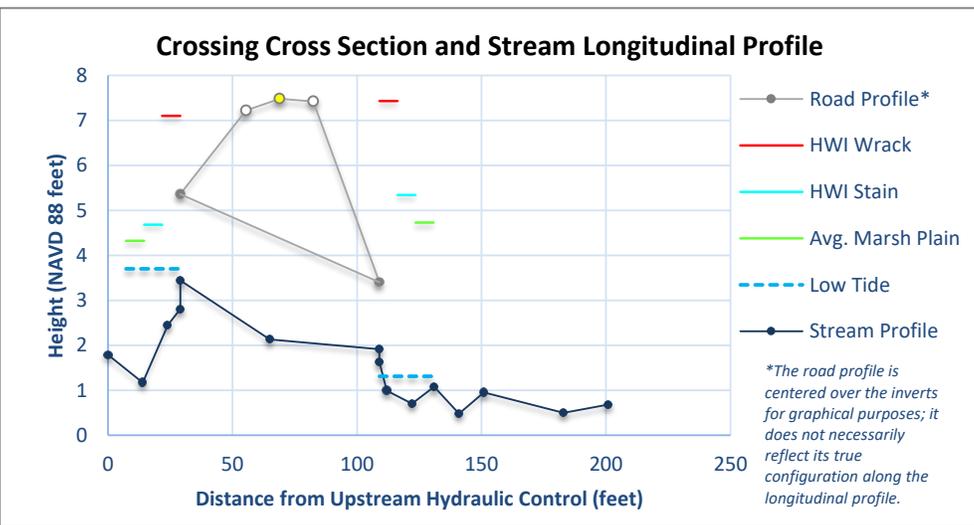
Long. Profile			
Dist.	Hght.	Feat.	Sub.
0	1.7903	CB	C/S
14	1.1703	P	G
24	2.4503	CB	G
29	2.8103	CB	S
29	3.4403	I	S
65	2.1303	CB	S
109	1.9103	I	B
109	1.6303	GC	B
112	0.9903	CB	G
122	0.7003	P	G
131	1.0803	HC	G
141	0.4803	P	G
151	0.9503	HC	G
183	0.5003	CB	G
201	0.6803	HC	G

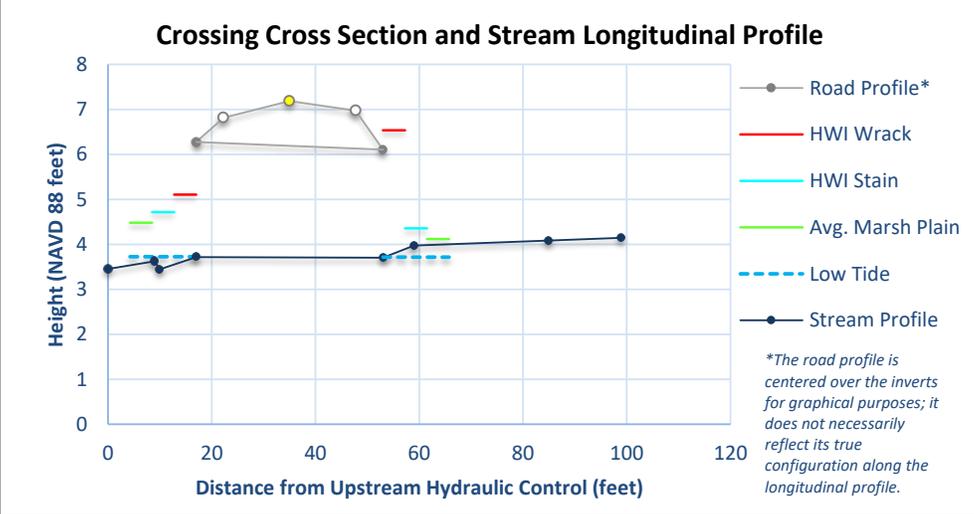
**Long. Profile**

Dist.	Hght.	Feat.	Sub.
0	3.455	HC	S
9	3.625	HC	C/S
10	3.445	CB	G
17	3.715	I	G
53	3.705	I	G
59	3.975	HC	G
85	4.085	CB	C/S
99	4.145	HC	C/S

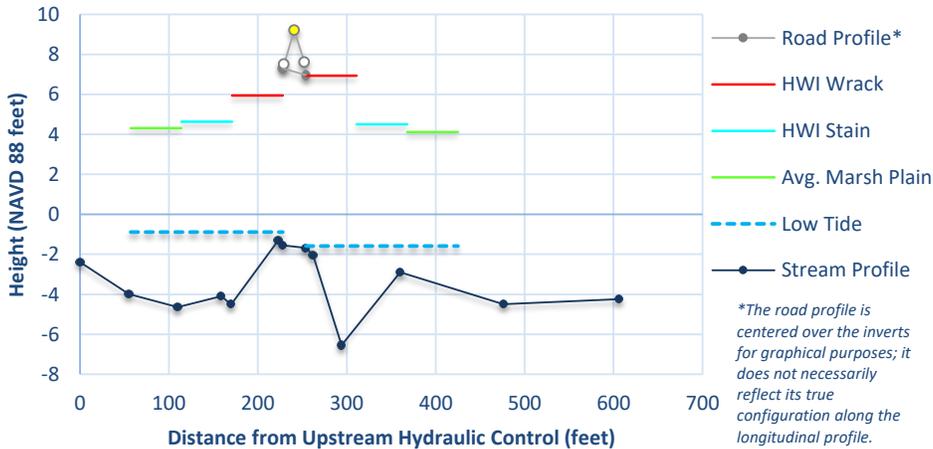
Crossing Cross Section and Stream Longitudinal Profile

Dist.	Hght.	Feat.	Sub.
0	-2.3972	HC	C/S
55	-3.9972	P	S
110	-4.6372	CB	C/S
159	-4.0972	HC	G
170	-4.5172	P	C
223	-1.3072	GC	B
228	-1.5472	I	C
254	-1.6772	I	C
262	-2.0472	GC	B
294	-6.5472	P	C
360	-2.8972	HC	G
476	-4.4972	P	C/S
606	-4.2472	HC	S

\*The road profile is centered over the inverts for graphical purposes; it does not necessarily reflect its true configuration along the longitudinal profile.

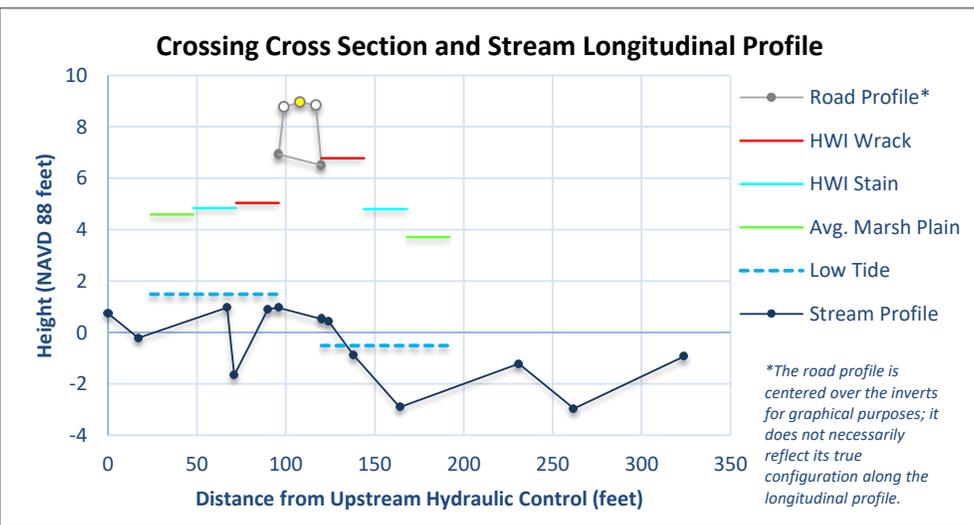
Long. Profile			
Dist.	Hght.	Feat.	Sub.
0	0.7367	HC	S
17	-0.2133	P	S
67	0.9667	HC	S
71	-1.6633	P	S
90	0.9167	GC	B
96	0.9567	I	B
120	0.5267	I	B
124	0.4367	GC	B
138	-0.8833	CB	C
164	-2.9133	P	C
231	-1.2133	HC	C/S
262	-2.9633	P	C/S
324	-0.9333	HC	C/S

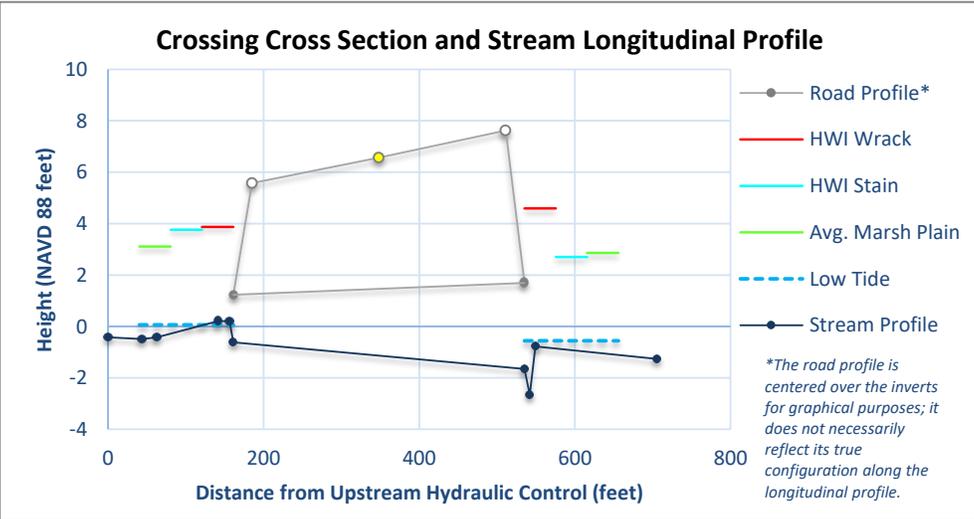
### Long. Profile

Dist.	Hght.	Feat.	Sub.
0	-0.4183	HC	C/S
44	-0.4883	HC	C/S
63	-0.4183	HC	C/S
142	0.2117	HC	G
156	0.2017	GC	B
161	-0.6183	I	C
535.2	-1.6483	I	C
542.2	-2.6583	P	C
549.2	-0.7783	HC	C
705.2	-1.2583	HC	G

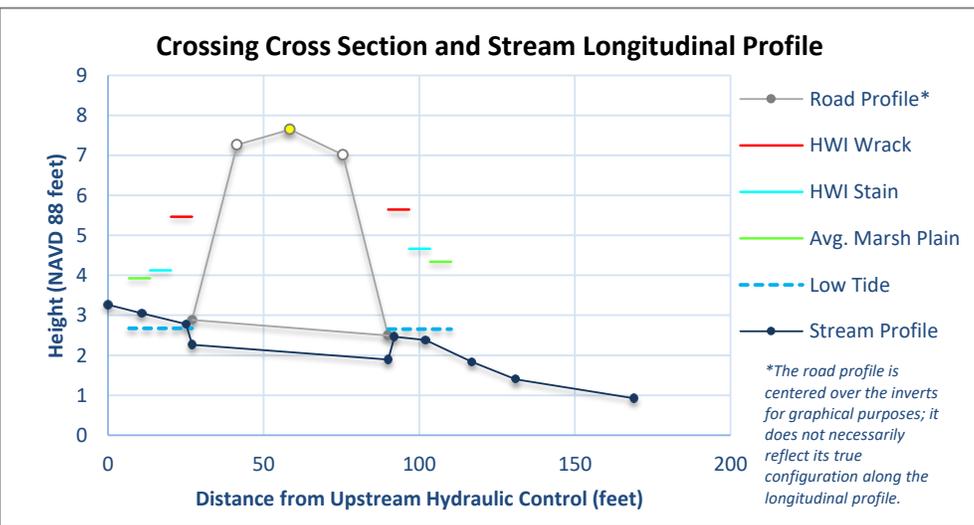
**Long. Profile**

Dist.	Hght.	Feat.	Sub.
0	3.2644	HC	C
11	3.0444	HC	C
25	2.7844	HC	G
27	2.2644	I	C
90	1.8944	I	C
92	2.4644	CB	G
102	2.3844	GC	G
117	1.8344	HC	G
131	1.3944	CB	G
169	0.9244	HC	G

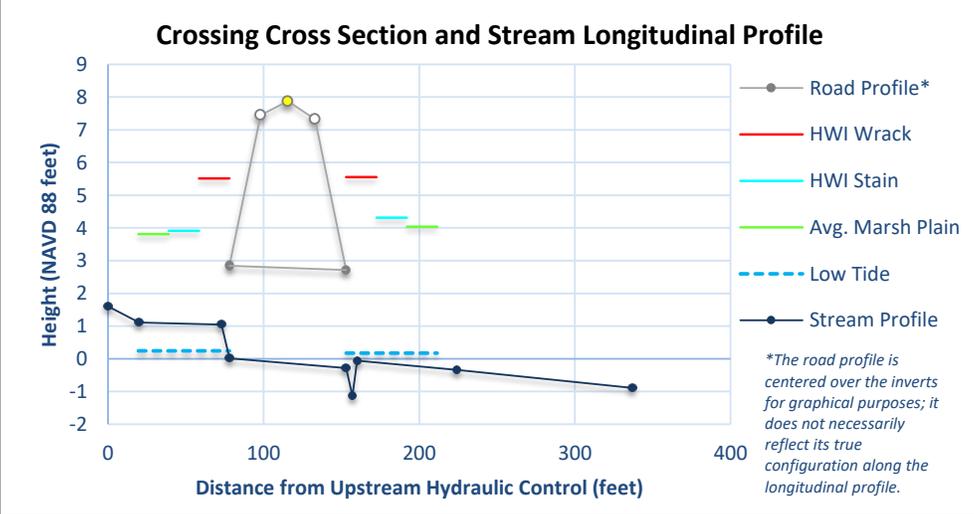
Long. Profile			
Dist.	Hght.	Feat.	Sub.
0	1.604	HC	G
20	1.114	CB	G
73	1.044	GC	C
78	0.014	I	G
153	-0.286	I	G
157	-1.136	P	G
160	-0.056	HC	G
224	-0.336	HC	G
337	-0.886	HC	C/S

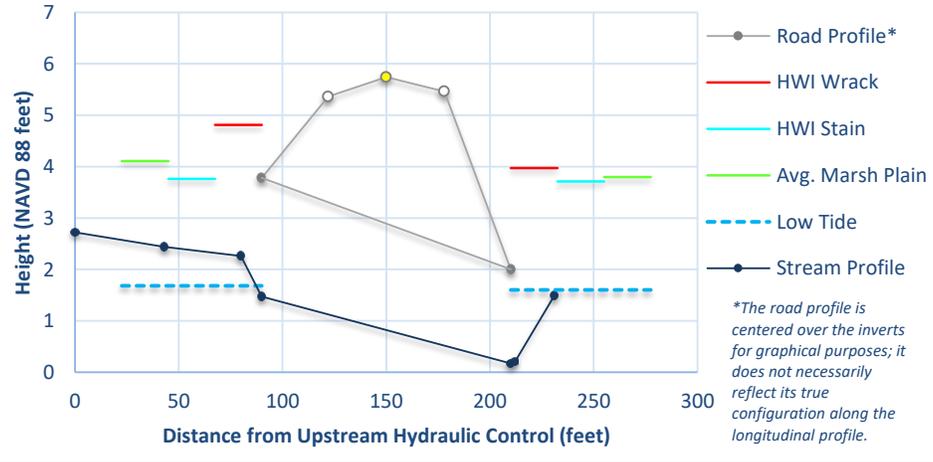
**Crossing Cross Section and Stream Longitudinal Profile**

Dist.	Hght.	Feat.	Sub.
0	2.7215	HC	C/S
43	2.4415	HC	C/S
80	2.2615	GC	C
90	1.4715	I	C
210	0.1715	I	C
212	0.2015	P	C
231	1.4915	HC	G

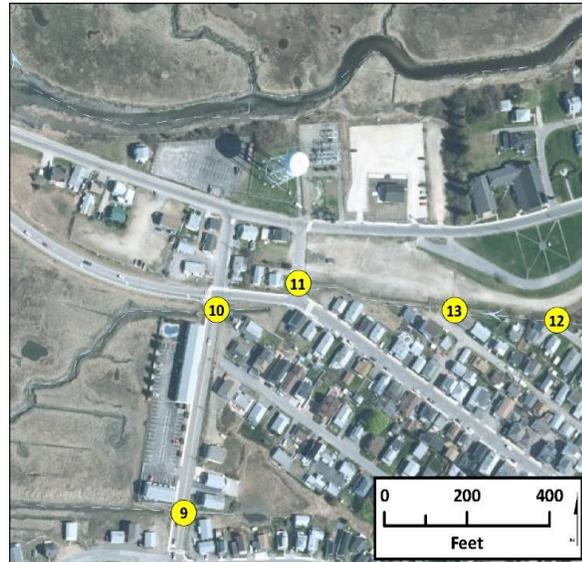
One of the small marshes in Hampton surrounded by development depends on the culvert under Highland Avenue in Hampton for its tides. The culvert is a round pipe about 3 feet in diameter, but its capacity is reduced by sediment. The crossing condition is poor, the channel is constrained with signs of erosion at the culvert. The original marsh is mostly filled by development. The overall combined score is 4, high priority for replacement.

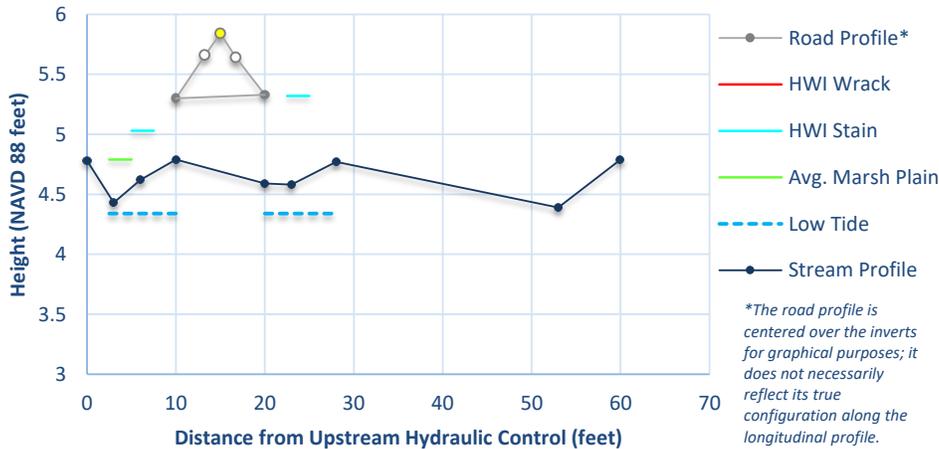
### Crossing Cross Section and Stream Longitudinal Profile

Dist.	Hght.	Feat.	Sub.
0	4.7799	HC	C/S
3	4.4299	P	G
6	4.6199	HC	G
10	4.7899	I	G
20	4.5899	I	G
23	4.5799	CB	G
28	4.7699	HC	C/S
53	4.3899	CB	C/S
60	4.7899	HC	C/S

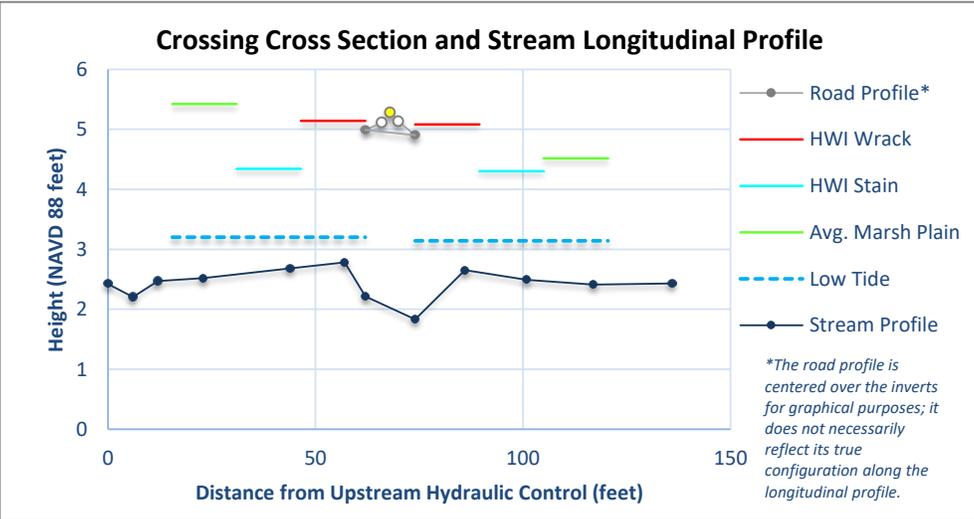
Long. Profile			
Dist.	Hght.	Feat.	Sub.
0	2.4222	HC	C/S
6	2.2022	P	C/S
12	2.4722	HC	C/S
23	2.5222	CB	S
44	2.6822	HC	C/S
57	2.7822	HC	C/S
62	2.2122	I	S
74	1.8322	I	C/S
86	2.6522	HC	C/S
101	2.4922	CB	C/S
117	2.4122	CB	C/S
136	2.4322	HC	C/S

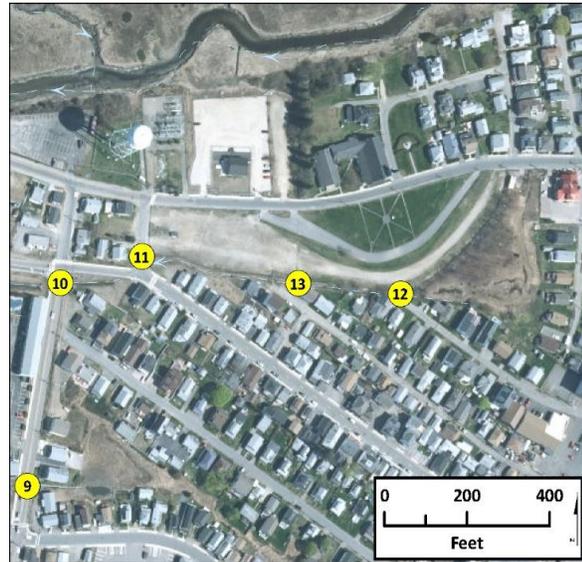
Church Street in Hampton crosses a tidal creek, providing tidal flow with a 2.5-foot round culvert. The crossing condition is fair and inundation risk to the road is high. Exotic Phragmites appears to increase above the crossing. The overall combined score is 4, high priority for replacement.

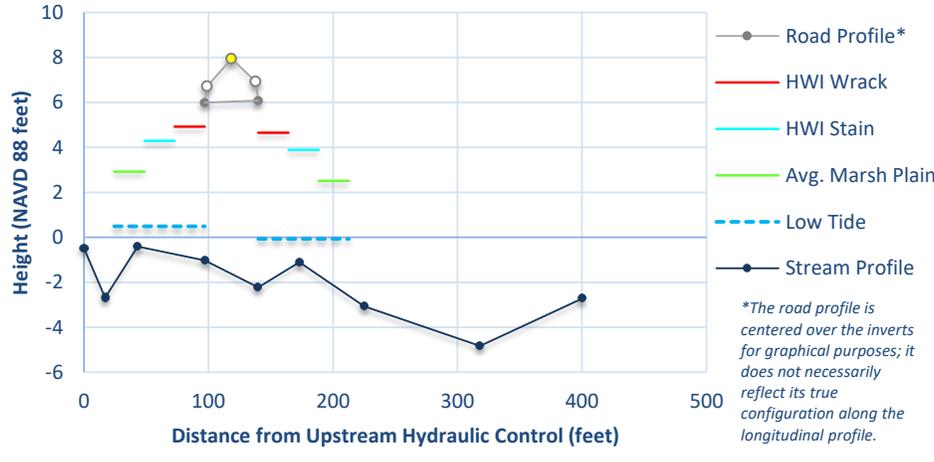
**Crossing Cross Section and Stream Longitudinal Profile**

Dist.	Hght.	Feat.	Sub.
0	-0.4904	HC	C
17	-2.6904	P	C/S
43	-0.4104	HC	C/S
97	-1.0304	I	C
140	-2.2204	I	C
173	-1.1104	HC	B
225	-3.0704	CB	G
318	-4.8304	P	G
400	-2.7304	HC	S

\*The road profile is centered over the inverts for graphical purposes; it does not necessarily reflect its true configuration along the longitudinal profile.

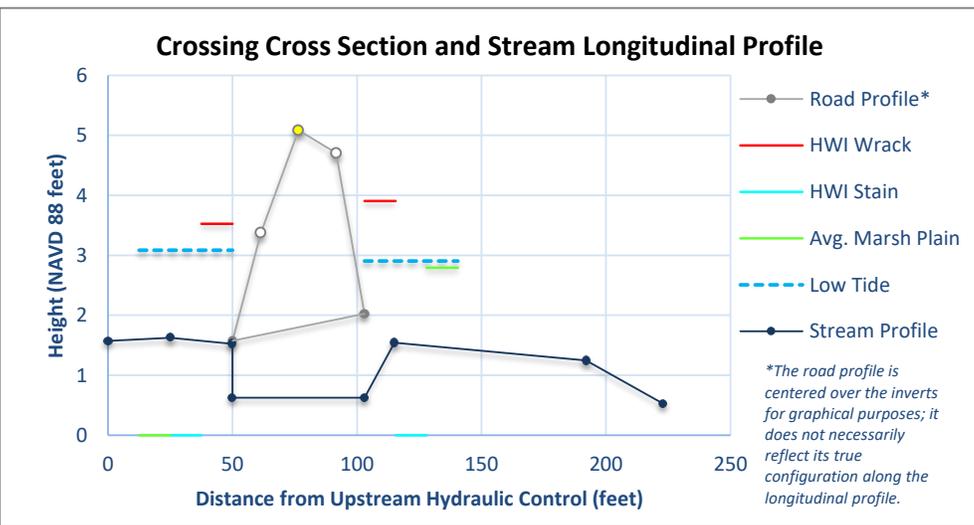
**Long. Profile**

Dist.	Hght.	Feat.	Sub.
0	1.5753	CB	C/S
25	1.6253	CB	C/S
50	1.5253	CB	C/S
50	0.6253	I	C/S
103	0.6253	I	C/S
115	1.5453	HC	C/S
192	1.2453	CB	C/S
223	0.5253	CB	C/S

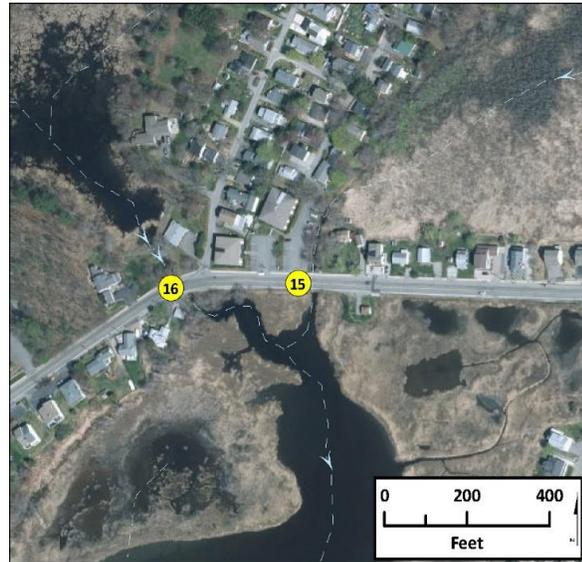
Fresh water from wetlands to the north drain into Meadow Pond under High Street in Hampton. The undersized culvert and low-lying roadway leave the crossing underwater at low tide and make it vulnerable to flooding. The crossing condition is poor and the potential for salt marsh expansion upstream is high, leading to an overall combined score of 5, highest priority for replacement.

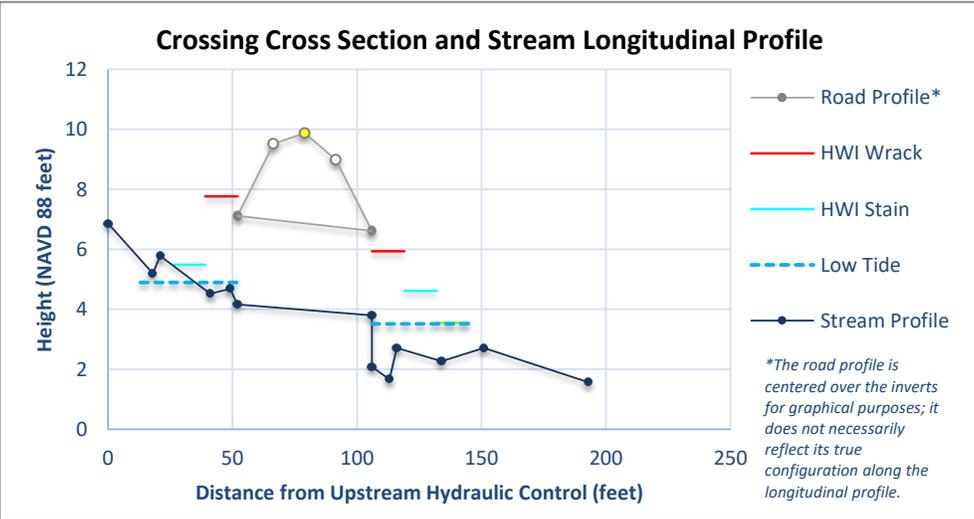
Long. Profile			
Dist.	Hght.	Feat.	Sub.
0	6.8653	HC	B
18	5.1953	P	B
21	5.7853	HC	B
41	4.5153	CB	B
49	4.6853	GC	B
52	4.1653	I	B
106	3.7953	I	B
106	2.0753	CB	B
113	1.6653	P	B
116	2.7153	GC	B
134	2.2653	CB	C
151	2.7153	HC	C
193	1.5653	P	C/S

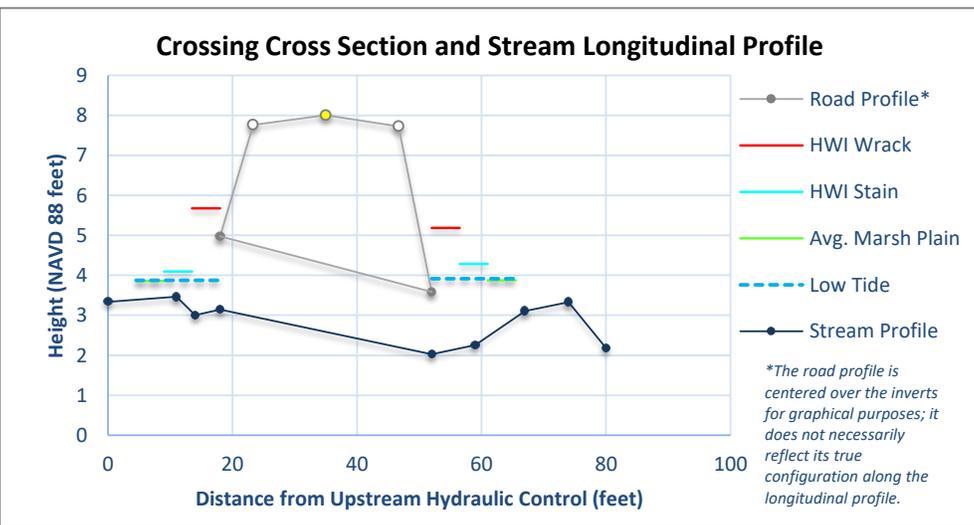
Long. Profile			
Dist.	Hght.	Feat.	Sub.
0	3.3352	CB	C/S
11	3.4652	CB	C/S
14	3.0052	P	C/S
18	3.1452	I	C/S
52	2.0252	I	G
59	2.2552	P	C/S
67	3.1052	CB	C/S
74	3.3252	CB	C/S
80	2.1852	P	C/S

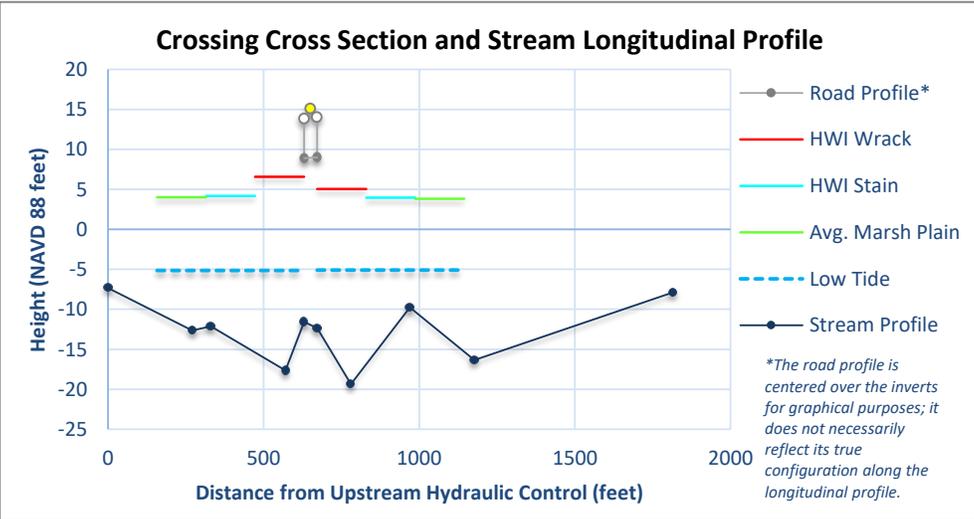
Long. Profile			
Dist.	Hght.	Feat.	Sub.
0	-7.3381	HC	S
270	-12.638	P	G
330	-12.138	HC	C
570	-17.638	P	S
630	-11.558	I	B
672	-12.358	I	B
780	-19.358	P	S
970	-9.7581	HC	G
1177	-16.358	P	C/S
1816	-7.8581	HC	S

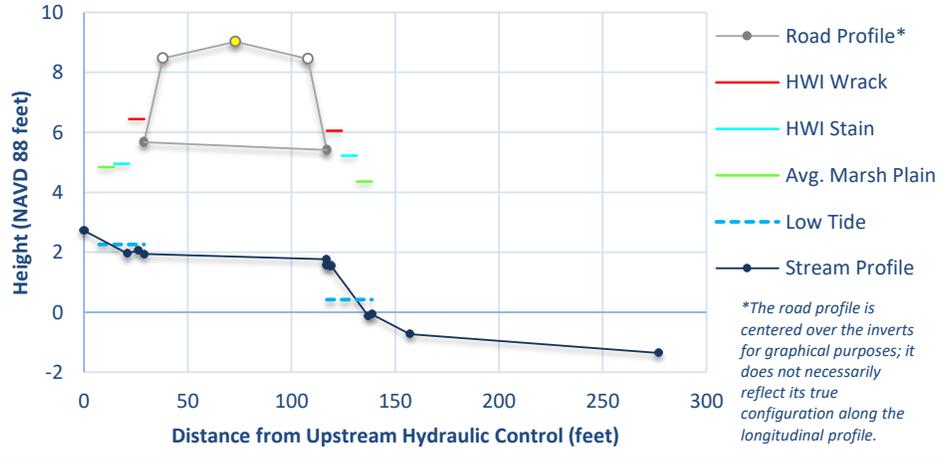
### Crossing Cross Section and Stream Longitudinal Profile

Dist.	Hght.	Feat.	Sub.
0	2.7223	HC	C
21	1.9523	CB	G
26	2.0723	GC	B
29	1.9423	I	B
117	1.7723	I	B
117	1.5723	CB	B
119	1.5523	GC	B
137	-0.1277	CB	C
139	-0.0777	HC	C
157	-0.7277	P	G
277	-1.3577	HC	S

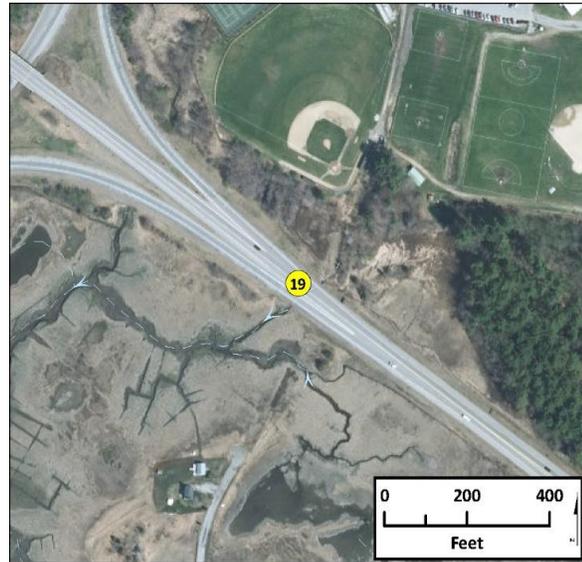
Route 101 was built at the edge of the Hampton Seabrook Estuary and a small marsh that was left upstream of the highway was provided with a 3.5-foot round concrete culvert to supply tidal flow and drainage. The crossing condition is poor, and the tidal range is muted, leading to fresher vegetation upstream of the crossing. The overall combined score is 4, a high priority for replacement of this crossing.

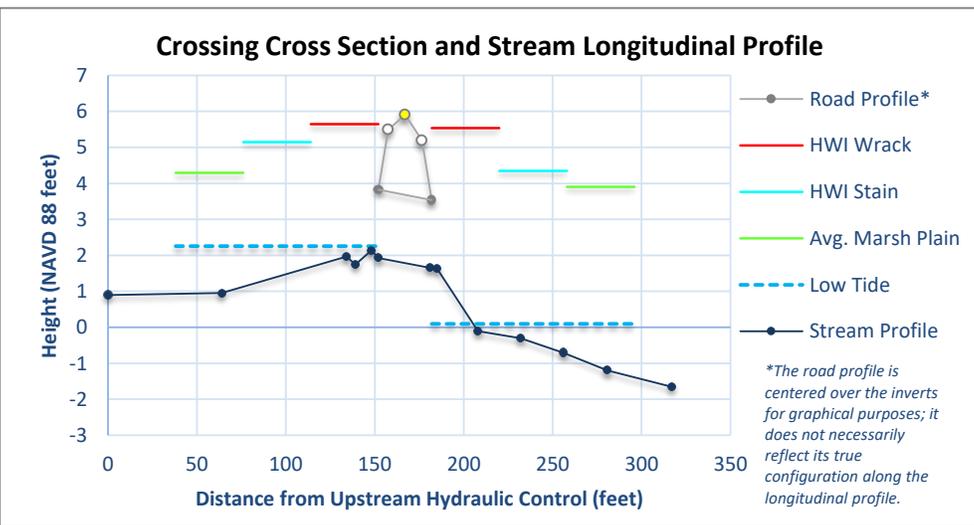
Long. Profile			
Dist.	Hght.	Feat.	Sub.
0	0.8955	HC	C/S
64	0.9555	P	C/S
134	1.9655	HC	G
139	1.7455	P	G
148	2.1355	GC	C
152	1.9255	I	C
181	1.6555	I	C
185	1.6255	GC	C
208	-0.1045	CB	G
232	-0.3045	HC	G
256	-0.7045	HC	G
281	-1.2045	CB	G
317	-1.6545	HC	G

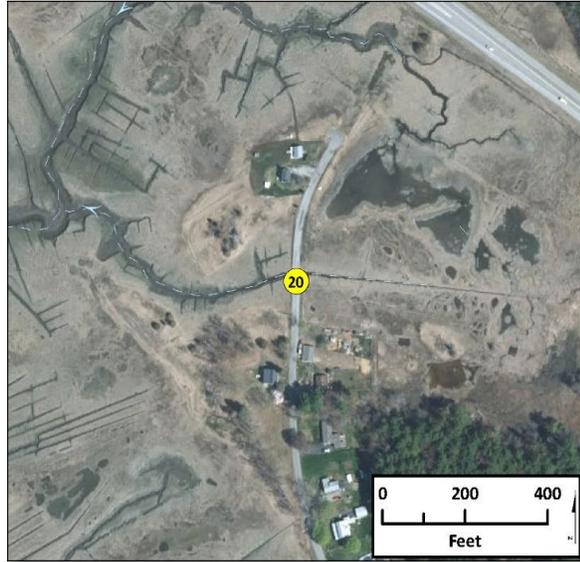
Landing Road in Hampton crosses an unnamed tidal creek with a 4 by 2-foot concrete box culvert that was installed as a tidal restoration in 2010. Tides regularly fill the undersized culvert and threaten to flood the road (and do flood the road during storms). The crossing condition is fair, inundation risk is very high and erosion is evident. In addition, the structure is perched. The overall combined score of 4 indicates this is a high priority for replacement.

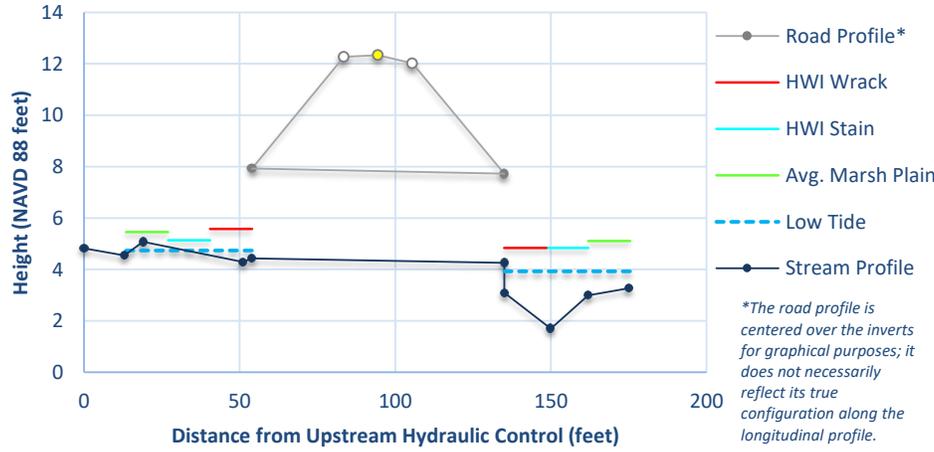
**Crossing Cross Section and Stream Longitudinal Profile**

Dist.	Hght.	Feat.	Sub.
0	4.826	HC	C
13	4.546	P	C
19	5.076	HC	G
51	4.296	P	G
54	4.426	I	C
135	4.256	I	C
135	3.096	CB	C
150	1.696	P	C/S
162	2.986	HC	C/S
175	3.266	HC	C/S

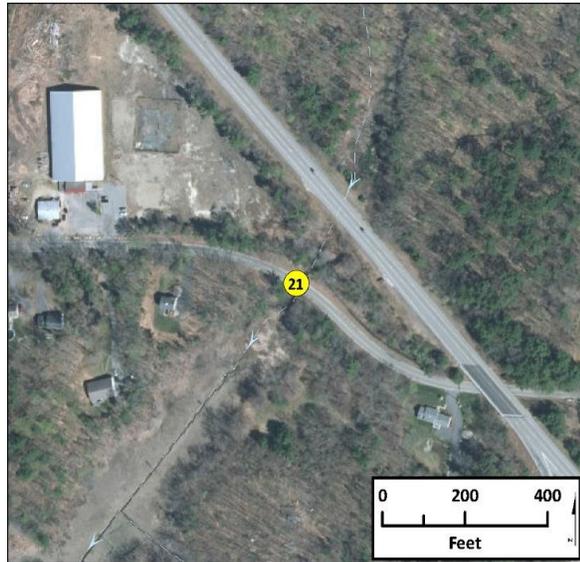
A 3.5-foot round concrete culvert under Drakeside Road drains a small wetland and its freshwater sources that were disrupted by the construction of Route 101. The longitudinal profile and water height indicators show the system is perched, impounding water upstream and preventing all but the highest tides from passing upstream, interfering with organism passage and influencing the upstream vegetation. The overall combined score is 4 for this culvert, indicating a high priority for replacement.

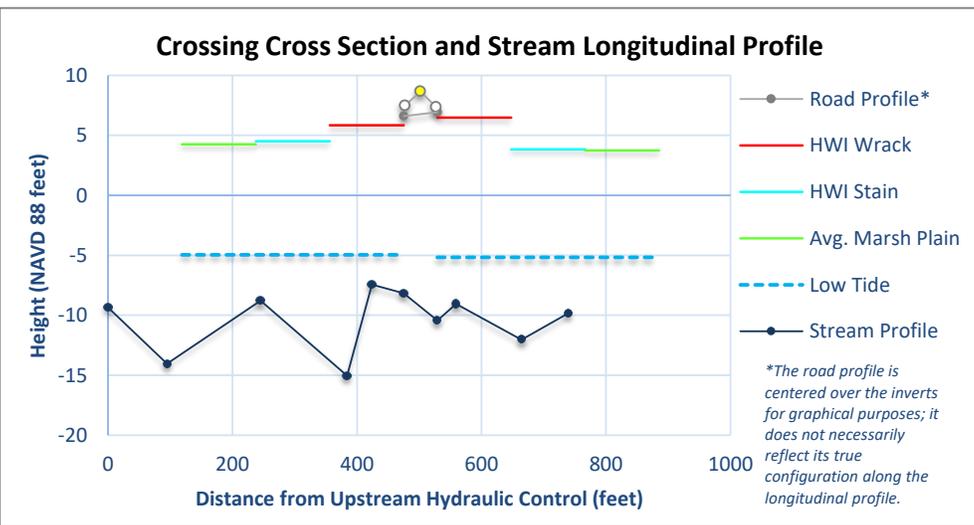
Long. Profile			
Dist.	Hght.	Feat.	Sub.
0	-9.3386	HC	C/S
95	-14.039	P	C/S
245	-8.7886	HC	G
384	-15.039	P	C
424	-7.4386	GC	G
475	-8.1686	I	B
529	-10.439	I	B
559	-9.0586	HC	C
664	-12.039	P	C
739	-9.8386	HC	G

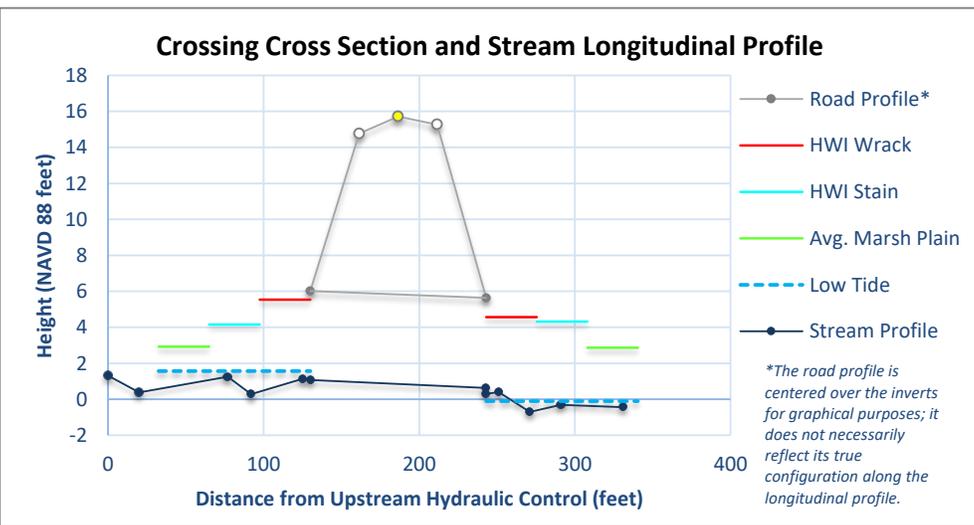
Long. Profile			
Dist.	Hght.	Feat.	Sub.
0	1.3152	HC	G
20	0.3752	P	G
77	1.2552	HC	G
92	0.2752	P	G
125	1.1452	GC	C
130	1.0752	I	C
243	0.6352	I	C
243.1	0.3052	CB	C
251	0.4052	GC	C
271	-0.7048	P	C
291	-0.3148	HC	G
331	-0.4348	HC	G

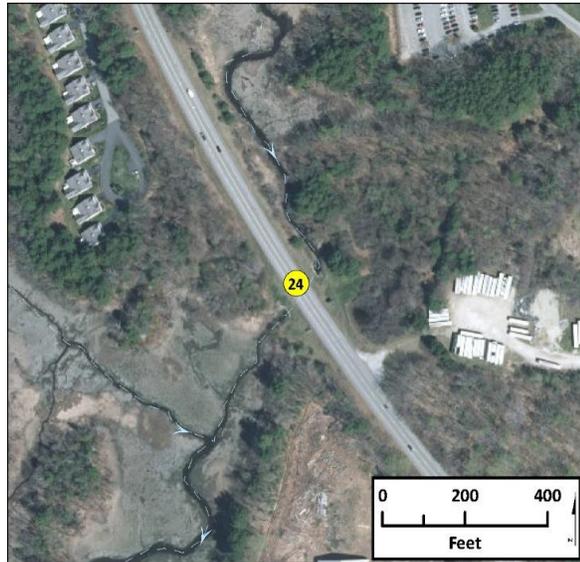
The upper crossing of Drakes River passes under Route 101 for over 100 feet and is a large concrete pipe alongside a rectangular culvert encased as a pair in concrete. The high water stain on the culvert structure indicates there is some tidal restriction and the culvert slope is about a foot and the low tide is more than 18 inches higher upstream, indicating impoundment. Along with high erosion, the perch (improperly high elevation of the culvert) leads to an overall combined score of 5: highest priority for replacement.

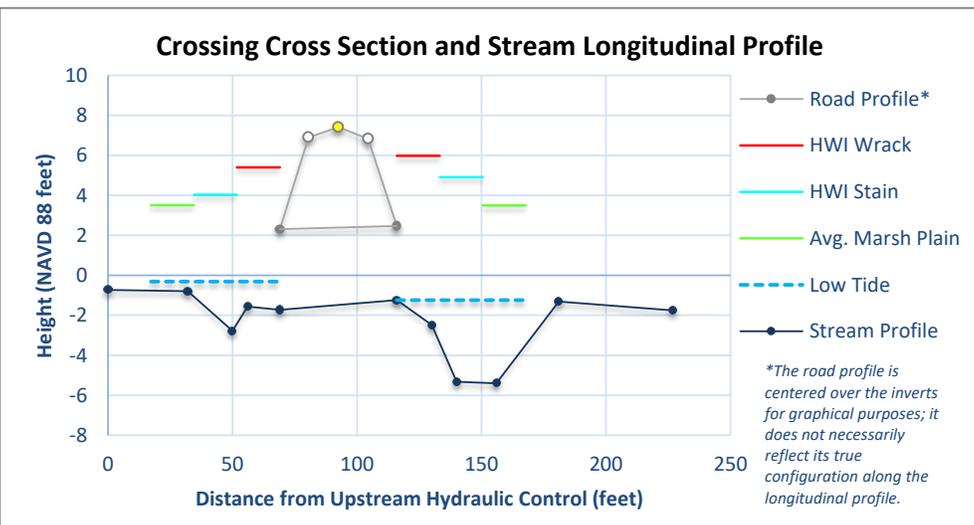
Long. Profile			
Dist.	Hght.	Feat.	Sub.
0	-0.7319	HC	G
32	-0.7919	HC	C
50	-2.7819	P	C
56	-1.5619	GC	C
69	-1.7319	I	B
116	-1.2319	I	B
130	-2.4819	GC	B
140	-5.3219	P	C
156	-5.4019	P	G
181	-1.3119	HC	C
227	-1.7519	HC	G

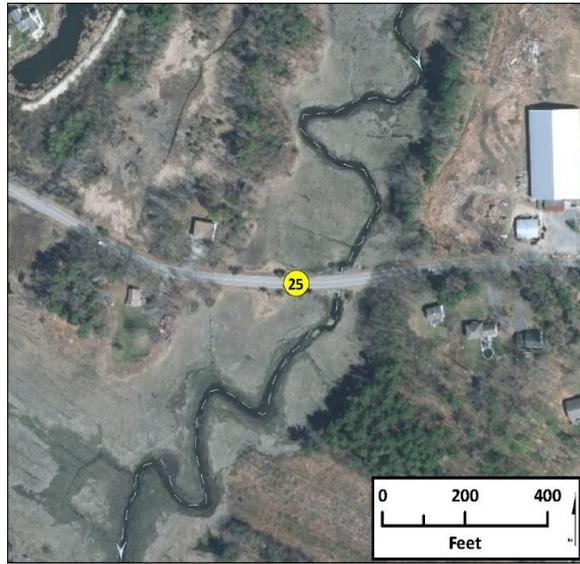
The lower tidal crossing of Drakes River passes under Drakeside Road through a 4 by 8 concrete culvert in Hampton. Despite restoration in 1996 tides are still restricted, with an overall combined score of 4 (high priority for replacement). This is due to reduced tidal range, interference with organism passage and poor crossing condition. *Phragmites*, which was overrunning the site in the mid-1990s, remains a visible feature in the marsh.

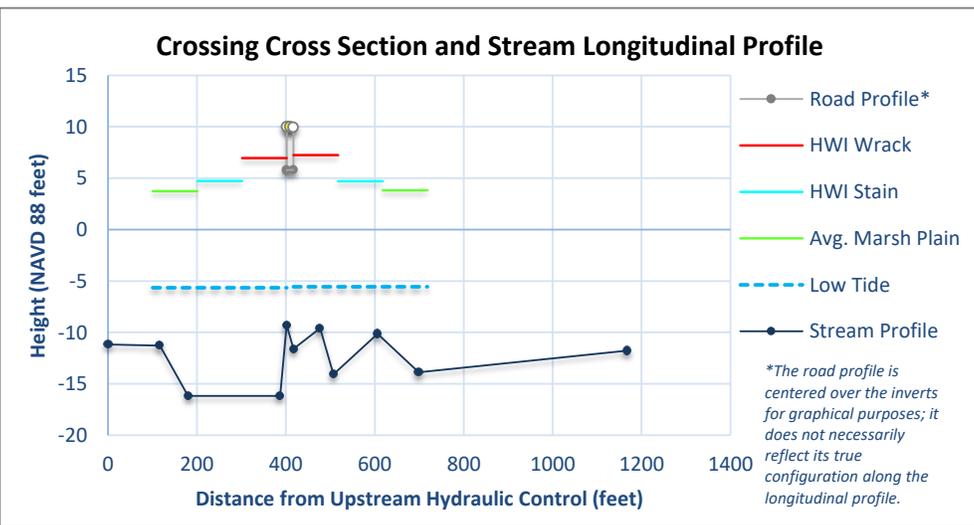
Long. Profile			
Dist.	Hght.	Feat.	Sub.
0	-11.173	HC	S
117	-11.273	HC	C/S
180	-16.173	P	C/S
387	-16.173	CB	C
402	-9.2734	I	B
417	-11.613	I	S
477	-9.5734	CB	C
507	-14.073	P	C
606	-10.123	HC	C
699	-13.873	P	C/S
1167	-11.773	HC	C/S

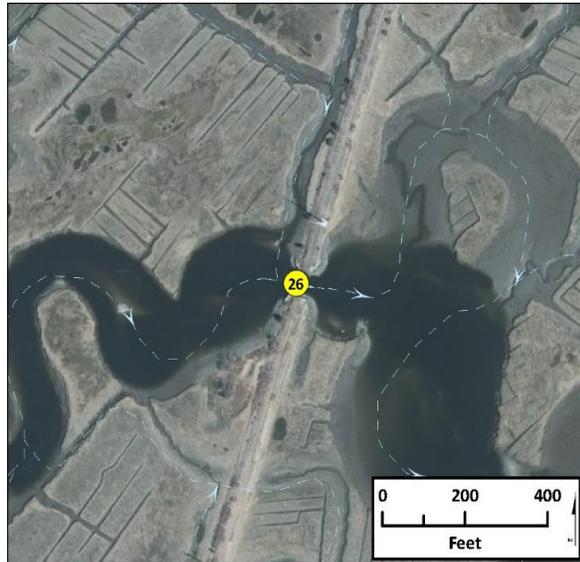
A railroad trestle crossing the Taylor River creates a constriction, approximately 60 by 16 feet in size, in the largest tributary to the Estuary. This is one of four tidal river crossings by the abandoned railroad bed that bisect Hampton Seabrook Estuary (the others are 28, 29 and 30) where tides are large (> 10 feet) and flows are huge. The crossing condition is rated poor and the potential for salt marsh migration in the upstream watershed is high. With an overall combined score of 4, this ranking indicates high priority for replacement or removal.

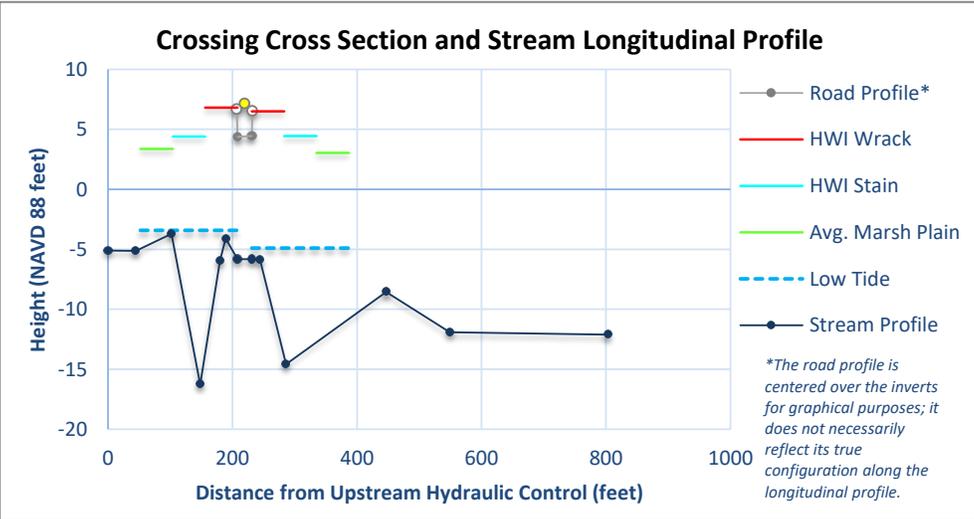
<u>Dist.</u>	<u>Hght.</u>	<u>Feat.</u>	<u>Sub.</u>
0	-5.0978	HC	G
45	-5.1378	CB	G
102	-3.7078	HC	Shell
148	-16.268	P	S
180	-5.9178	CB	C
189	-4.0978	GC	C
208	-5.8178	I	C
231	-5.8178	I	B
244	-5.8678	CB	B
286	-14.568	P	C/S
447	-8.5678	HC	S
549	-11.918	P	S
803	-12.118	CB	C/S

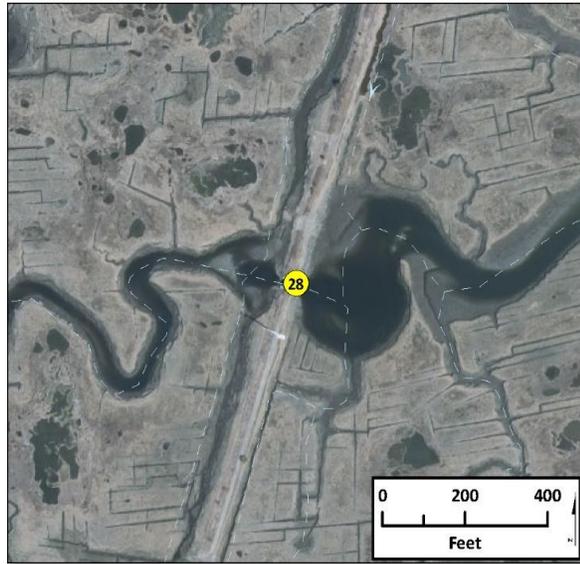
One of four tidal river crossings by the abandoned railroad bed that bisect Hampton Seabrook Estuary, this old granite bridge carries the flow of a major tidal creek. Despite its large size (16 feet by 10 feet), it constricts flow as shown by the very large plunge pools on either side of the crossing. The crossing condition is poor with high inundation risk and salt marsh migration potential in the upstream watershed, leading to an overall combined score of 5: highest priority for replacement (or removal).

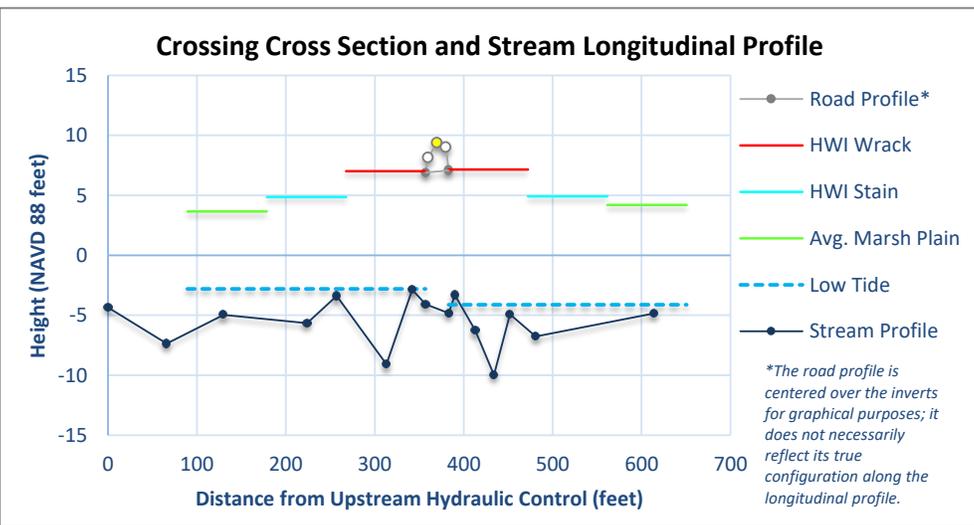
Long. Profile			
Dist.	Hght.	Feat.	Sub.
0	-4.3468	HC	S
66	-7.3468	P	S
130	-4.9768	HC	S
224	-5.6468	CB	S
257	-3.3968	HC	S
313	-9.0768	P	S
342	-2.8668	GC	B
357	-4.0868	I	C
383	-4.8168	I	C
390	-3.3168	GC	B
413	-6.2668	CB	C
434	-9.9768	P	C
452	-4.9068	HC	C
481	-6.7568	P	G
614	-4.8468	HC	G

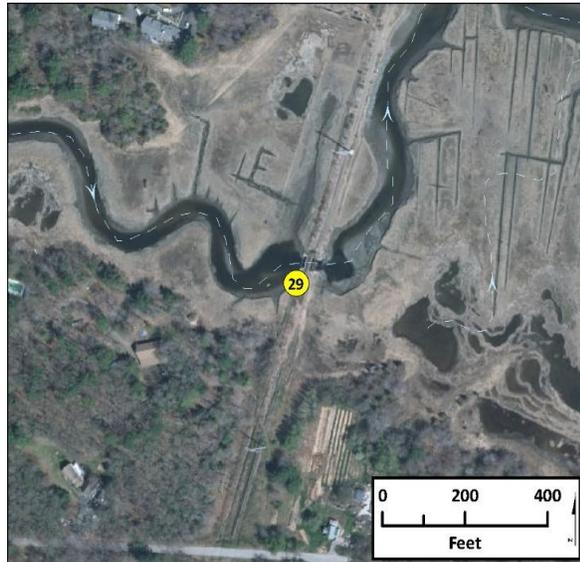
The granite structure conducts the Hampton Falls River, one of four tidal river crossings by the abandoned railroad bed that bisect Hampton Seabrook Estuary. The high water wrack line indicates tides in excess of 10 feet are not uncommon here and the large 27 foot by 11.5-foot structure is still shown to restrict tides by the 5 to 7-foot-deep plunge pools and over six inches of subsidence of the upstream marsh plain. The overall combined score of 4, high priority, is largely due to the poor structural condition of the crossing. Like crossings 26 and 28, this supports an abandoned railroad and could be removed.

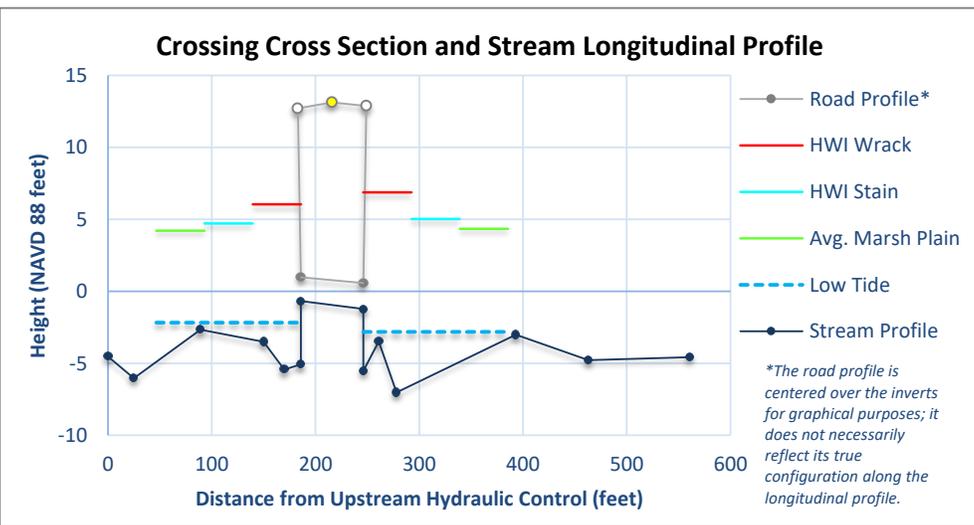
Long. Profile			
Dist.	Hght.	Feat.	Sub.
0	-4.5266	HC	C/S
25	-6.0466	P	C/S
89	-2.6666	HC	G
150	-3.5066	CB	S
170	-5.4466	P	S
186	-5.0766	I	B
186	-0.6766	I	C
246	-1.2166	I	B
246	-5.5166	I	B
261	-3.4966	GC	B
278	-7.0266	P	G
393	-3.0066	HC	G
463	-4.7866	P	C/S
561	-4.5766	HC	C/S

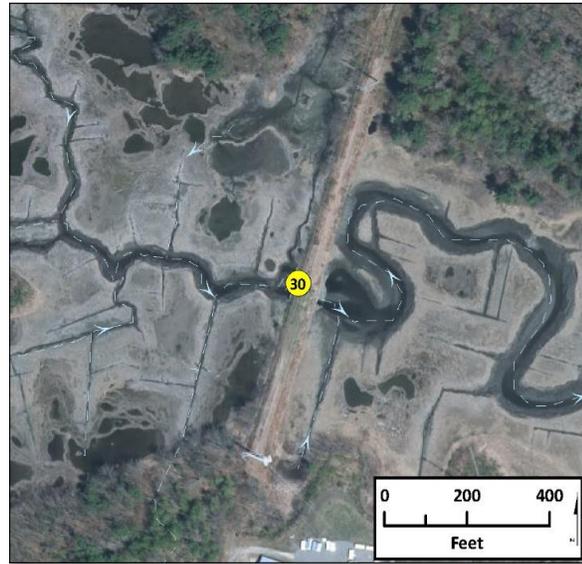
The crossing at Brown’s River was under an inactive rail line and the 48-inch diameter culvert was too small and perched too high, leading to tidal restriction and upstream marsh subsidence (about 5 inches) and invasion of exotic Phragmites. In addition, the ebb flow led to a greatly eroded channel, which is still evident (high crossing ratio score). In 2005, tidal flow was enhanced by the addition of a 4 by 6-foot culvert placed lower in the intertidal zone to support organism passage and reduce the tidal restriction. Although the marsh surface measurements were limited, the survey team found that the subsidence had decreased to only 1.5 inches in 2018. Despite the added benefits from the additional culvert, the crossing condition is poor, and the entire structure is regularly overfilled by tides, leading to an overall combined score of 4: high priority for replacement

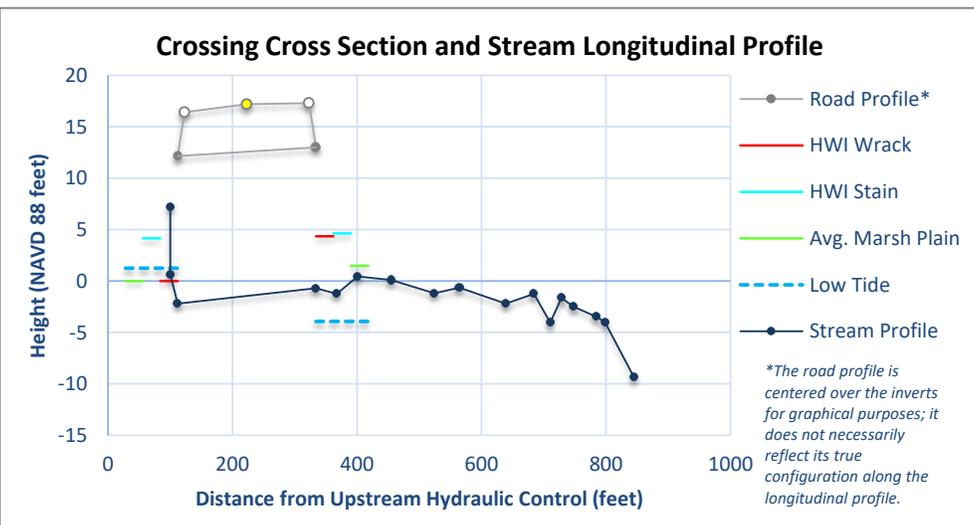
Long. Profile			
Dist.	Hght.	Feat.	Sub.
100	7.2116	HC	N/A
100	0.6516	CB	B
112	-2.1984	I	B
334.24	-0.6884	I	C/S
367.24	-1.2484	P	C/S
401.24	0.4516	HC	C
454.24	0.1016	HC	G
524.24	-1.1984	P	C
564.24	-0.6484	HC	G
639.24	-2.1984	P	G
684.24	-1.2484	HC	C
710.24	-4.0484	P	B
728.24	-1.6584	HC	B
748.24	-2.5284	HC	B
784.24	-3.4784	HC	S
798.24	-4.0184	CB	C/S
845.24	-9.3984	CB	C/S

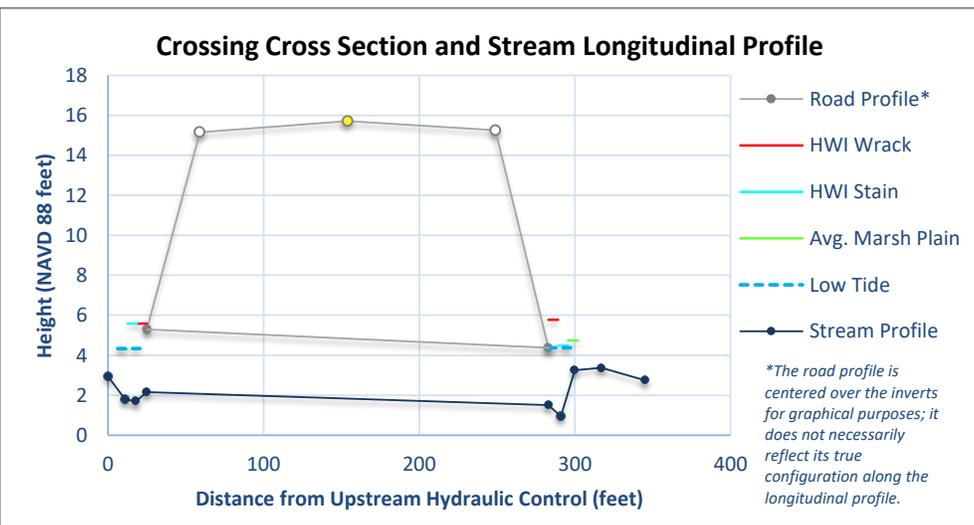
Long. Profile			
Dist.	Hght.	Feat.	Sub.
0	2.9452	CB	C/S
11	1.7852	HC	C/S
18	1.7052	CB	B
25	2.1552	I	B
283	1.5052	I	C/S
291	0.9452	P	C/S
300	3.2552	HC	C/S
317	3.3752	CB	C/S
345	2.7452	I	C/S

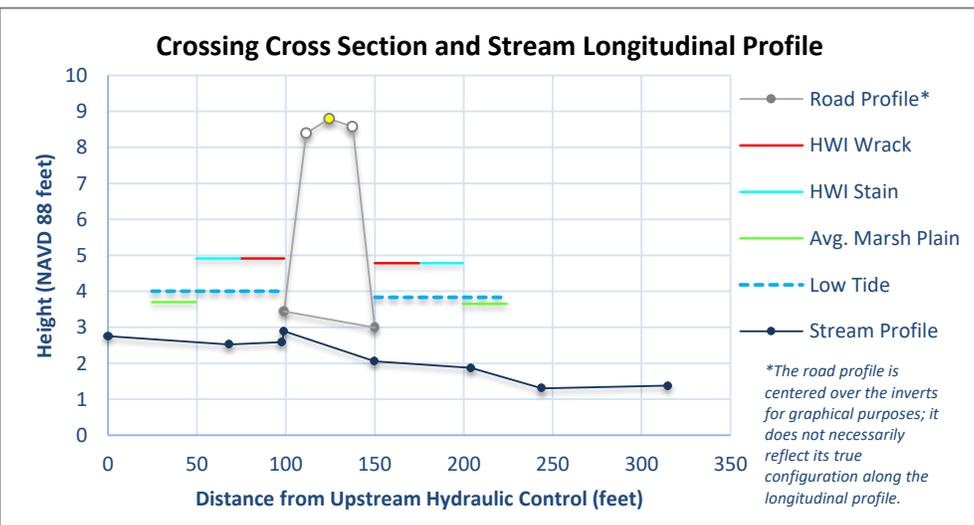
Long. Profile			
Dist.	Hght.	Feat.	Sub.
0	2.7527	HC	S
68	2.5227	HC	C/S
98	2.5927	P	C/S
99	2.8927	I	C/S
150	2.0527	I	G
204	1.8727	P	C/S
244	1.3027	HC	C/S
315	1.3827	HC	C/S

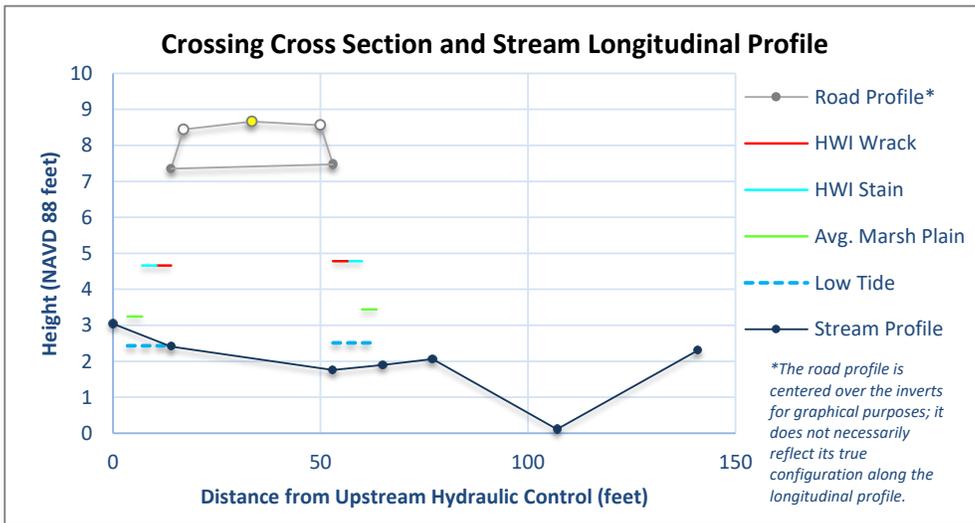
Dist.	Hght.	Feat.	Sub.
0	3.0414	CB	C/S
14	2.4114	I	C/S
53	1.7614	I	C/S
65	1.9014	HC	C/S
77	2.0614	HC	C/S
107	0.1114	P	C/S
141	2.3114	HC	C/S
