# Tidal Crossing Summary Sheet

## New Hampshire's Tidal Crossing Assessment Protocol

Crossing ID: 1

Observer(s) & Organization:	TS, JB (NHDES Coastal)
Municipality:	SEABROOK
Stream Name:	Blackwater River
Road Name:	Route 286

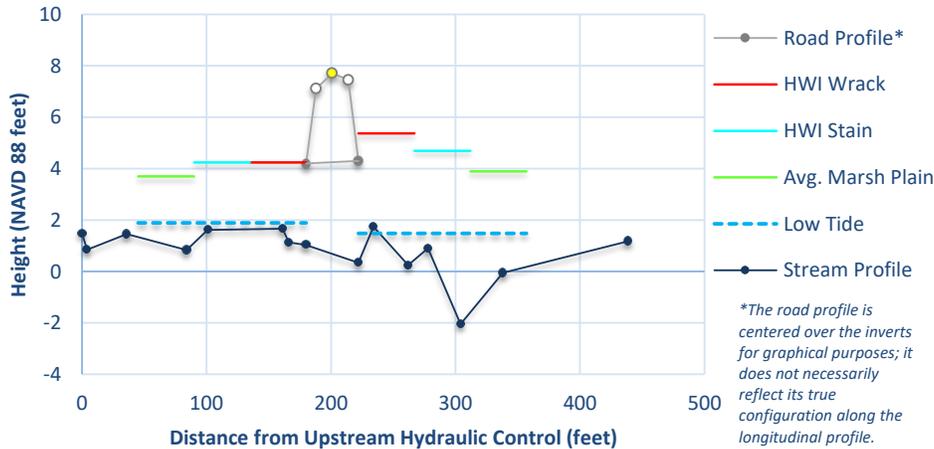
### Crossing Cross Section and Stream Longitudinal Profile

Dist.	Hght.	Feat.	Sub.
0	1.48	HC	S
4	0.84	P	S
36	1.46	HC	S
84	0.83	P	S
101	1.61	HC	S
161	1.66	HC	S
166	1.13	CB	S
180	1.03	I	G
222	0.34	I	C
234	1.74	GC	C
262	0.25	P	G
278	0.9	HC	G
304	-2.05	P	G
338	-0.05	HC	S
439	1.18	HC	S

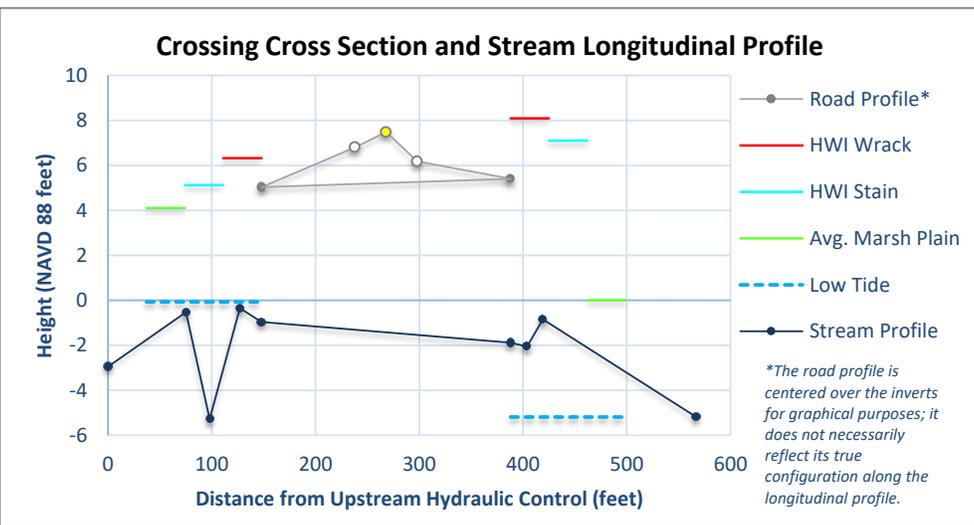
Dist.	Hght.	Feat.	Sub.
0	-2.9497	HC	G
75	-0.5297	HC	G
98	-5.2797	P	S
127	-0.3497	GC	C
148	-0.9597	I	B
388	-1.8897	I	C
404	-2.0497	P	C
419	-0.8397	HC	B
567	-5.1897	HC	C

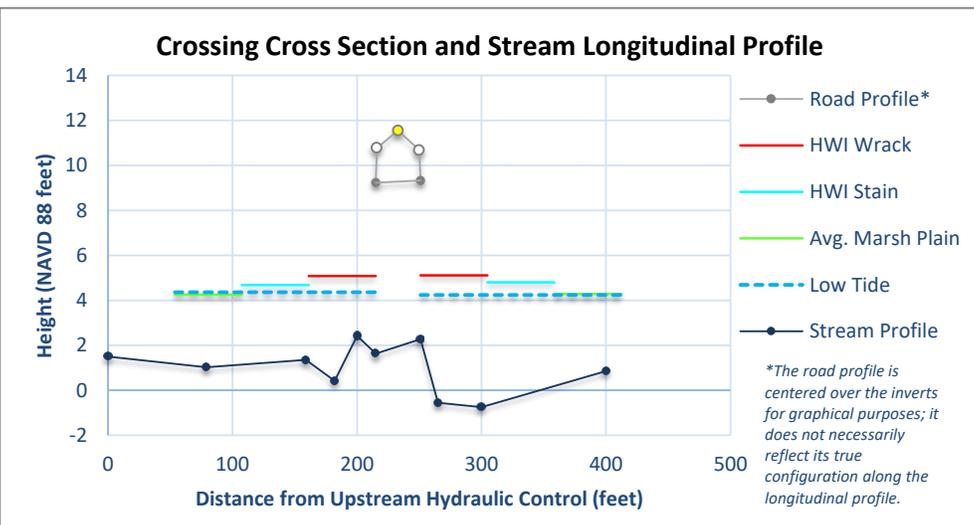
Long. Profile			
Dist.	Hght.	Feat.	Sub.
0	1.4986	HC	C/S
79	1.0286	P	C/S
159	1.3486	HC	C/S
182	0.4186	P	G
200	2.4186	GC	C
215	1.6286	I	C
251	2.2786	I	C
265	-0.5514	P	C
300	-0.7514	HC	C/S
400	0.8586	HC	C/S

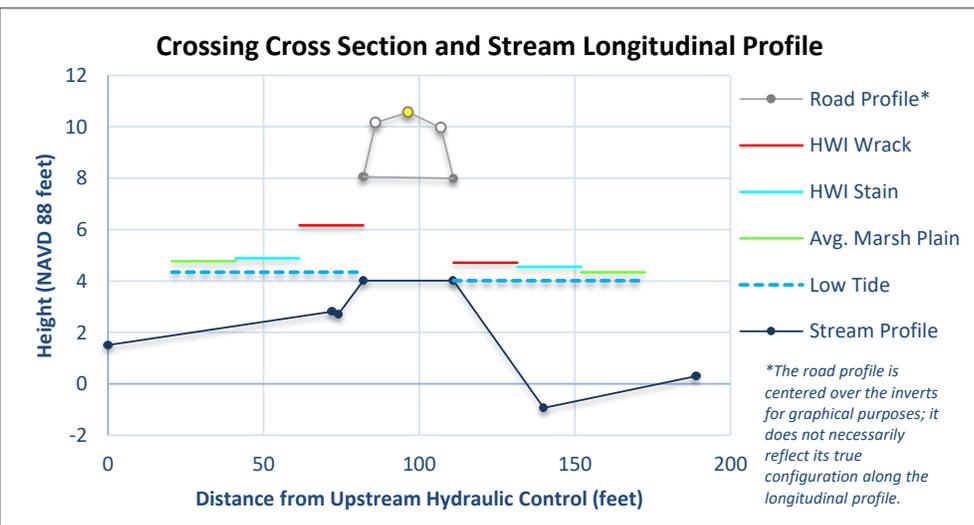
Dist.	Hght.	Feat.	Sub.
0	1.5143	HC	C/S
72	2.8143	HC	G
74	2.7143	P	G
82	4.0143	I	C
111	4.0143	I	C
140	-0.9357	P	B
189	0.3043	HC	G

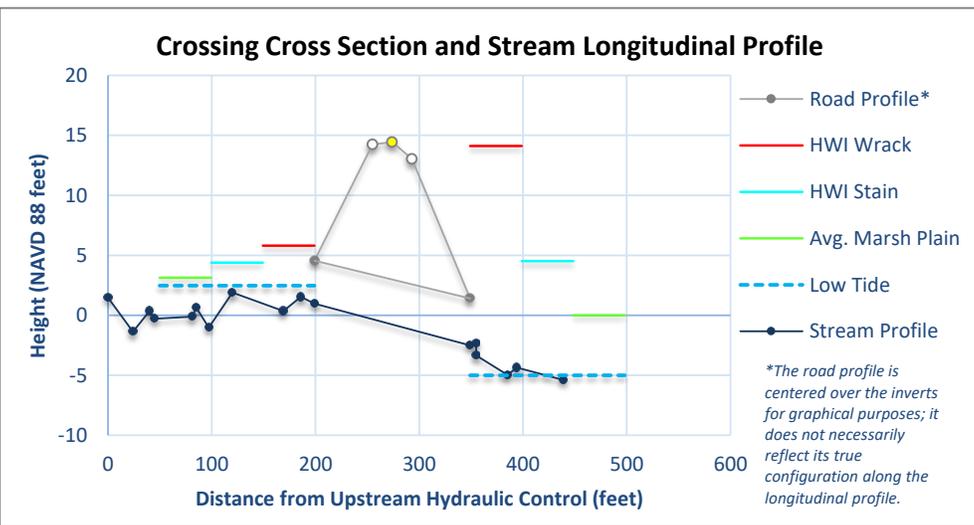
### Long. Profile

Dist.	Hght.	Feat.	Sub.
0	1.4657	HC	G
24	-1.3643	P	C
40	0.3657	GC	B
45	-0.2743	I	B
81	-0.1043	I	B
85	0.6357	GC	B
97	-1.0143	P	S
120	1.8957	HC	S
169	0.3557	P	G
186	1.5357	GC	C
199	0.9657	I	C
349	-2.4943	I	B
355	-2.3443	GC	B
355	-3.3443	CB	B
385	-4.9843	P	G
394	-4.3543	HC	B
439	-5.3943	HC	B

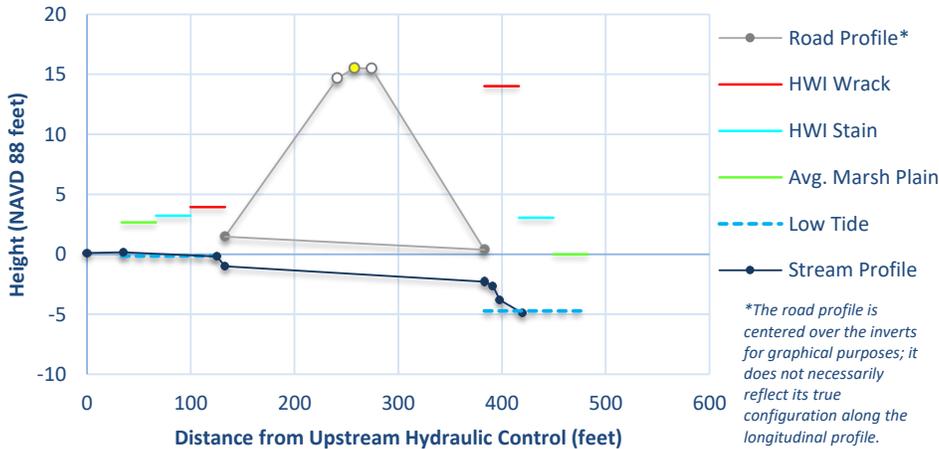
**Crossing Cross Section and Stream Longitudinal Profile**

Dist.	Hght.	Feat.	Sub.
0	0.1184	HC	C/S
35	0.1684	HC	G
125	-0.1816	GC	G
133	-1.0116	I	C
383	-2.2816	I	B
391	-2.6316	HC	B
398	-3.8016	CB	B
420	-4.9216	HC	C

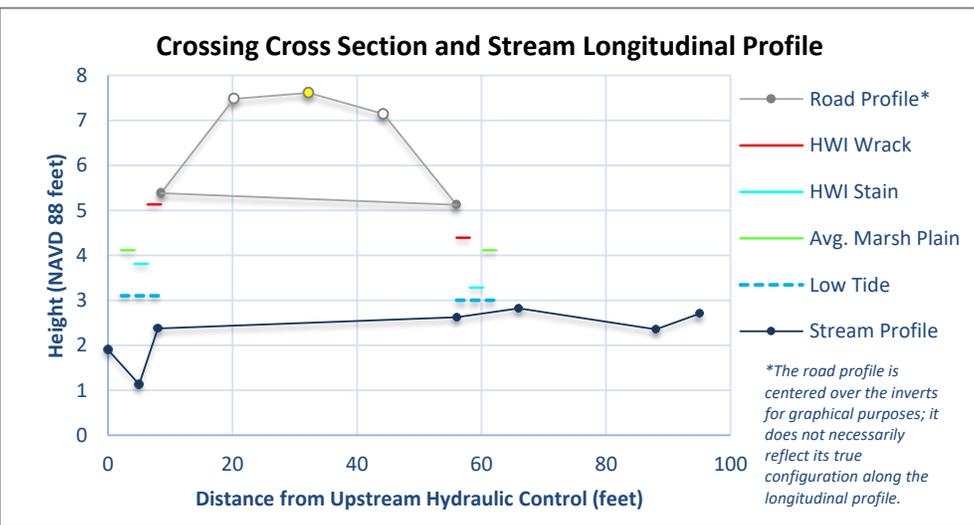
Long. Profile			
Dist.	Hght.	Feat.	Sub.
0	1.9015	CB	C/S
5	1.1315	P	C/S
8	2.3715	I	C/S
56	2.6215	I	S
66	2.8215	HC	G
88	2.3515	P	C/S
95	2.7015	HC	C/S

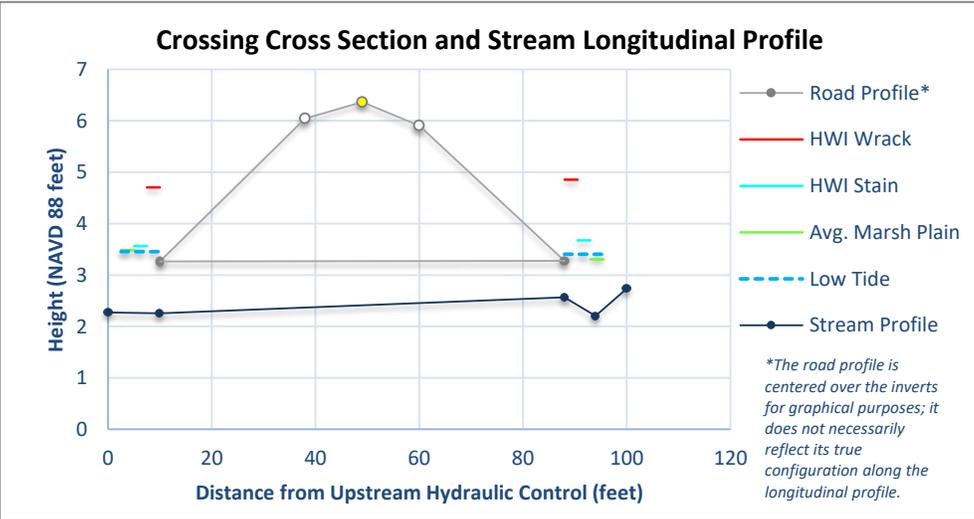
Long. Profile			
Dist.	Hght.	Feat.	Sub.
0	2.2748	CB	C/S
10	2.2548	I	S
88	2.5648	I	S
94	2.2048	P	G
100	2.7348	CB	S

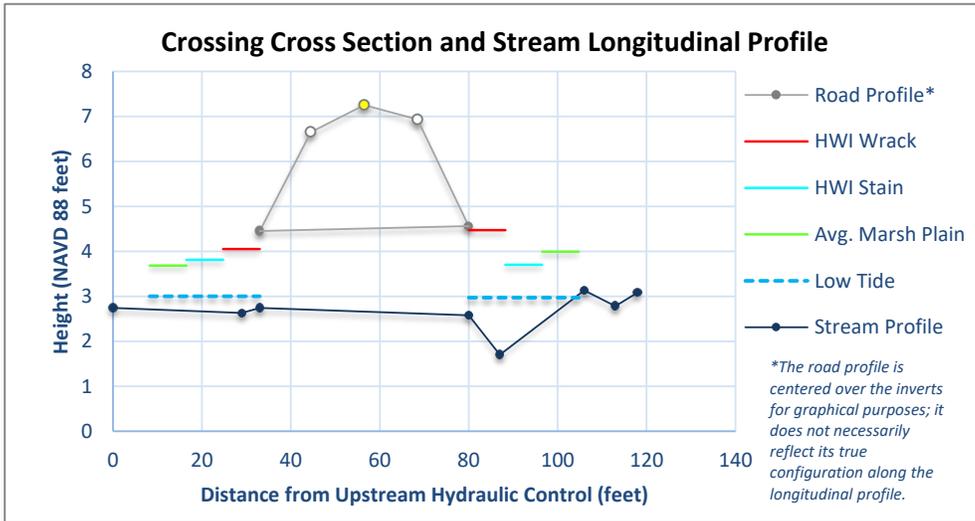
Long. Profile			
Dist.	Hght.	Feat.	Sub.
0	2.7407	HC	C/S
29	2.6307	CB	C/S
33	2.7407	I	C/S
80	2.5807	I	G
87	1.7007	P	S
106	3.1307	HC	G
113	2.7807	CB	S
118	3.0807	HC	S

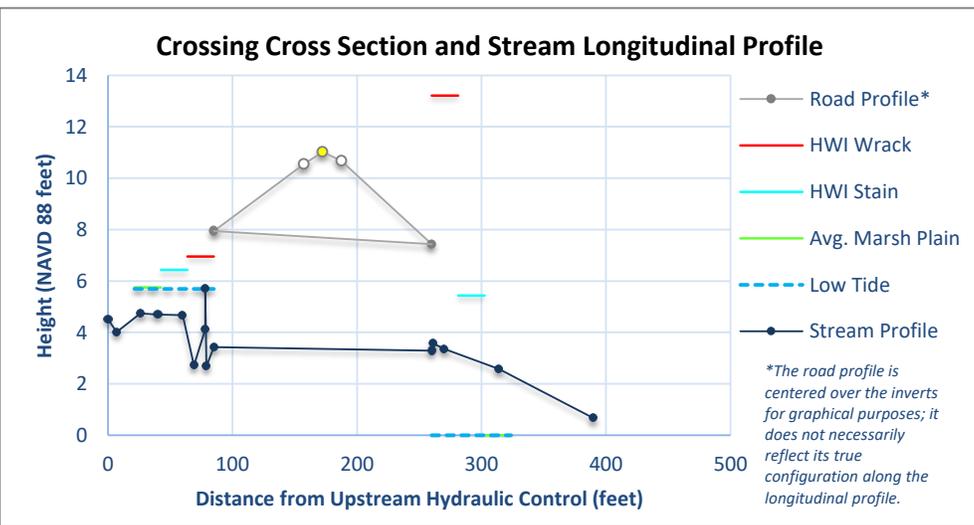
Long. Profile			
Dist.	Hght.	Feat.	Sub.
0	4.5136	HC	S
7	4.0136	P	S
26	4.7436	HC	S
40	4.6936	CB	S
60	4.6736	HC	S
69	2.7136	P	G
78	4.1136	CB	G
78	5.7136	GC	N/A
79	2.6836	GC	N/A
85	3.4336	I	G
260	3.2936	I	S
261	3.5736	HC	G
270	3.3536	CB	S
314	2.5736	CB	S
390	0.6636	GC	S

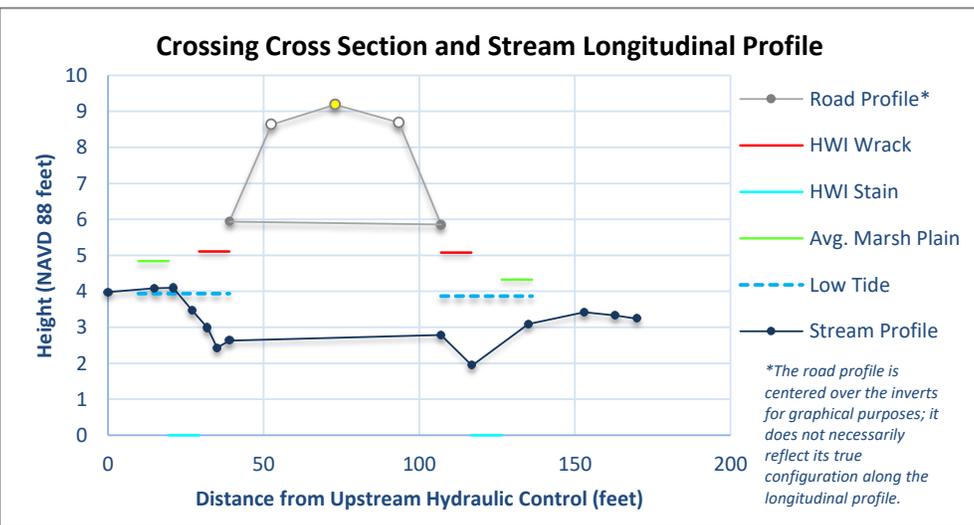
Long. Profile			
Dist.	Hght.	Feat.	Sub.
0	3.9764	HC	C/S
15	4.0864	CB	C/S
21	4.0964	HC	C/S
27	3.4664	HC	C/S
32	2.9864	HC	C/S
35	2.4364	P	C/S
39	2.6264	I	C/S
107	2.7864	I	C/S
117	1.9364	P	C/S
135	3.0864	HC	C/S
153	3.4164	HC	C/S
163	3.3264	CB	C/S
170	3.2364	HC	C/S

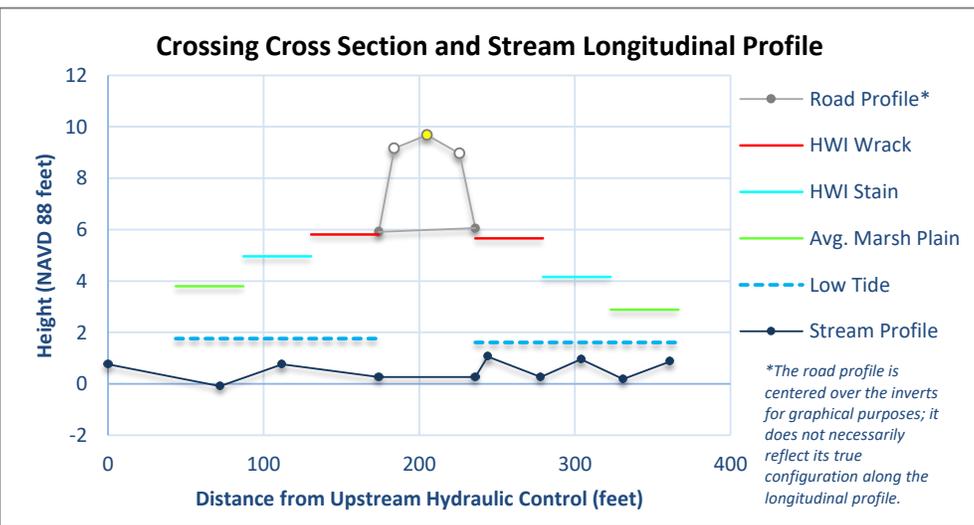
Long. Profile			
Dist.	Hght.	Feat.	Sub.
0	0.76	HC	C/S
72	-0.09	P	C/S
112	0.76	HC	S
174	0.26	I	G
236	0.26	I	G
244	1.06	GC	C
278	0.26	P	G
304	0.96	HC	G
331	0.19	P	G
361	0.86	HC	G

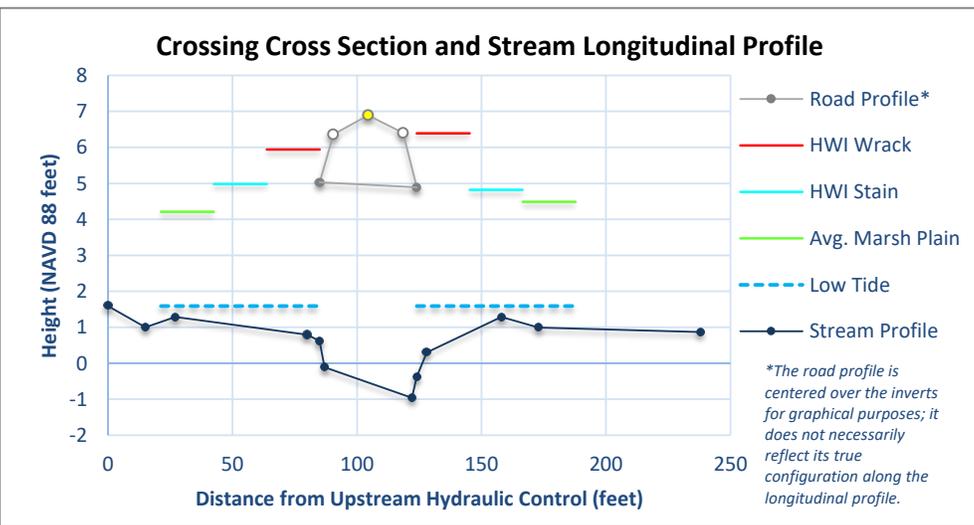
Long. Profile			
Dist.	Hght.	Feat.	Sub.
0	1.5901	US HC	S
15	1.0001	US HC	S
27	1.2901	US HC	S
80	0.7901	US P	S
85	0.6201	US I	S
87	-0.1099	US P	G
122	-0.9599	DS P	S
124	-0.3799	DS I	S
128	0.3001	DS P	S
158	1.2901	DS HC	S
173	0.9901	DS P	S
238	0.8701	DS HC	G

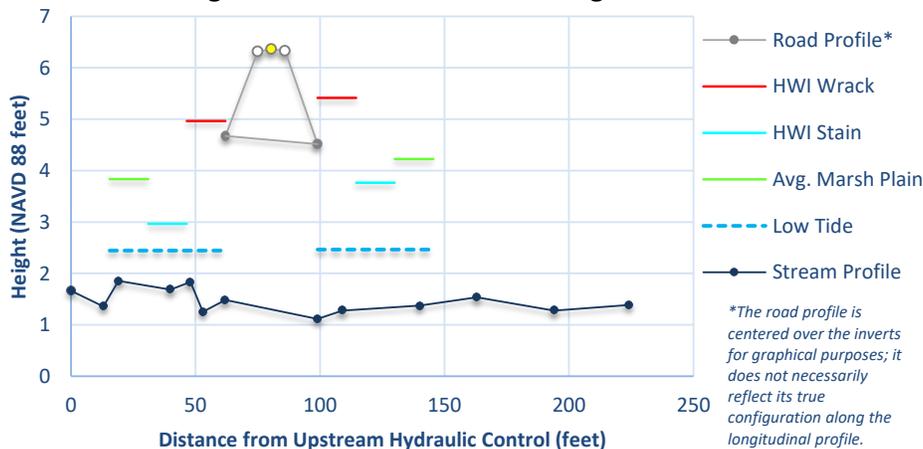
### Crossing Cross Section and Stream Longitudinal Profile

Dist.	Hght.	Feat.	Sub.
0	1.6648	HC	C/S
13	1.3548	P	S
19	1.8548	HC	C/S
40	1.6848	CB	C/S
48	1.8348	HC	G
53	1.2548	P	G
62	1.4848	I	G
99	1.1148	I	G
109	1.2748	P	G
140	1.3748	HC	C/S
163	1.5348	P	C/S
194	1.2748	HC	C/S
224	1.3848	HC	S

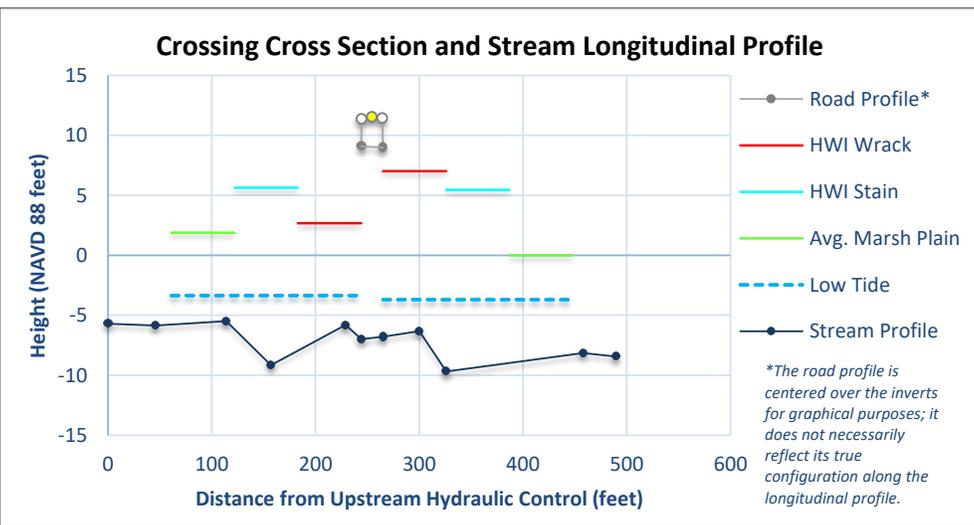
Long. Profile			
Dist.	Hght.	Feat.	Sub.
0	-5.7043	HC	S
46	-5.8543	P	S
114	-5.4843	HC	S
157	-9.1543	P	S
229	-5.8043	GC	Shell
244	-6.9943	I	B
265	-6.7943	I	B
300	-6.3143	GC	B
326	-9.6843	P	C
458	-8.1543	HC	C
490	-8.4543	CB	C

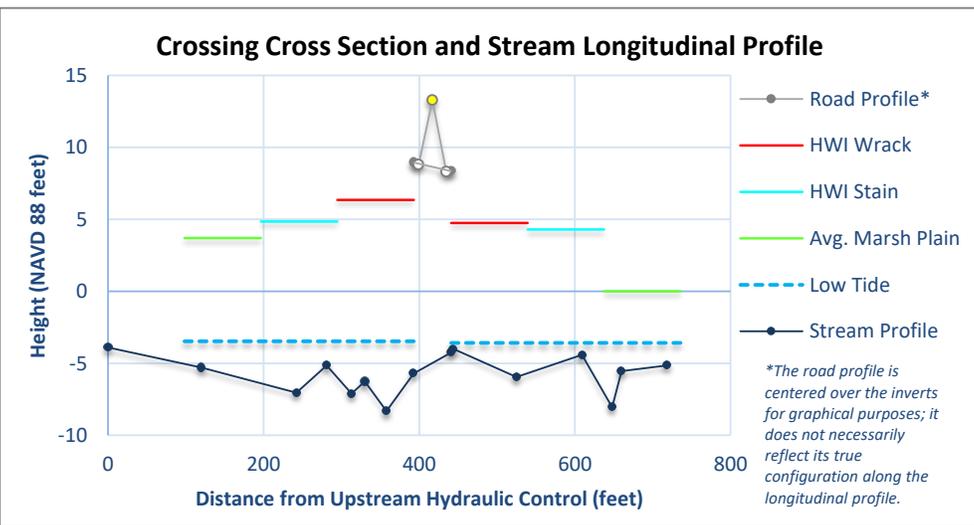
Long. Profile			
Dist.	Hght.	Feat.	Sub.
0	-3.9026	HC	S
120	-5.3026	CB	G
242	-7.0526	P	C/S
281	-5.1526	HC	C
313	-7.1026	P	S
330	-6.2526	CB	C
358	-8.3226	P	C
393	-5.7026	I	C
441	-4.2526	I	G
444	-4.0026	GC	B
525	-5.9526	P	C
609	-4.4026	HC	B
648	-8.0526	P	G
660	-5.5526	CB	G
718	-5.1526	HC	G

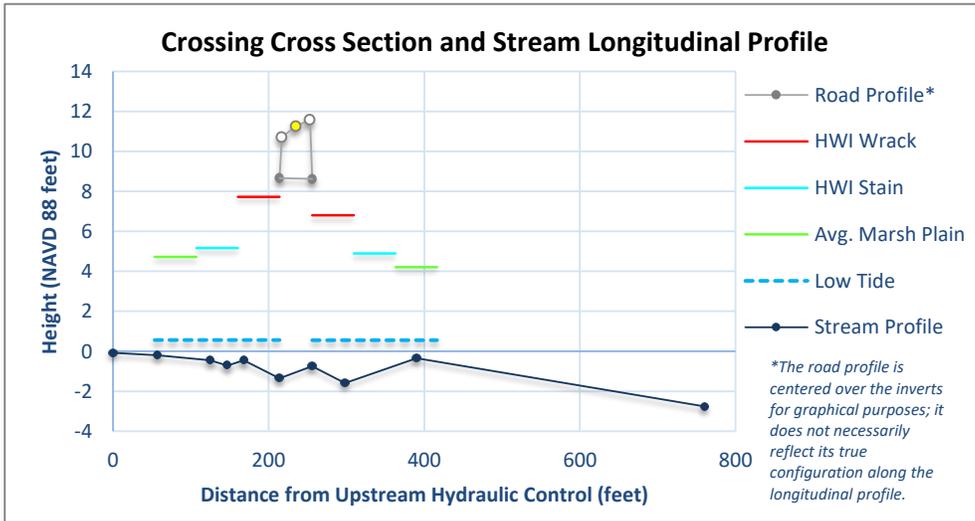
Long. Profile			
Dist.	Hght.	Feat.	Sub.
0	-0.0767	HC	S
57	-0.1967	CB	S
125	-0.4467	HC	S
147	-0.7167	P	S
168	-0.4567	HC	S
214	-1.3567	I	S
256	-0.7467	I	B
298	-1.5967	P	C
390	-0.3467	HC	G
760	-2.7567	HC	G

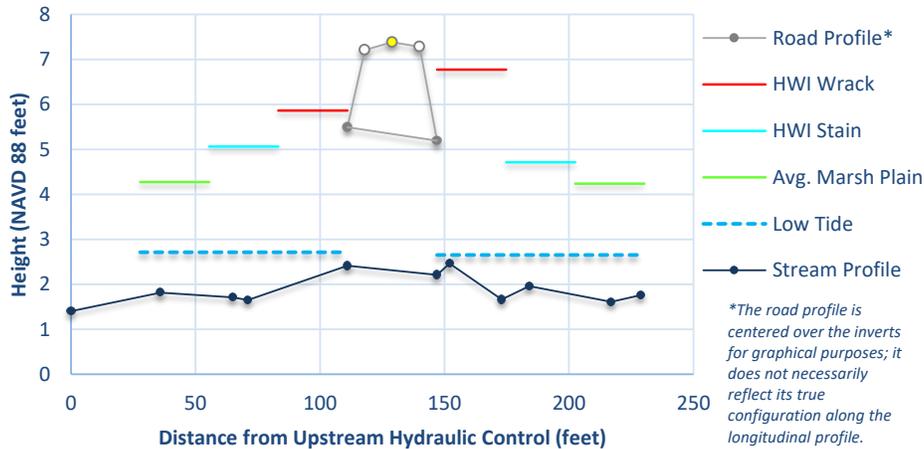
### Crossing Cross Section and Stream Longitudinal Profile

Dist.	Hght.	Feat.	Sub.
0	1.4019	HC	C/S
36	1.8119	CB	C/S
65	1.7119	HC	S
71	1.6519	P	S
111	2.4119	I	G
147	2.2119	I	S
152	2.4619	GC	C
173	1.6619	P	C
184	1.9619	HC	G
217	1.6119	P	C
229	1.7619	HC	C

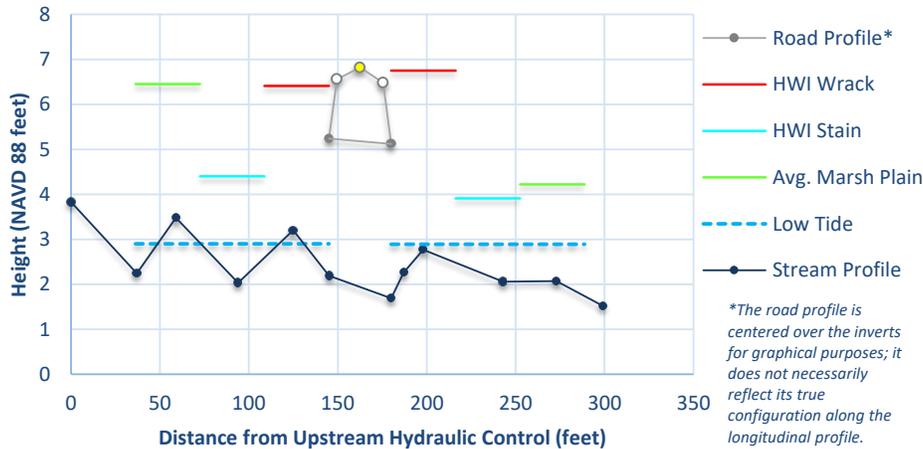
### Crossing Cross Section and Stream Longitudinal Profile

Dist.	Hght.	Feat.	Sub.
0	3.8302	HC	C/S
37	2.2402	P	C/S
59	3.4802	HC	C/S
94	2.0302	P	C/S
125	3.2002	GC	C
145	2.1902	I	C
180	1.6902	I	G
187	2.2602	P	G
198	2.7702	HC	C/S
243	2.0602	P	C/S
273	2.0702	HC	C/S
299	1.5202	P	C/S

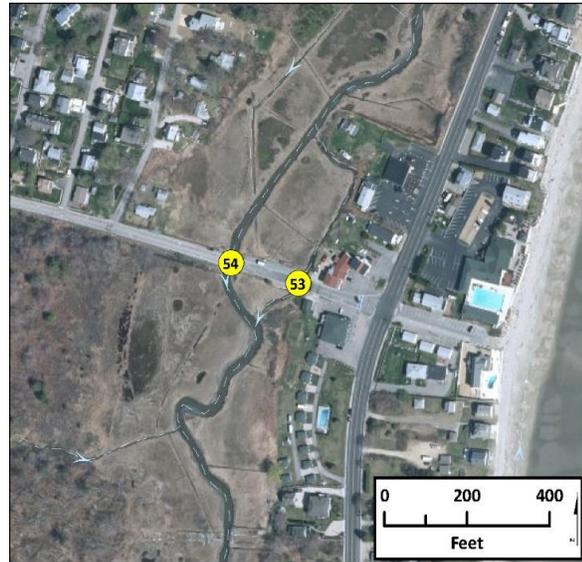
The Parsons Creek Marsh has an inlet under Route 1A and the north branch of the main tidal creek passes under Wallis Road where a 4 by 10-foot box culvert was installed by the Town of Rye in 1998 to relieve the previous tidal restriction. This eastern crossing (western crossing is #54) conducts minor amounts of tidal flow and is partially filled with sediment but becomes important for higher and storm tides. It has an overall combined score replacement priority of moderate: 3, mostly due to high flooding risk. Information on restoration can be found at:

<b>Structure Type:</b>	Box Culvert	<b>Date of Last Known Replacement:</b>	N/A
<b>Structure Material:</b>	Concrete		
<b>Tide Gate Present:</b>	No

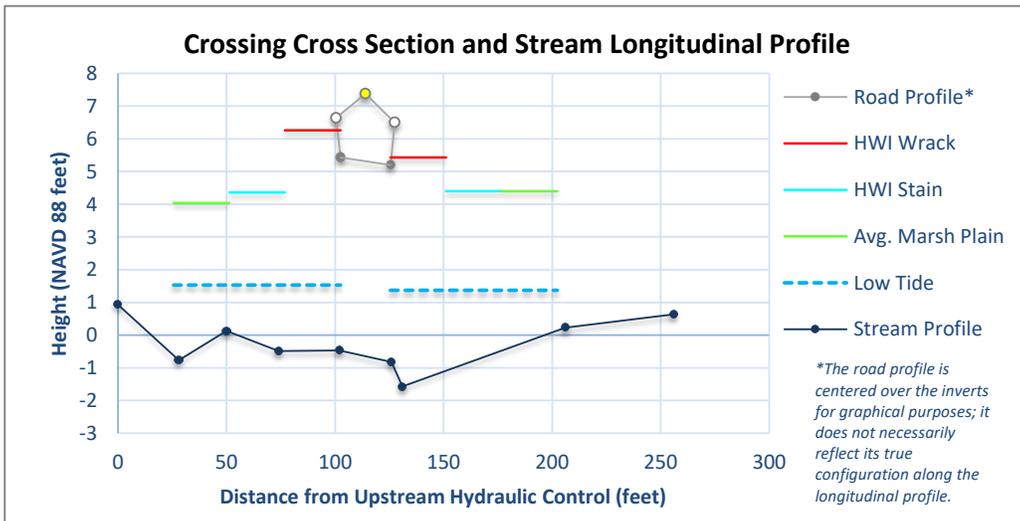
Dist.	Hght.	Feat.	Sub.
0	0.9299	HC	S
28	-0.7701	P	S
50	0.1299	HC	G
74	-0.4901	P	S
102	-0.4701	I	C
126	-0.8201	I	S
131	-1.5701	P	S
206	0.2299	HC	S
256	0.6299	HC	S

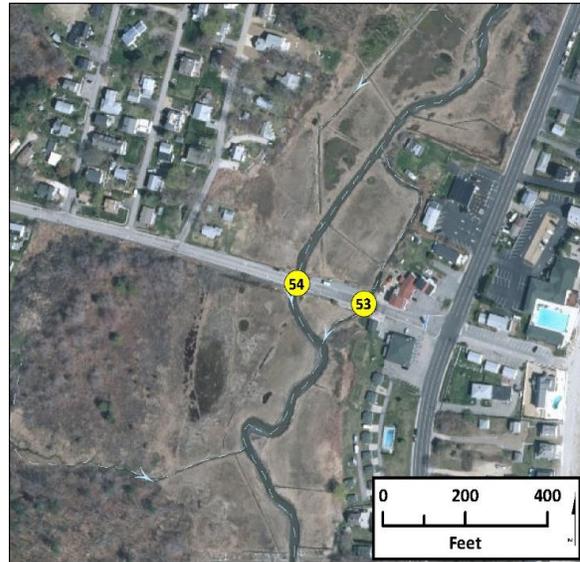
The Parsons Creek Marsh has an inlet under Route 1A and the north branch of the main tidal creek passes under Wallis Road where two 6 by 12-foot box culverts were installed by the Town of Rye in 1998 to relieve the previous tidal restriction. This is the western crossing (eastern crossing is #53) that conducts most of the tidal flow, but it shows little evidence of erosion. It has an overall combined score of 3, indicating moderate replacement priority, only because the road is vulnerable to inundation. Information on restoration can be found at:

<b>Structure Type:</b>	Box Culvert	<b>Date of Last Known Replacement:</b>	1998
<b>Structure Material:</b>	Concrete		
<b>Tide Gate Present:</b>	No

<b>Structure Condition Comments:</b>	Twin 12 ft box culverts assessed as one structure
--------------------------------------	---

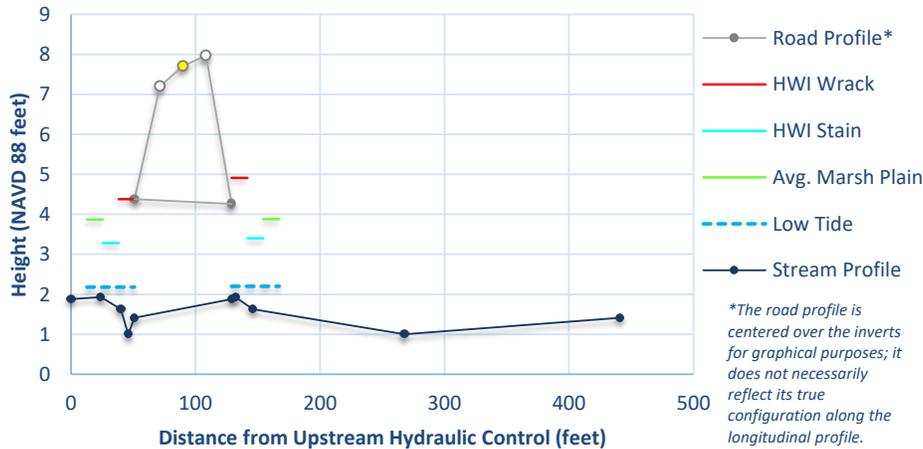
### Crossing Cross Section and Stream Longitudinal Profile

Dist.	Hght.	Feat.	Sub.
0	1.88	HC	C/S
24	1.93	HC	C/S
40	1.63	CB	C/S
46	1	P	C/S
51	1.41	I	C/S
129	1.88	HC	C/S
132	1.93	HC	C/S
146	1.63	CB	C/S
268	1	P	C/S
441	1.41	I	C/S

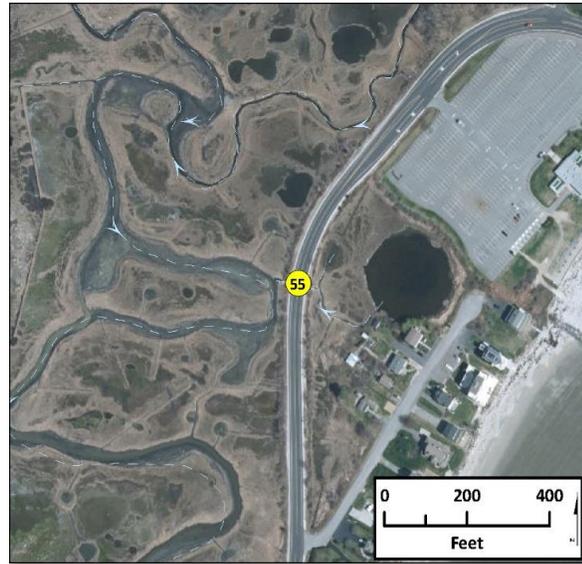
A small portion of the Parsons Creek Marsh is crossed again by Route 1A and extends eastward up to the private residences on the barrier beach. In 1999 a 3 foot round corrugated metal pipe was replaced with a 3 by 6-foot concrete box culvert by the Town of Rye. The current restriction, if any, appears to be minor and the overall combined score is 3, moderate priority for replacement. Information on the 1999 restoration can be found at:

<b>Structure Type:</b>	Box Culvert	<b>Date of Last Known Replacement:</b>	1999
<b>Structure Material:</b>	Concrete		
<b>Tide Gate Present:</b>	No

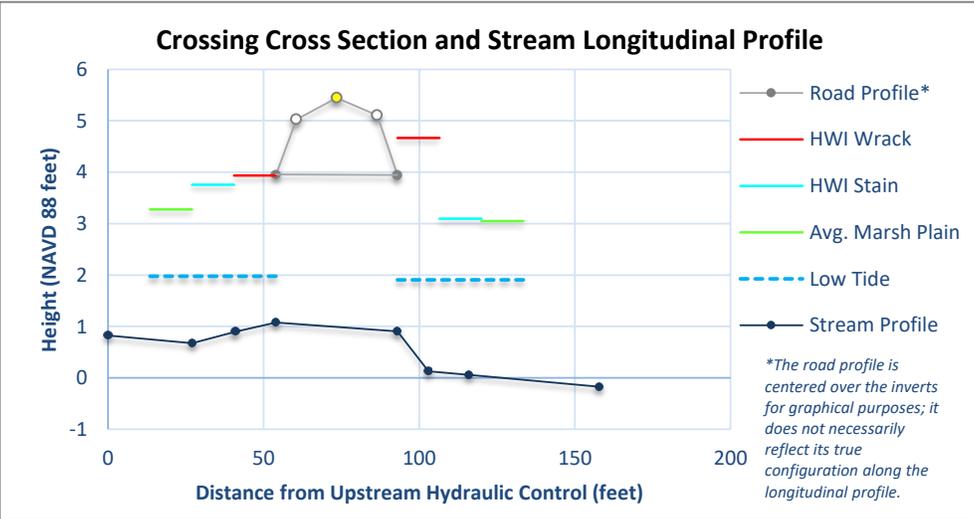
Long. Profile			
Dist.	Hght.	Feat.	Sub.
0	0.8262	HC	C/S
27	0.6762	CB	C/S
41	0.8962	P	C/S
54	1.0762	I	G
93	0.9062	I	G
103	0.1262	P	C/S
116	0.0562	CB	C/S
158	-0.1738	CB	C/S

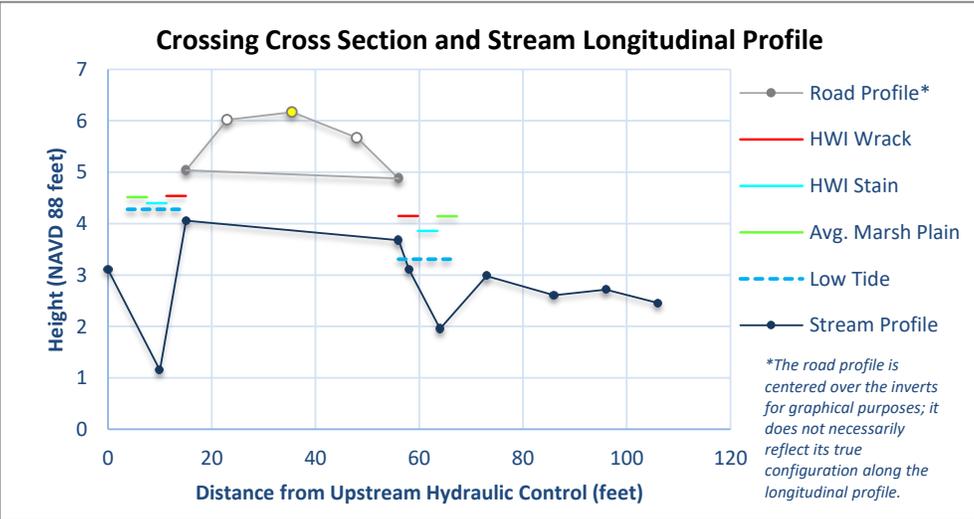
Long. Profile			
Dist.	Hght.	Feat.	Sub.
0	3.108	CB	C/S
10	1.148	P	C/S
15	4.058	I	C/S
56	3.678	I	C
58	3.108	GC	C
64	1.958	P	G
73	2.978	HC	C/S
86	2.608	P	C/S
96	2.718	HC	S
106	2.458	CB	S

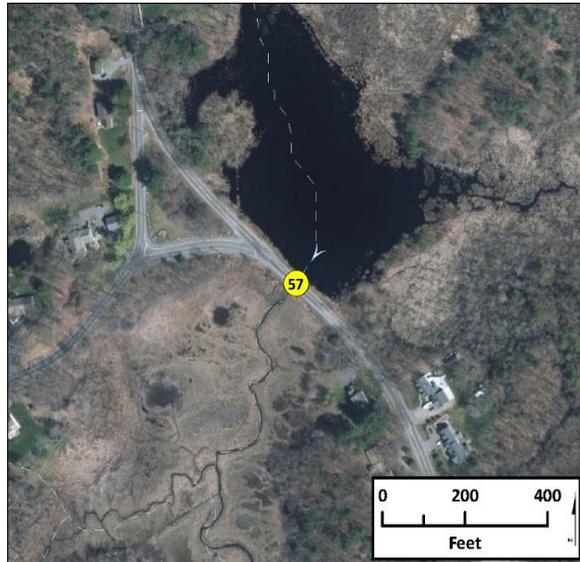
The upper section of Parsons Creek Marsh drains from a freshwater impoundment caused by an undersized crossing (1-foot diameter pipe) running under Parsons Road in Rye. Although the crossing condition is good, the undersized pipe results in a poor crossing ratio, restricted tidal range, poor organism passage and an impediment to salt marsh migration. The result is a fresh to brackish pond rather than a continuation of the salt marsh that is found below Parsons Road. The overall combined score is a 5, indicating highest priority for replacement.

<b>Structure Type:</b>	Round Culvert	<b>Date of Last Known Replacement:</b>	N/A
<b>Structure Material:</b>	Plastic - Corrugated		
<b>Tide Gate Present:</b>	No

<b>Structure Condition Comments:</b>	Scour at wingwalls
--------------------------------------	--------------------

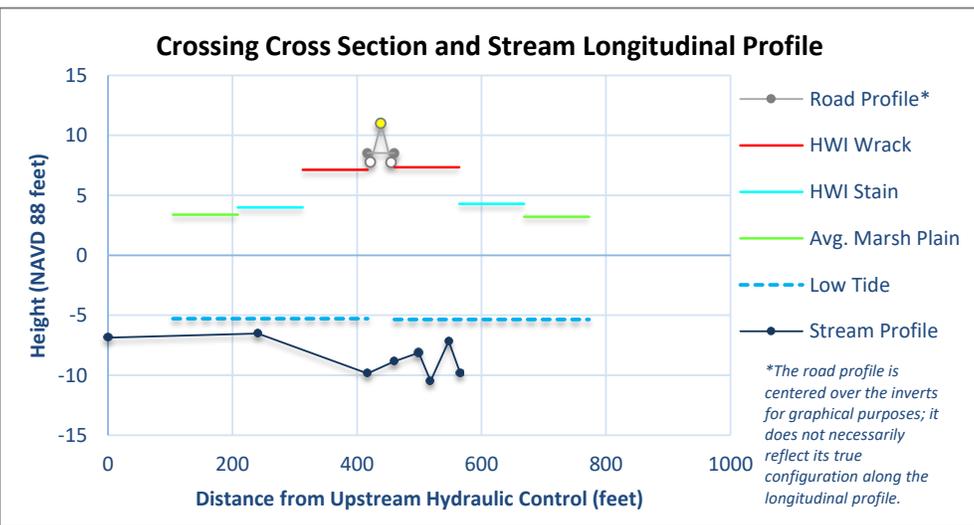
Dist.	Hght.	Feat.	Sub.
0	-6.8592	HC	S
241	-6.5192	HC	S
417	-9.8492	I	S
460	-8.8392	I	G
499	-8.1292	HC	C
518	-10.479	P	G
547	-7.1492	HC	C
566	-9.8492	CB	C

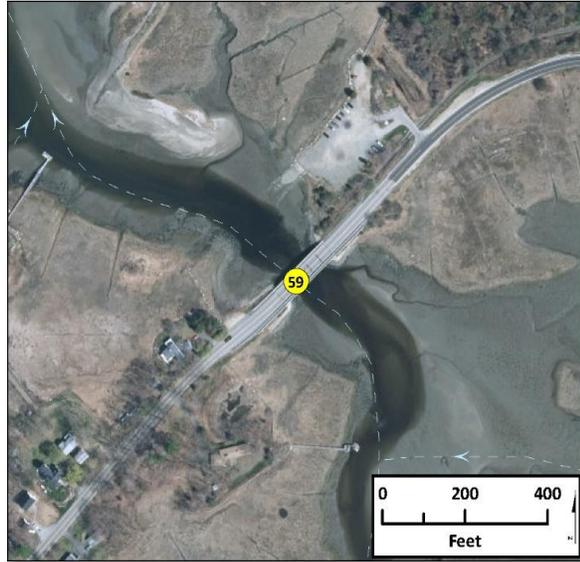
<b>Structure Type:</b>	Bridge with Abutments	<b>Date of Last Known Replacement:</b>	N/A
<b>Structure Material:</b>	Wood		
<b>Tide Gate Present:</b>	No

<b>Structure Condition Comments:</b>	Wood ceiling. Concrete abutments. Metal pillars.
--------------------------------------	--

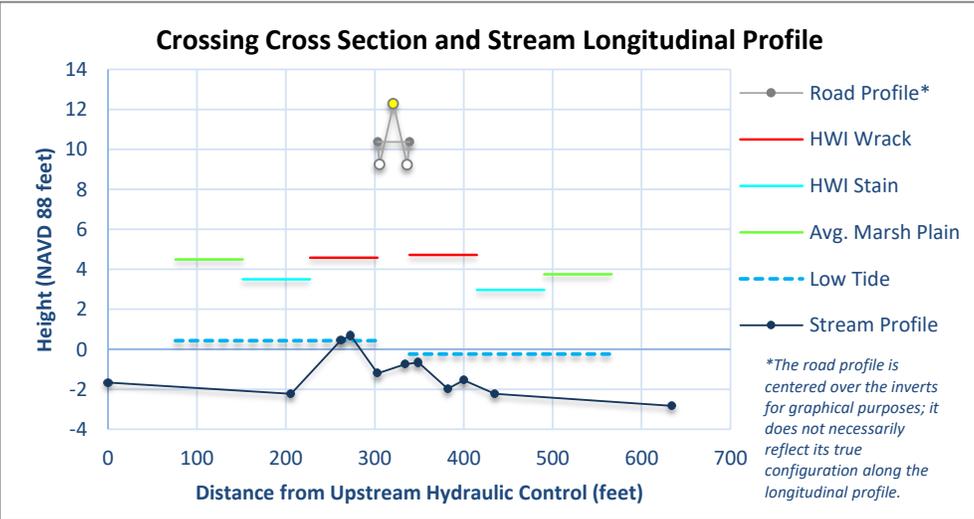
Long. Profile			
Dist.	Hght.	Feat.	Sub.
0	-1.6597	HC	C/S
206	-2.2297	P	G
262	0.4703	CB	C
273	0.6703	GC	B
303	-1.1997	I	C
334	-0.7497	I	G
349	-0.6597	GC	G
382	-1.9697	P	G
400	-1.5497	HC	G
435	-2.2197	P	G
634	-2.8297	HC	G

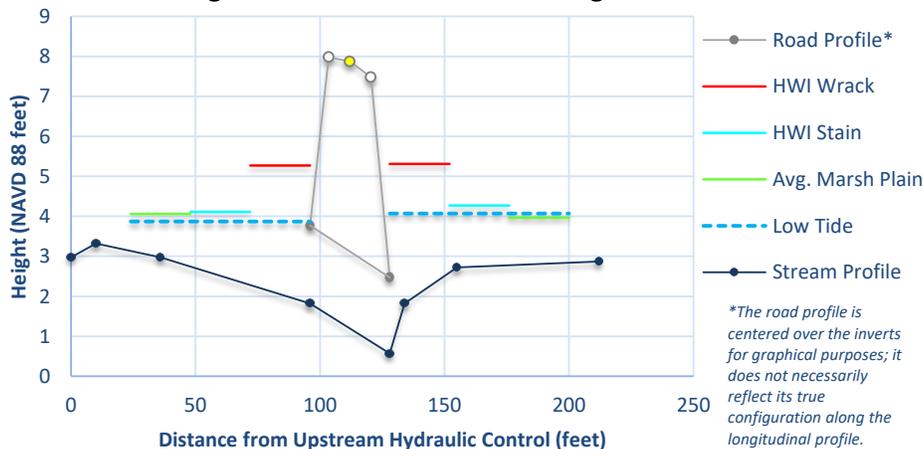
Crossing Cross Section and Stream Longitudinal Profile

Dist.	Hght.	Feat.	Sub.
0	2.9701	US HC	C/S
10	3.3201	US HC	C/S
36	2.9701	US P	C/S
96	1.8201	US I	C/S
128	0.5701	DS I	C/S
134	1.8201	DS P	C/S
155	2.7201	DS HC	C/S
212	2.8701	DS HC	C/S

\*The road profile is centered over the inverts for graphical purposes; it does not necessarily reflect its true configuration along the longitudinal profile.

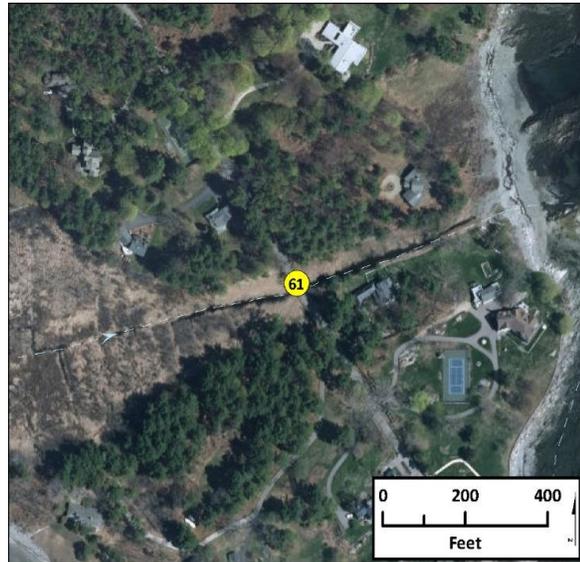
A small back-barrier wetland landward of Fort Stark has a central ditch that is crossed by Wild Rose Lane and has a 3-foot round culvert. The wetland appears fresh to brackish, with exotic common reed and cattail, and is cut off from tidal flooding by gravel barrier beaches to the east and south. The crossing is an undersized culvert that is continually and entirely under water. It has an overall combined score of 3, indicating moderate priority for replacement.

<b>Structure Type:</b>	Round Culvert	<b>Date of Last Known Replacement:</b>	N/A
<b>Structure Material:</b>	Concrete		
<b>Tide Gate Present:</b>	No

<b>Structure Condition Comments:</b>	Structure completely flooded. Difficult to get structure measurements
--------------------------------------	---

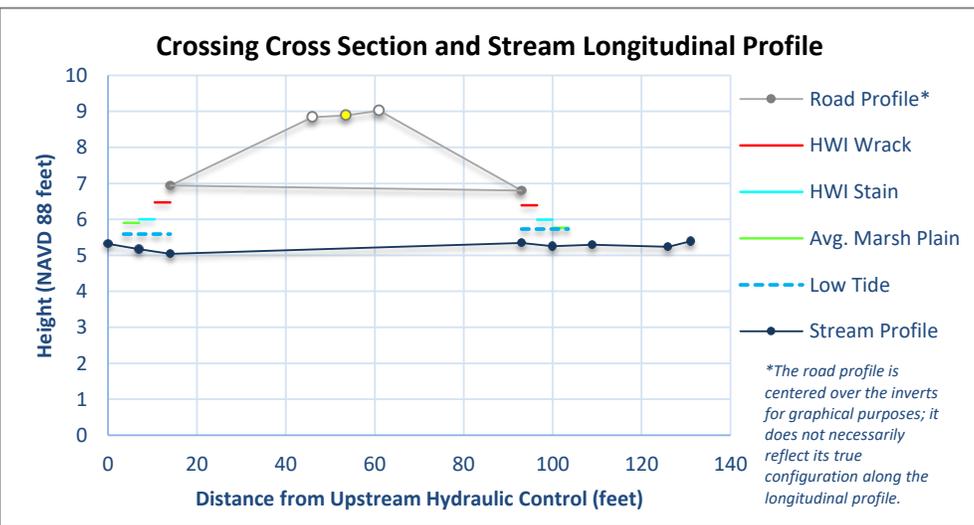
Long. Profile			
Dist.	Hght.	Feat.	Sub.
0	5.3201	HC	C/S
7	5.1701	P	C/S
14	5.0401	I	C/S
93	5.3401	I	C/S
100	5.2501	P	C/S
109	5.2901	HC	C/S
126	5.2401	P	C/S
131	5.3901	HC	C/S

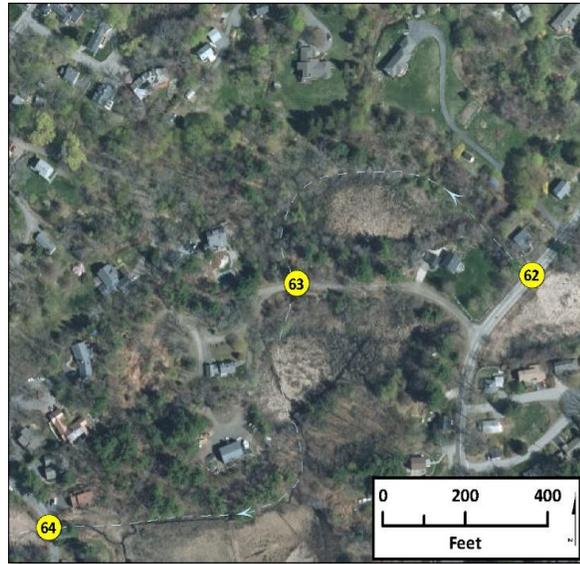
<b>Structure Type:</b>	Round Culvert	<b>Date of Last Known Replacement:</b>	N/A
<b>Structure Material:</b>	Steel - Corrugated		
<b>Tide Gate Present:</b>	No

<b>Structure Condition Comments:</b>	Bottom of culvert rusted out. Water flow under culvert. No observed flow during assessment.
--------------------------------------	---

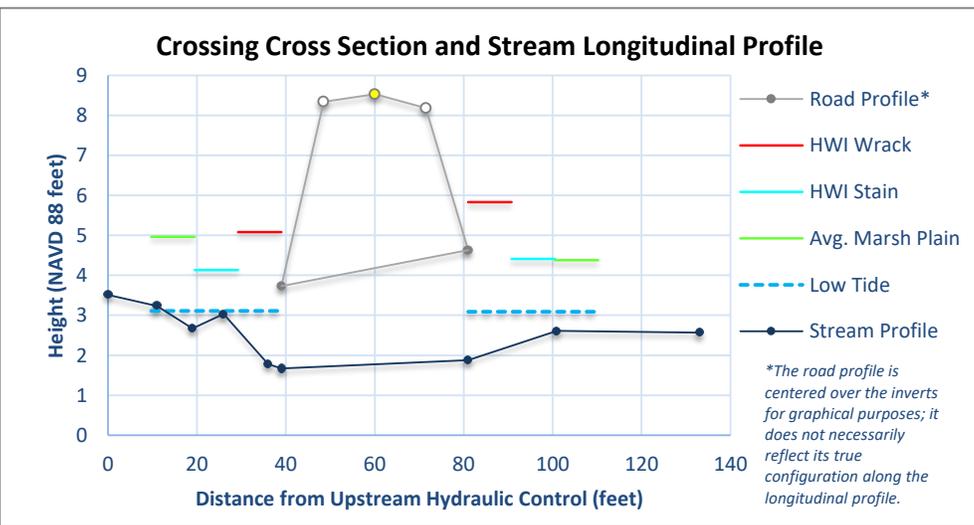
Dist.	Hght.	Feat.	Sub.
0	3.5102	HC	C/S
11	3.2302	HC	C/S
19	2.6702	P	C/S
26	3.0302	HC	C/S
36	1.7802	P	C/S
39	1.6702	I	C/S
81	1.8802	I	C/S
101	2.6102	HC	C/S
133	2.5702	HC	C/S

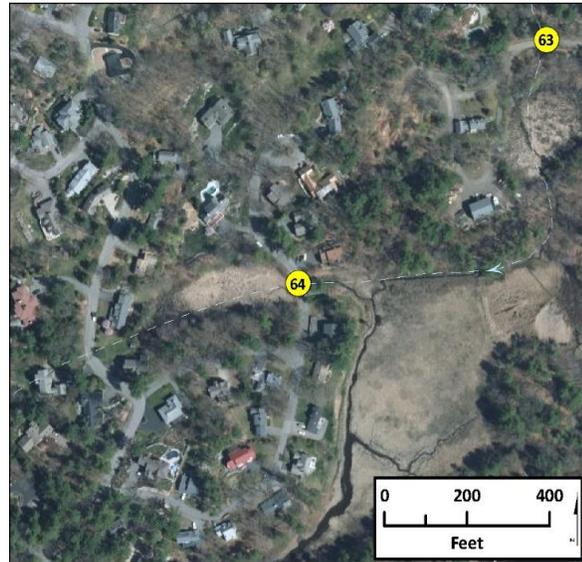
A small marsh extends west of Lavenger Creek in New Castle and its tidal creek runs under Quarterdeck Lane through a concrete box culvert 4 feet wide by 3 feet tall. This culvert replaced a 3-foot pipe in 2008 that was restricting flow and impounding water. Although the crossing condition is very good, erosion is evident, the tidal flow appear restricted and tides regularly overflow the culvert. The upstream marsh is cattail while the downstream marsh is dominated by salt marsh grasses. The overall combined score is 3, indicating moderate priority for replacement.

<b>Structure Type:</b>	Box Culvert	<b>Date of Last Known Replacement:</b>	2008
<b>Structure Material:</b>	Concrete		
<b>Tide Gate Present:</b>	No

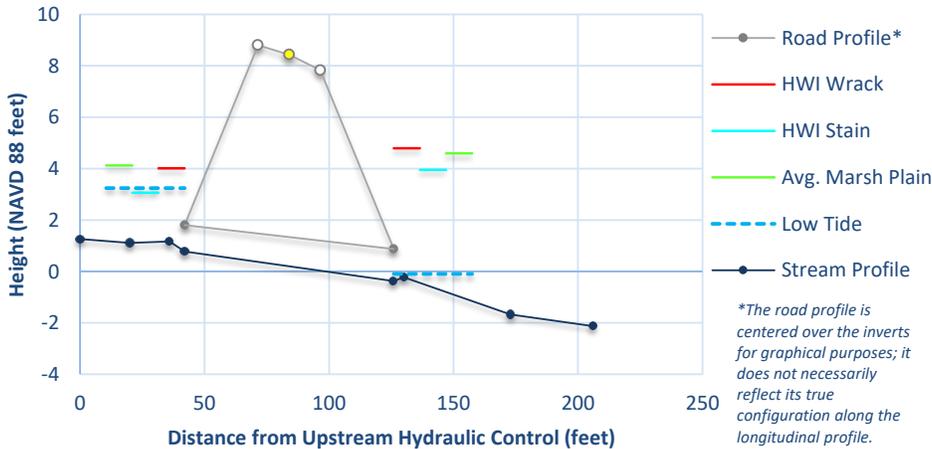
**Crossing Cross Section and Stream Longitudinal Profile**

Dist.	Hght.	Feat.	Sub.
0	1.2618	HC	S
20	1.1118	HC	G
36	1.1718	GC	G
42	0.7718	I	G
126	-0.3782	I	G
130	-0.2282	HC	G
173	-1.6782	HC	G
206	-2.1282	HC	G

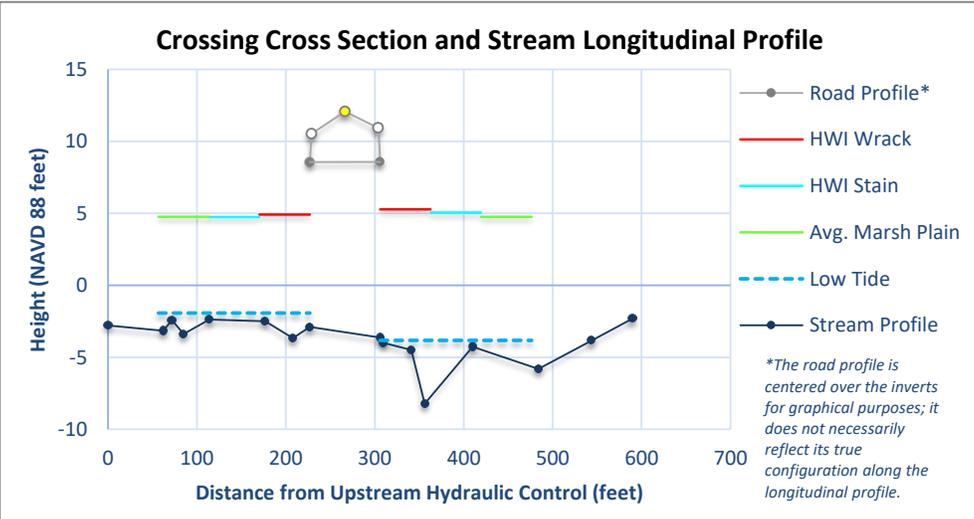
Long. Profile			
Dist.	Hght.	Feat.	Sub.
0	-2.7965	HC	C
62	-3.1665	P	C
72	-2.4265	HC	C
85	-3.3765	P	C
114	-2.3765	HC	C
177	-2.4965	CB	G
208	-3.6765	P	G
227	-2.8865	I	C
306	-3.6365	I	C
310	-4.0065	CB	S
341	-4.4865	CB	C
356	-8.2265	P	G
410	-4.2765	HC	G
484	-5.8165	P	G
544	-3.8465	HC	G
590	-2.3065	CB	C

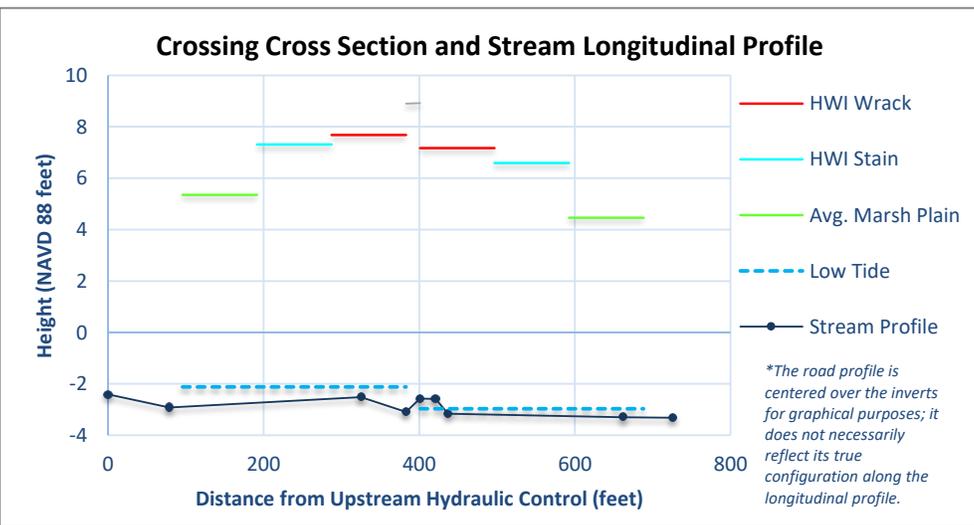
Dist.	Hght.	Feat.	Sub.
0	-2.4086	HC	C/S
79	-2.9186	CB	Shell
325	-2.5186	GC	Shell
383	-3.0986	I	Shell
401	-2.5786	I	Shell
421	-2.5886	GC	Shell
437	-3.1586	CB	Shell
662	-3.2986	HC	S
726	-3.3186	CB	S

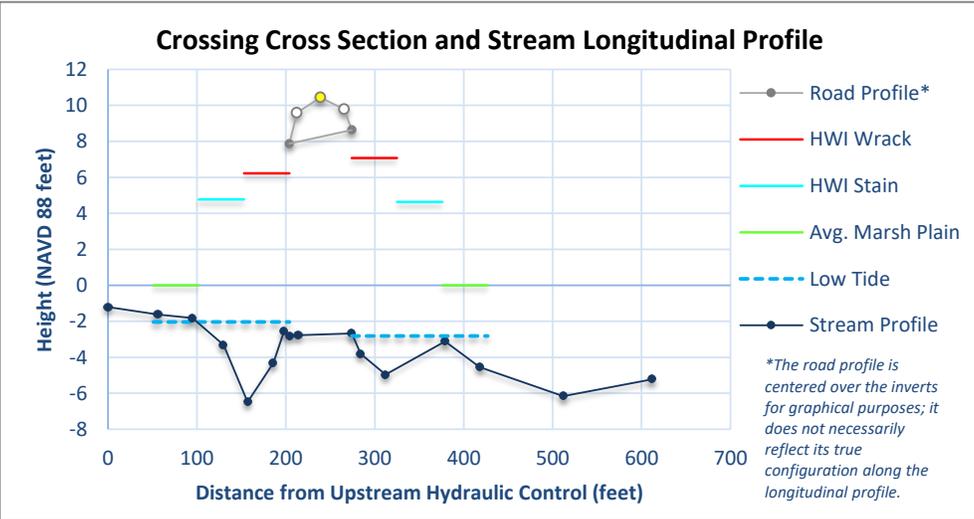
<u>Dist.</u>	<u>Hght.</u>	<u>Feat.</u>	<u>Sub.</u>
0	-1.2069	HC	G
56	-1.6269	CB	G
95	-1.8169	HC	G
130	-3.3169	CB	C
157	-6.4869	P	C
186	-4.3169	CB	B
198	-2.5669	GC	B
204	-2.8169	I	B
214	-2.7669	CB	Shell
274	-2.6669	I	Shell
284	-3.8069	CB	Shell
312	-4.9669	P	G
379	-3.1169	HC	C
418	-4.5469	CB	G
512	-6.1669	P	G
612	-5.2169	HC	C

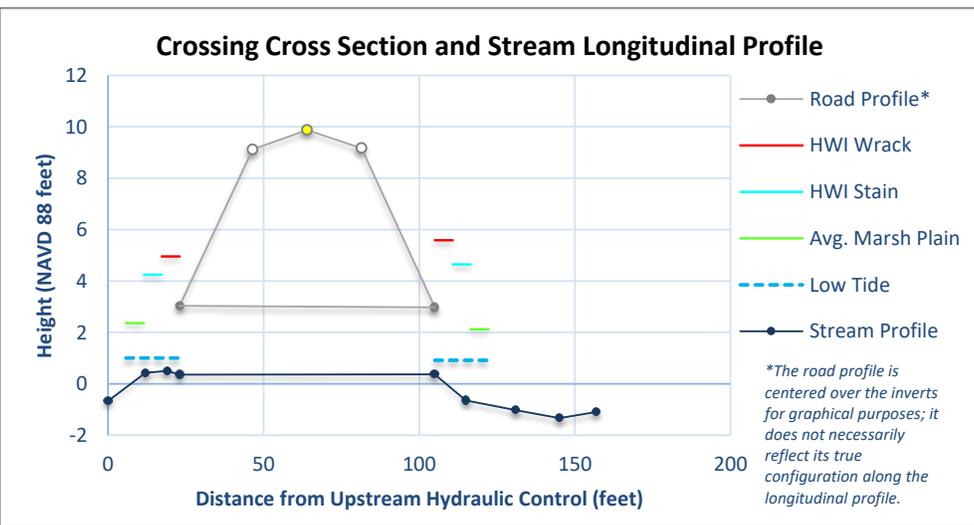
Long. Profile			
Dist.	Hght.	Feat.	Sub.
0	-0.6647	P	G
12	0.4253	CB	C
19	0.5053	HC	C
23	0.3553	I	C
105	0.3653	I	Shell
115	-0.6447	CB	G
131	-1.0247	HC	G
145	-1.3347	P	G
157	-1.0947	HC	C/S

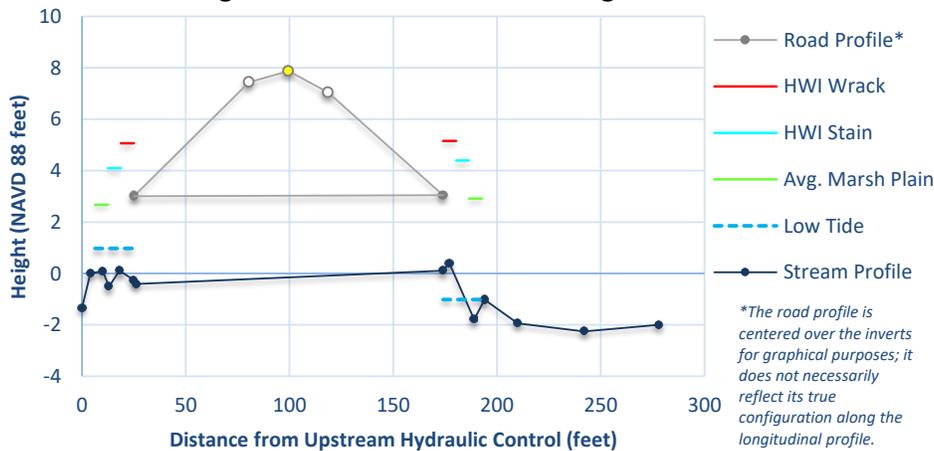
### Crossing Cross Section and Stream Longitudinal Profile

Dist.	Hght.	Feat.	Sub.
0	-1.346	P	S
4	0.004	HC	G
10	0.084	CB	C
13	-0.516	P	G
18	0.104	HC	G
25	-0.266	I	C
26	-0.406	CB	G
174	0.104	I	Shell
177	0.404	GC	B
189	-1.796	P	G
194	-1.016	HC	B
210	-1.946	CB	G
242	-2.256	P	G
278	-1.996	HC	C/S
