# Tidal Crossing Summary Sheet

## New Hampshire's Tidal Crossing Assessment Protocol

Crossing ID: 1

Observer(s) & Organization:	TS, JB (NHDES Coastal)
Municipality:	SEABROOK
Stream Name:	Blackwater River
Road Name:	Route 286

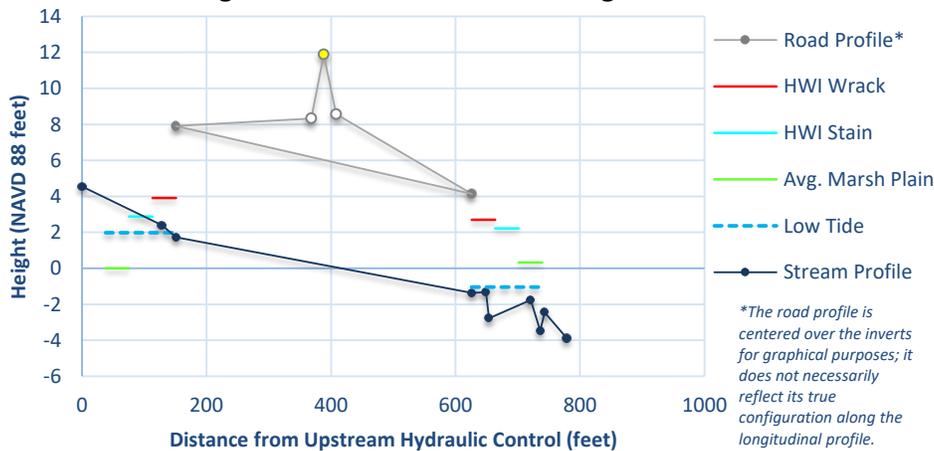
Crossing Cross Section and Stream Longitudinal Profile

Dist.	Hght.	Feat.	Sub.
0	4.5466	HC	B
128	2.4066	HC	B
151	1.7266	I	B
626	-1.3634	I	B
649	-1.3334	GC	B
654	-2.7734	P	C
721	-1.7634	HC	C
736	-3.4634	P	C
743	-2.4534	HC	C
779	-3.8934	CB	C

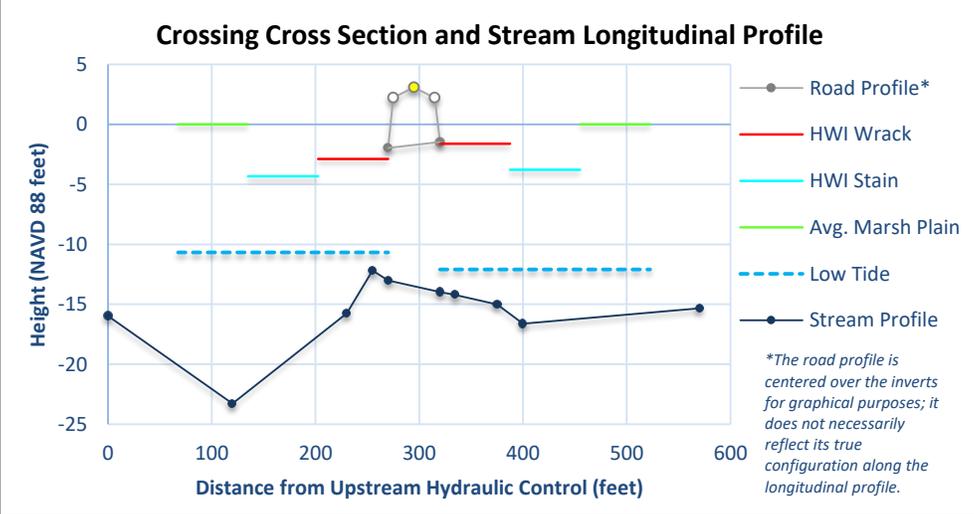
Long. Profile			
Dist.	Hght.	Feat.	Sub.
0	-15.966	HC	G
120	-23.276	P	C
230	-15.766	CB	B
255	-12.186	GC	B
270	-13.006	I	B
320	-13.966	I	B
335	-14.226	GC	B
375	-15.026	CB	C
400	-16.626	P	C
570	-15.326	CB	C

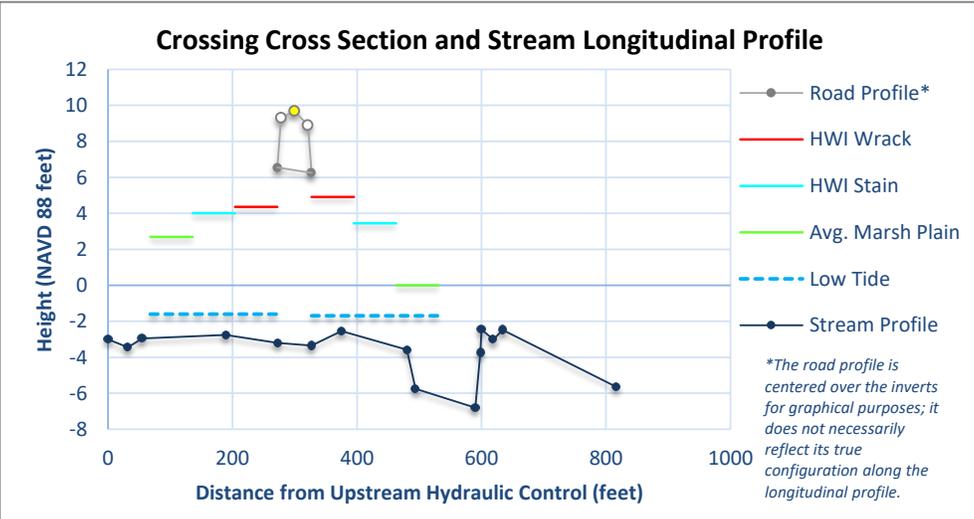
Long. Profile			
Dist.	Hght.	Feat.	Sub.
0	-3.0015	HC	G
32	-3.4515	P	G
55	-2.9515	HC	G
189	-2.7515	HC	G
272	-3.2015	I	C
327	-3.3515	I	C
375	-2.5515	HC	G
480	-3.5815	CB	C
494	-5.7515	P	C/S
590	-6.8015	CB	C
598	-3.7515	CB	C
600	-2.4515	HC	C
619	-3.0215	CB	C
634	-2.4815	HC	G
817	-5.6515	HC	C

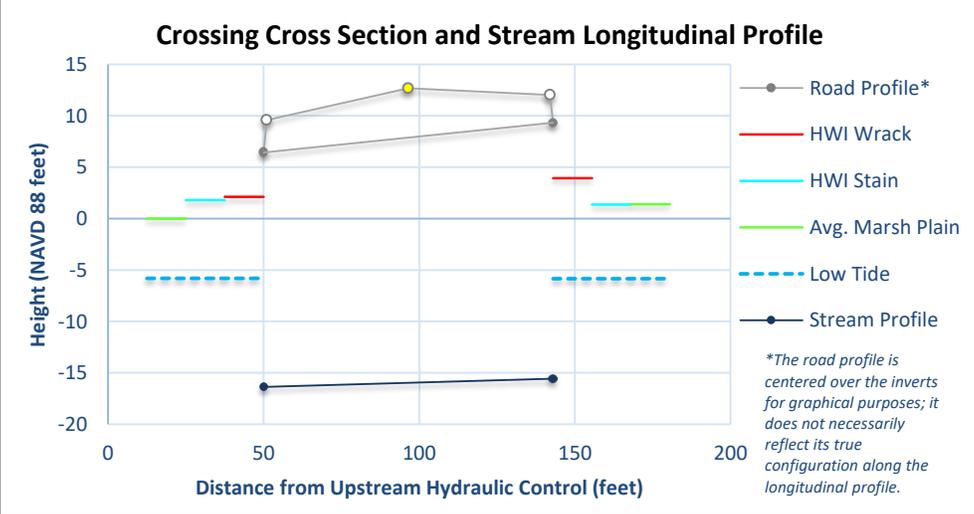
Dist.	Hght.	Feat.	Sub.
50	-16.37	I	B
143	-15.57	I	B

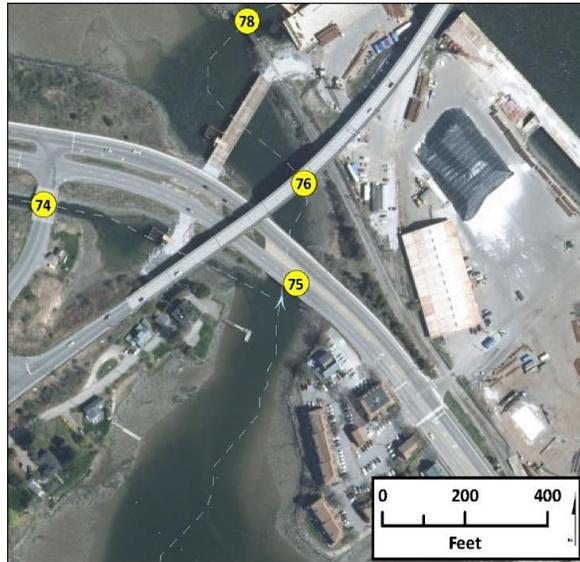
Market Street Extension is built over the inlet to the North Mill Pond system and the crossing is very large (23 by 130 feet) that carries the tides without restriction. The structure is in very good shape and the overall combined score is 2, low priority for replacement.

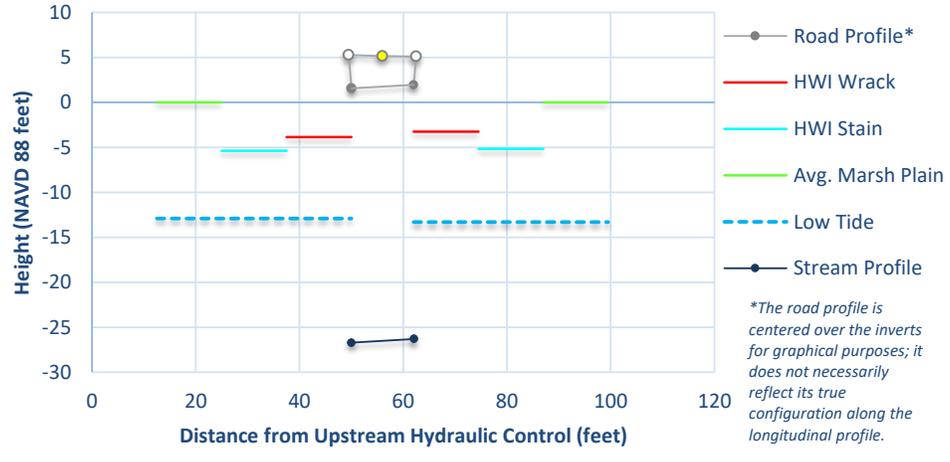
**Crossing Cross Section and Stream Longitudinal Profile**

Dist.	Hght.	Feat.	Sub.
50	-26.709	I	B
62	-26.309	I	B

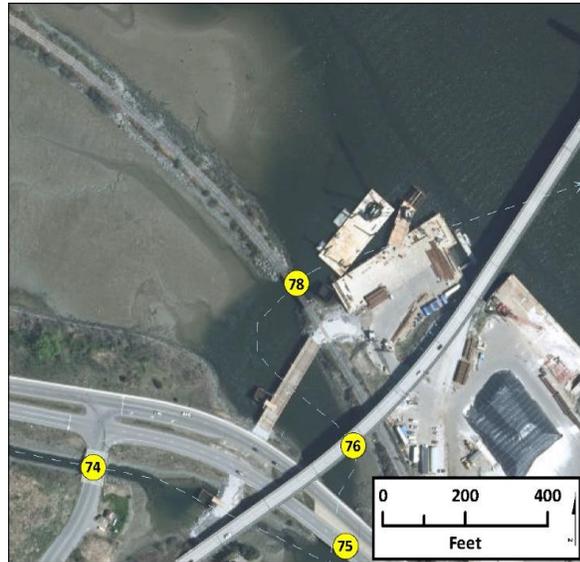
This is the railroad bridge for a spur line that was built out upon Cutts Cove to connect a gypsum plant that makes wallboard. The crossing is somewhat restrictive in that it increases current speed through the opening, but it likely doesn't affect high tides upstream of the 96-foot span. The overall combined score is 2, indicating low priority for replacement.

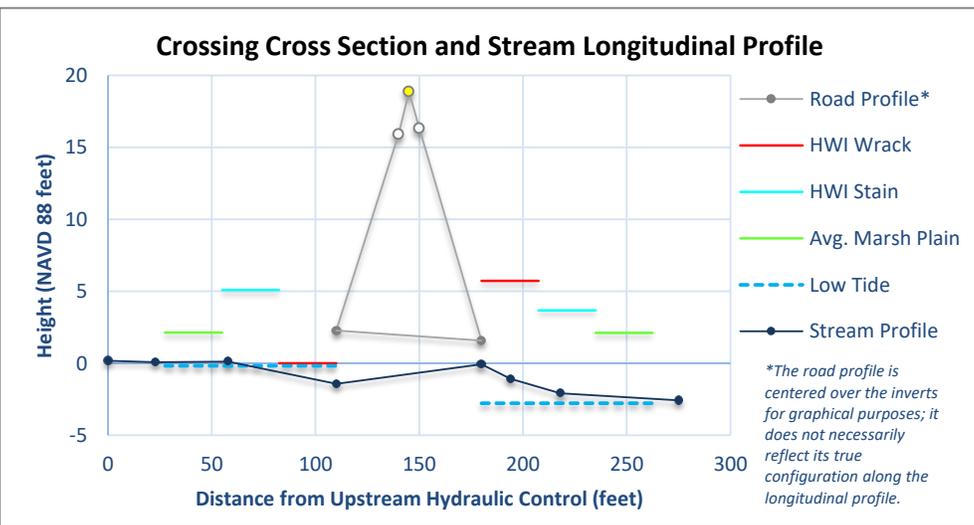
Long. Profile			
Dist.	Hght.	Feat.	Sub.
0	0.1748	HC	C/S
23	0.0748	P	C/S
58	0.1248	HC	C/S
110	-1.4252	I	C/S
180	-0.0752	I	C/S
194	-1.0752	HC	C
218	-2.0752	CB	G
275	-2.5752	CB	C/S

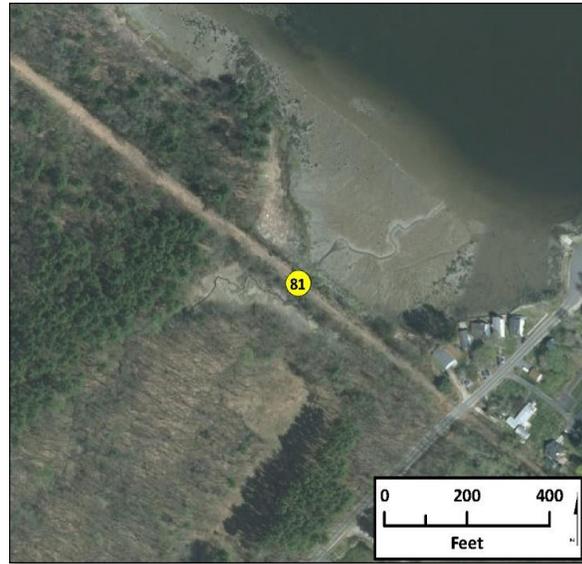
An unnamed tidal creek supplying a salt marsh with tidal flow is crossed by Boston and Maine Corporation rail line by a 3-foot-wide by 4-foot-tall granite culvert that connects the wetland to the Piscataqua River. The crossing condition is poor, erosion is evident, and the entire culvert is underwater on a daily basis. In addition, the culvert is perched and the upstream plant community is different. All these deficiencies and vulnerabilities make this a high priority for replacement with an overall combined score of 4.

<b>Structure Condition Comments:</b>	Highly scoured. DS structure destroyed
--------------------------------------	--

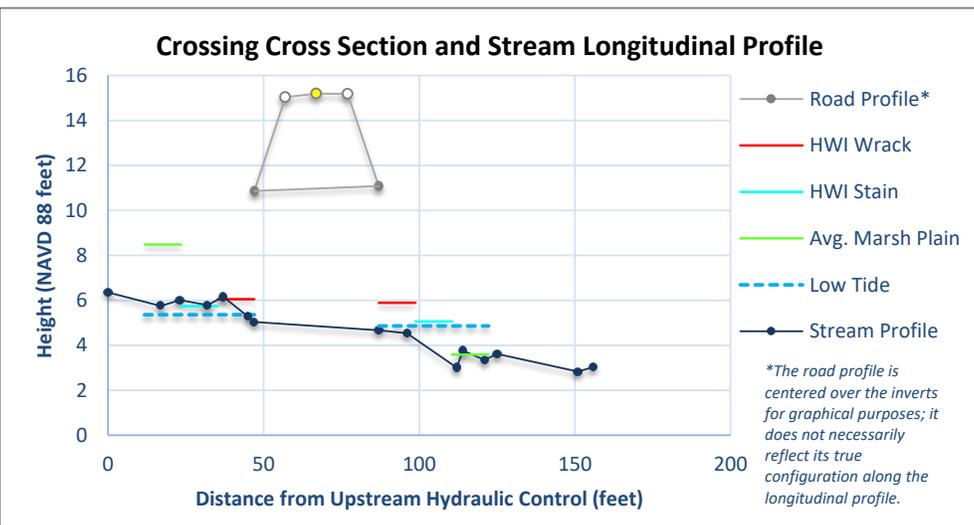
Long. Profile			
Dist.	Hght.	Feat.	Sub.
0	6.3503	HC	S
17	5.7403	P	S
23	6.0103	HC	S
32	5.7903	P	C
37	6.1503	HC	C
45	5.2703	GC	C
47	5.0403	I	C
87	4.6703	I	S
96	4.5403	HC	C
112	3.0103	P	S
114	3.7603	GC	B
121	3.3503	P	S
125	3.6203	HC	C
151	2.8303	P	S
156	3.0303	GC	C

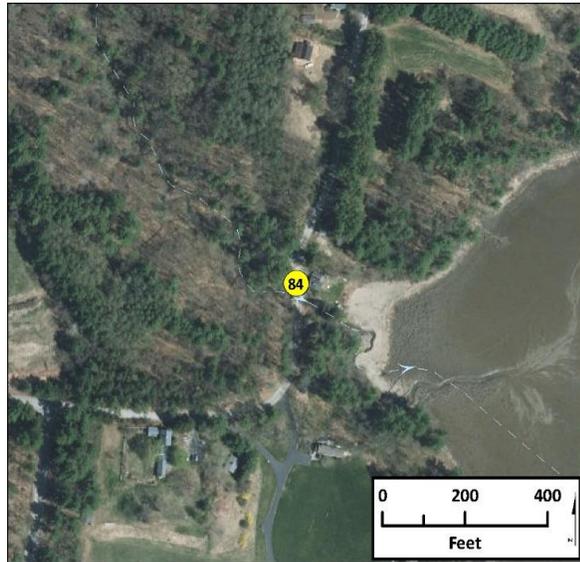
Sligo Road in Rollinsford crosses the Sligo Brook and provides drainage through a 6 by 6-foot stone culvert with a crossing condition rated as poor. The potential for tidal flow through a restored culvert is low until sea level rise occurs because the crossing is perched at the head of tide. The overall combined score is 4: high priority for replacement.

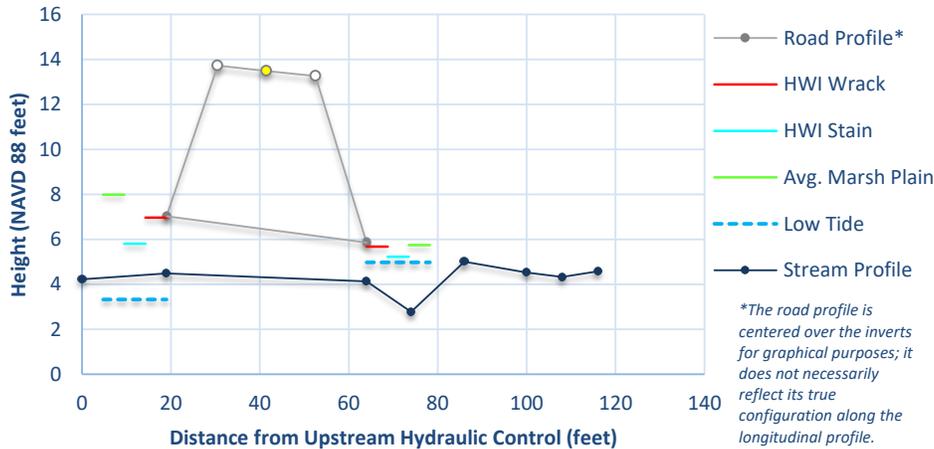
### Crossing Cross Section and Stream Longitudinal Profile

Dist.	Hght.	Feat.	Sub.
0	4.2243	US HC	C/S
19	4.4843	US I	G
64	4.1243	DS I	G
74	2.7743	DS P	G
86	5.0043	DS HC	S
100	4.5243	DS HC	S
108	4.3243	DS P	S
116	4.5743	DS HC	S

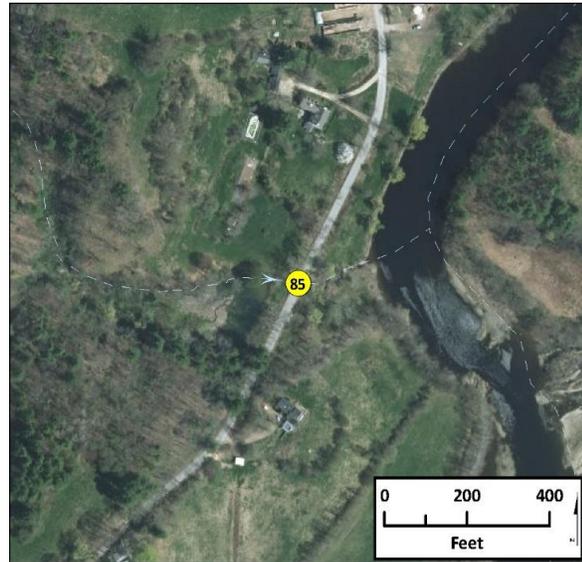
Sligo Road crosses an unnamed creek just north of crossing #84 through a 6 by 2-foot stone culvert. The crossing condition is poor with erosion and tidal restriction observed, including a plunge pool downstream and an impoundment upstream. The overall combined score is 4: high priority for replacement. The roadway was washed out in 2011 and a pipe was added above the failing culvert to prevent another washout, highlighting the need for replacement.

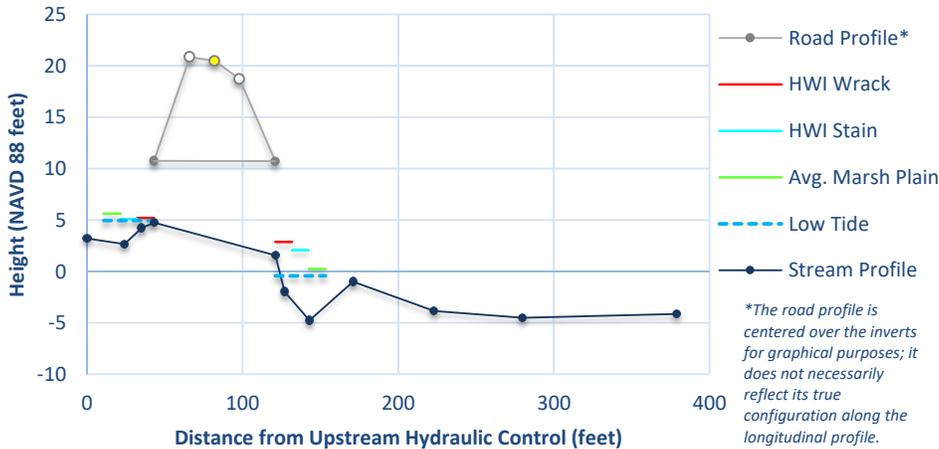
### Crossing Cross Section and Stream Longitudinal Profile

Dist.	Hght.	Feat.	Sub.
0	3.2002	HC	G
24	2.6702	P	G
35	4.2102	GC	B
43	4.7502	I	B
121	1.5702	I	B
127	-1.9798	GC	B
143	-4.7598	P	B
171	-0.9898	GC	B
223	-3.8598	HC	B
280	-4.5098	P	B
379	-4.1298	HC	C/S

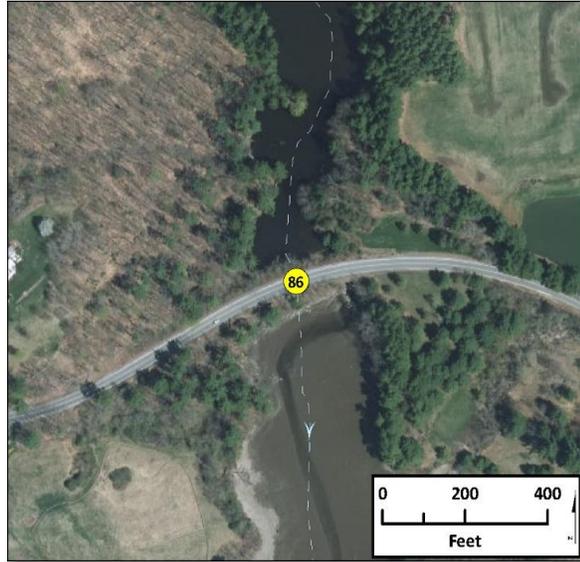
The crossing over Fresh Creek is a 6 by 20-foot culvert that is relatively new and in good shape, but it is perched just above the high water line. The overall combined score is a 5, highest priority for replacement because it cuts off the entire watershed from tidal waters and prevents organism passage, including anadromous fish. It has been considered as a possible restoration site.

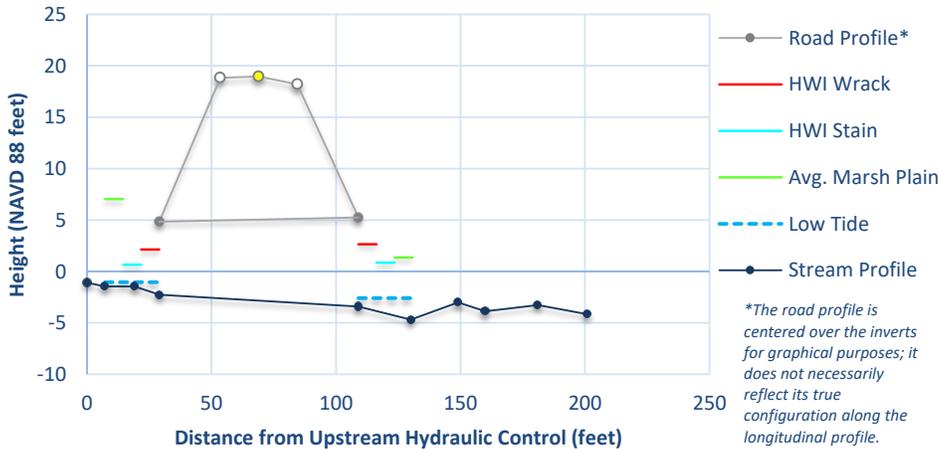
### Crossing Cross Section and Stream Longitudinal Profile

Dist.	Hght.	Feat.	Sub.
0	-1.0867	HC	G
7	-1.4667	P	G
19	-1.4467	GC	C
29	-2.2667	I	C
109	-3.4067	I	C
130	-4.6867	P	C
149	-3.0167	CB	C
160	-3.8667	P	C
181	-3.2767	HC	G
201	-4.1567	P	C/S
237	-3.8067	CB	C/S

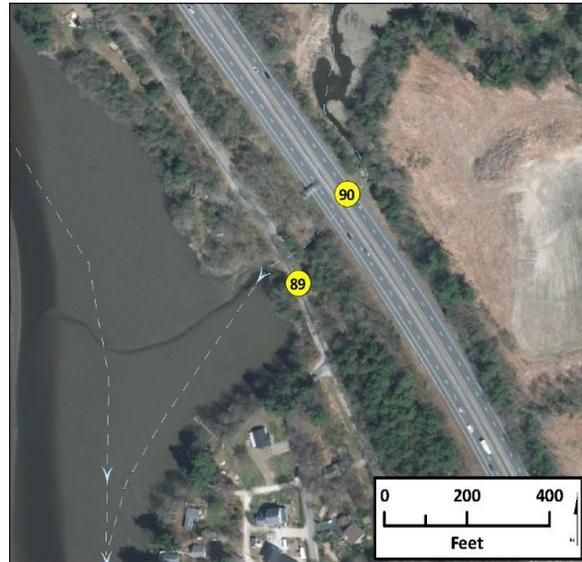
Spur road in Dover crosses Varney Brook with a 7 by 8-foot granite culvert. Just 80 feet upstream of this crossing Route 16 crosses the Brook (#90) with double 6-foot diameter round culverts. The upstream area is heavily shaded and is not likely to support tidal marsh plants. The overall combined score for this crossing is 5, highest priority for replacement based upon crossing conditions, erosion and tidal restriction.

<b>Structure Condition Comments:</b>	Overall not bad. Collapsing wing walls.
--------------------------------------	---

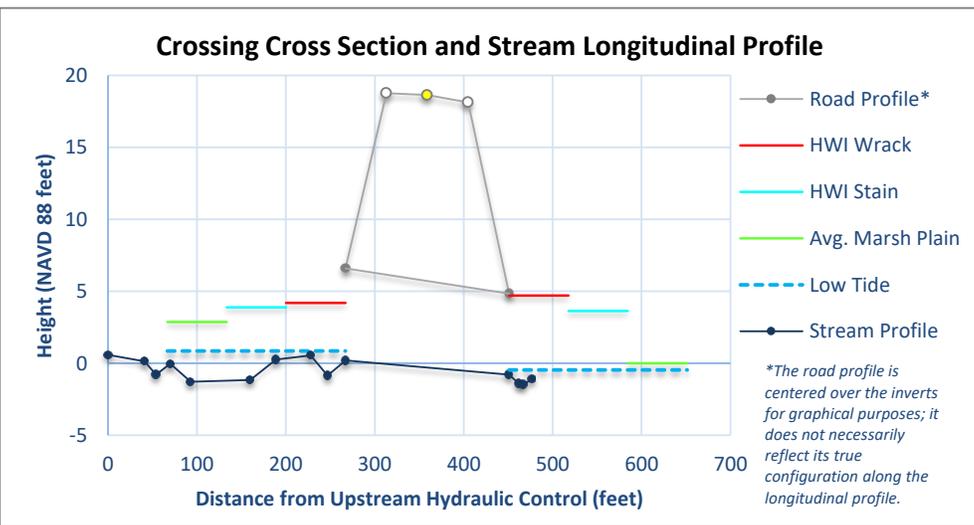
Long. Profile			
Dist.	Hght.	Feat.	Sub.
0	0.5852	HC	C/S
41	0.1452	CB	C/S
54	-0.7948	P	G
70	-0.0248	HC	B
93	-1.2848	P	G
160	-1.1548	CB	S
189	0.2652	HC	G
228	0.5552	HC	B
247	-0.8448	P	G
267	0.2052	I	C
451	-0.7948	I	B
462	-1.4148	P	C
467	-1.4748	HC	B
477	-1.1048	HC	B

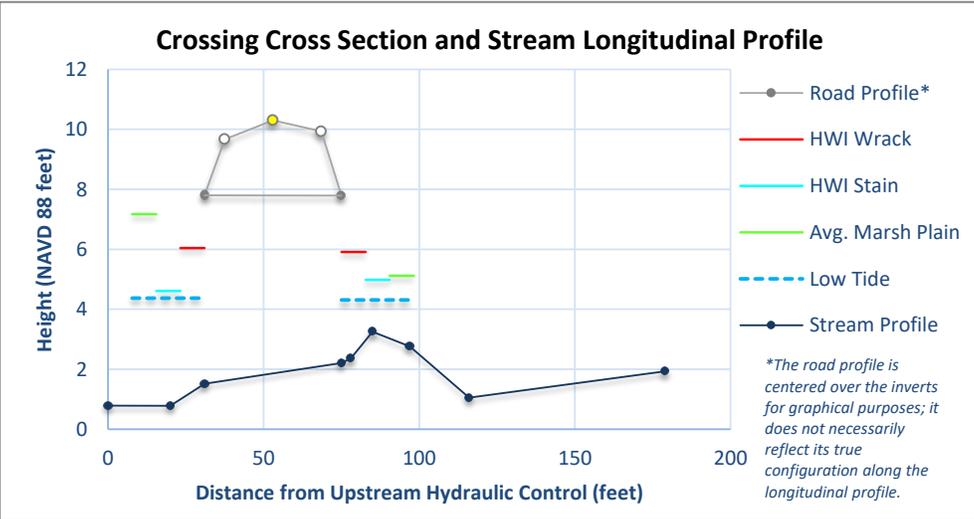
Long. Profile			
Dist.	Hght.	Feat.	Sub.
0	0.7918	HC	G
20	0.7818	P	C
31	1.5218	I	G
75	2.2118	I	C
78	2.3618	P	G
85	3.2518	CB	C
97	2.7618	HC	C
116	1.0518	P	G
179	1.9318	HC	S

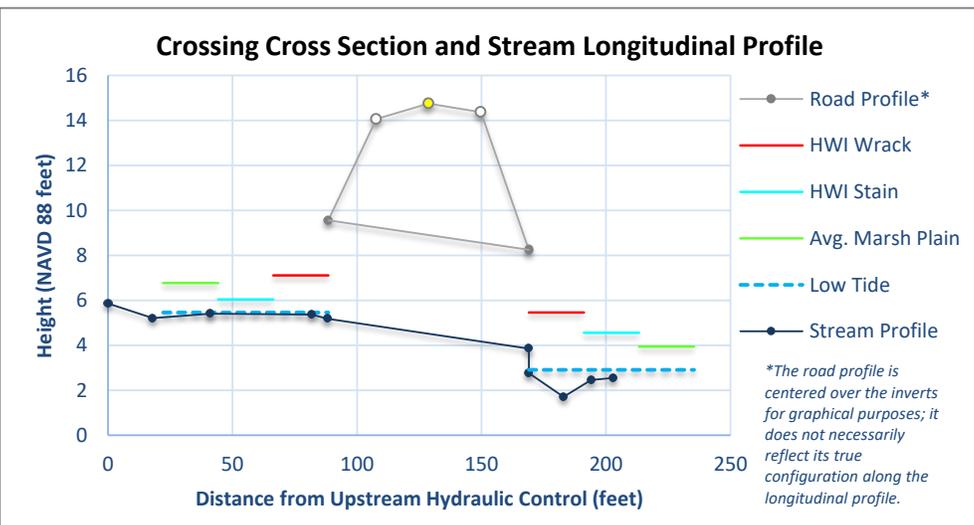
Long. Profile			
Dist.	Hght.	Feat.	Sub.
0	5.8574	HC	G
18	5.2074	P	C/S
41	5.4074	HC	S
82	5.3674	GC	C
88	5.1874	I	G
169	3.8574	I	C
169	2.7574	CB	C
183	1.7074	P	S
194	2.4574	HC	C
203	2.5474	HC	C
214	1.8574	P	C
242	2.3274	HC	C

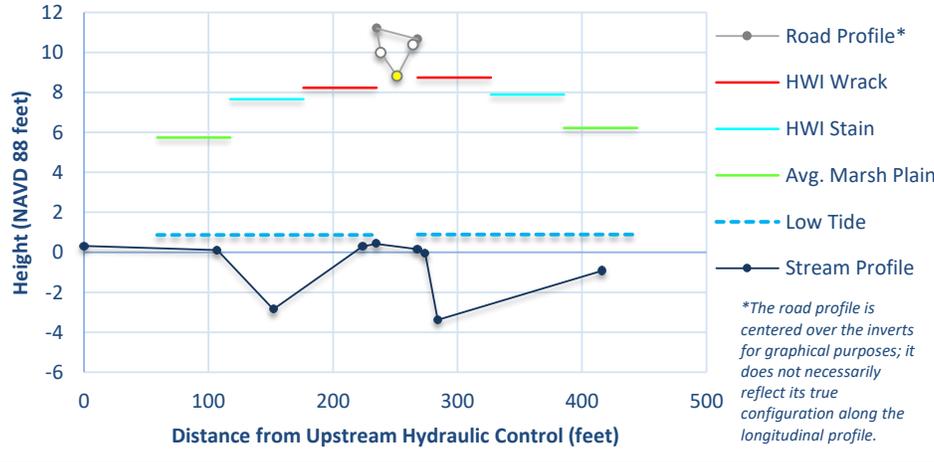
### Crossing Cross Section and Stream Longitudinal Profile

Dist.	Hght.	Feat.	Sub.
0	0.3191	HC	C/S
107	0.1091	HC	C/S
152	-2.8509	P	G
224	0.2991	GC	Shell
235	0.4191	I	Shell
268	0.1491	I	Shell
274	-0.0709	GC	Shell
284	-3.3809	P	G
416	-0.9309	HC	C/S

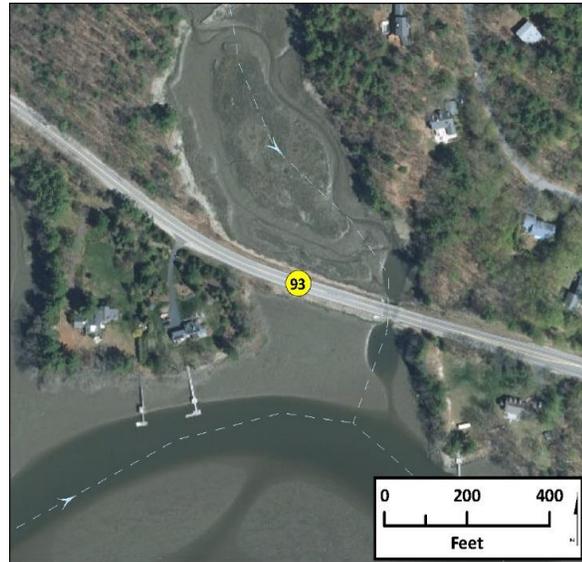
The crossing of Bunker Creek at Route 4 in Durham is a 10.5 by 13-foot concrete structure showing multiple signs of wear and erosion. It features plunge pools on either side and restricts tidal flow to an upstream marsh that is largely tall form cordgrass (in contrast, almost all marshes in the State are dominated by salt hay). The upstream marsh is managed by NH Fish and Game and is a sentinel site with long term monitoring for the Great Bay National Estuarine Research Reserve. The combined overall combined score is 4, a high priority for replacement.

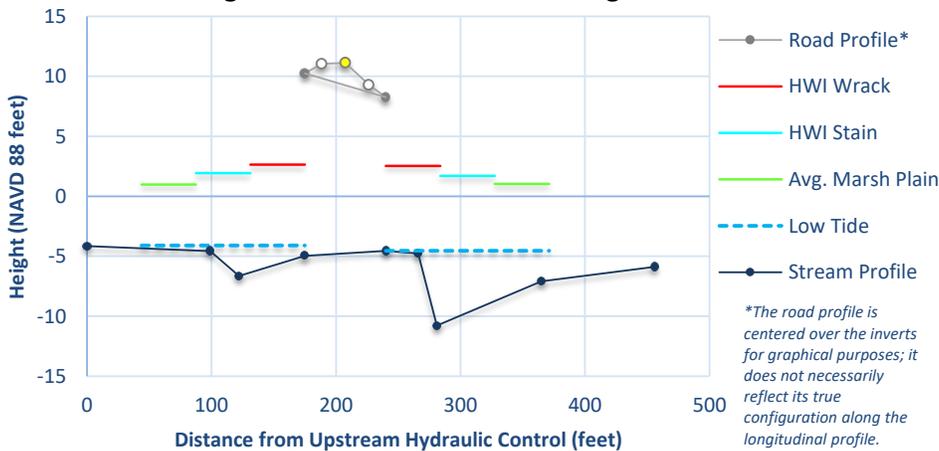
### Crossing Cross Section and Stream Longitudinal Profile

Dist.	Hght.	Feat.	Sub.
0	-4.148	HC	C/S
99	-4.578	HC	C/S
122	-6.648	P	C/S
175	-4.958	I	G
240	-4.538	I	B
266	-4.778	GC	B
281	-10.778	P	C/S
365	-7.098	HC	C/S
456	-5.868	HC	G

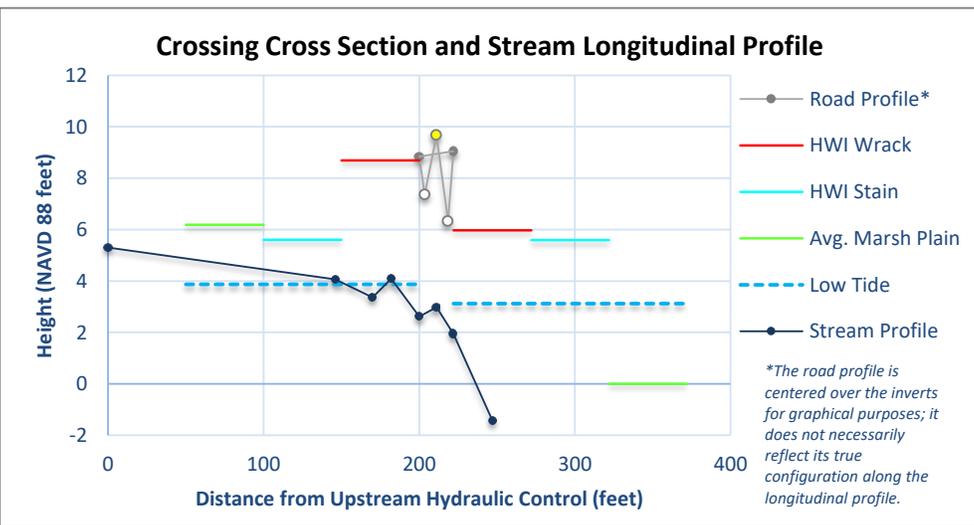
**Long. Profile**

Dist.	Hght.	Feat.	Sub.
0	5.3019	HC	C/S
146	4.0619	HC	C/S
170	3.3619	P	C/S
182	4.0819	HC	C/S
200	2.6119	I	B
211	2.9819	HC	B
222	1.9519	I	B
247	-1.4281	P	B

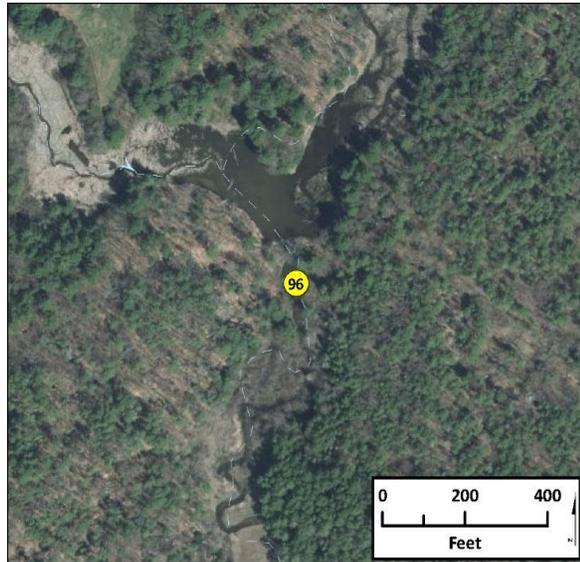
Johnson Creek is a long narrow tidal creek that reaches into Madbury as it becomes brackish and fresh. Creek Road crosses the waterway with a 9.3 feet wide by 6.8 feet tall stone bridge. The crossing condition is poor, crossing ratio is poor and erosion is evident. The overall combined score is 5, highest priority for replacement.

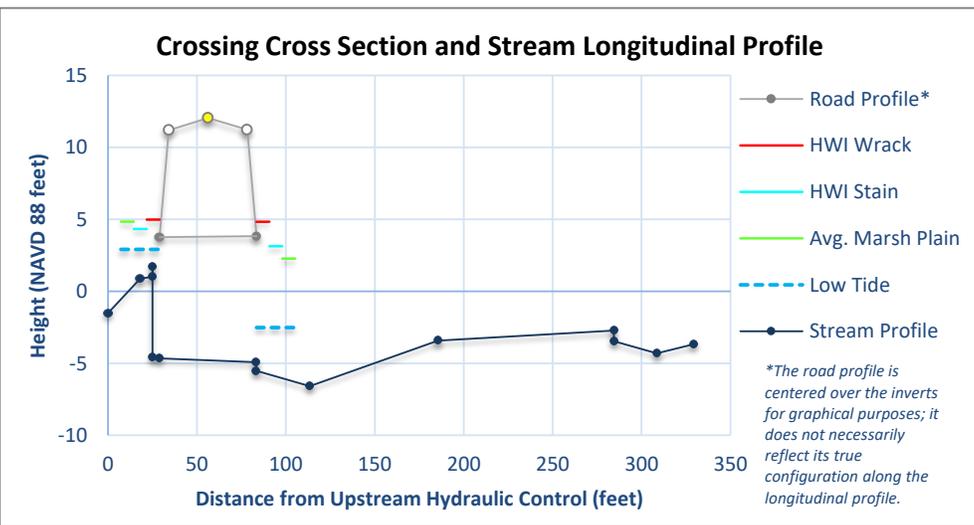
Long. Profile			
Dist.	Hght.	Feat.	Sub.
0	-1.5193	P	G
18	0.8607	CB	C
25	1.0107	CB	C
25	1.7107	CB	N/A
25	-4.5893	GC	N/A
29	-4.6693	I	N/A
83.5	-4.9193	I	C/S
83.5	-5.5193	CB	C/S
113.5	-6.5893	P	B
185.5	-3.4193	CB	G
284.5	-2.7193	GC	N/A
284.5	-3.4693	CB	C
308.5	-4.3193	P	S
329.5	-3.6693	HC	G

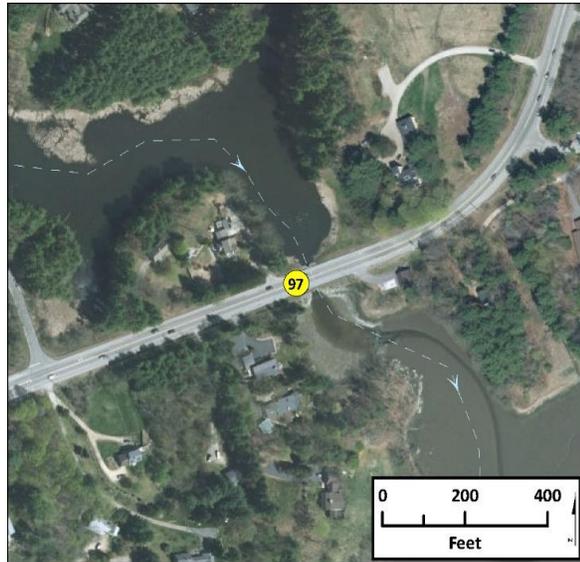
The entrance to the town center of Durham on Route 108 (Dover Road) passes over Beards Creek which drains through an 8.5 high by 7.5-foot-wide concrete box culvert. Stop logs had kept the upstream wetland an open freshwater pond with no tidal exchange. The crossing is in good shape but has severe ecological impacts to the upstream wetlands and will prevent future marsh migration. The overall combined score is a 5, highest priority for replacement due to the ecological impacts. The main sewage line leading to the treatment plant to the south crosses the mouth of the culvert, below the stop logs, so that tidal restoration would require reconfiguration of the sewer line.

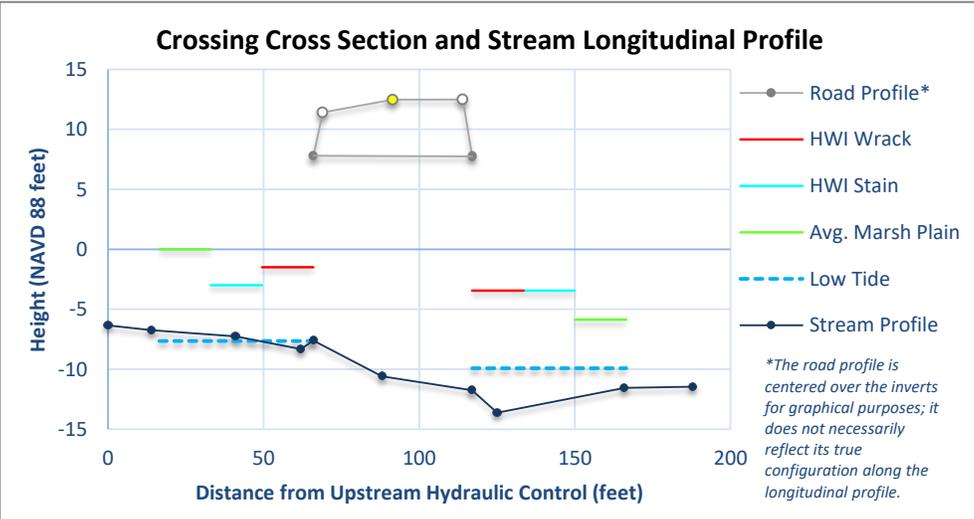
Long. Profile			
Dist.	Hght.	Feat.	Sub.
0	-6.3428	HC	C
14	-6.7428	CB	C
41	-7.2628	HC	B
62	-8.3128	P	B
66	-7.5928	I	B
88	-10.593	CB	B
117	-11.743	I	S
125	-13.623	P	B
166	-11.543	HC	B
188	-11.443	HC	B

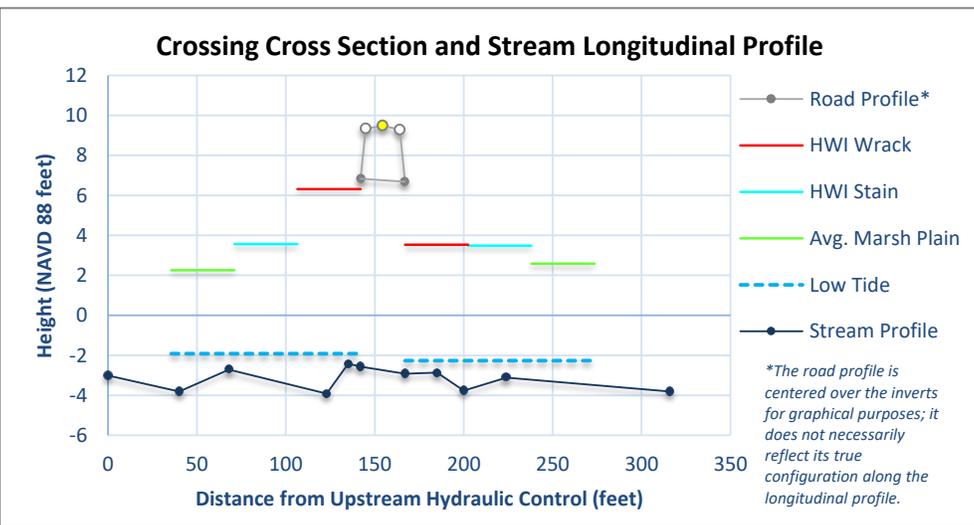
Long. Profile			
Dist.	Hght.	Feat.	Sub.
0	-3.0184	HC	C/S
40	-3.8184	P	G
68	-2.7184	HC	G
123	-3.9184	P	G
135	-2.4184	GC	G
142	-2.5684	I	G
167	-2.9184	I	G
185	-2.8684	GC	G
200	-3.7684	P	C/S
224	-3.1184	HC	G
316	-3.8184	HC	C/S

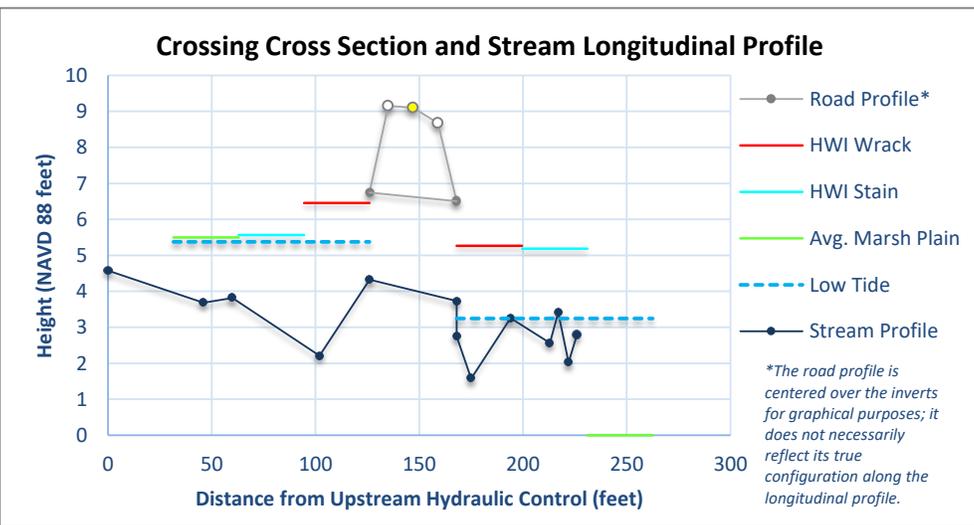
Long. Profile			
Dist.	Hght.	Feat.	Sub.
0	4.5743	HC	C/S
46	3.6843	CB	C/S
60	3.8143	HC	C/S
102	2.2143	P	C/S
126	4.3243	I	C/S
168	3.7343	I	N/A
168	2.7443	CB	G
175	1.5743	P	G
194	3.2543	HC	C
213	2.5643	CB	C/S
217	3.4143	HC	C/S
222	2.0243	P	G
226	2.7943	HC	G

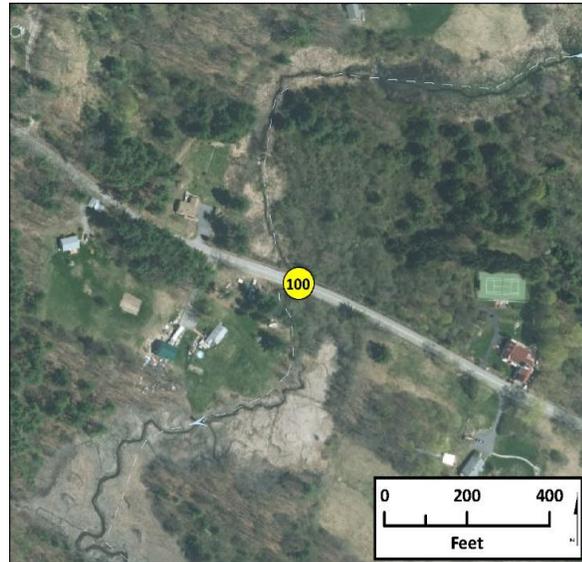
The crossing at Lubberland Creek, where it crosses Bay Road in Newmarket is effectively at the head of tide. The restrictive crossing is in poor condition; it contributes to the inundation risk from stormwater flooding, and is undersized, leading to severe scour, strongly restricting tides and prevention of organism passage. The overall combined score is 5 indicating highest priority for restoration. The culvert is slated to be restored in 2019 and the project champion and abutting landowner is The Nature Conservancy.

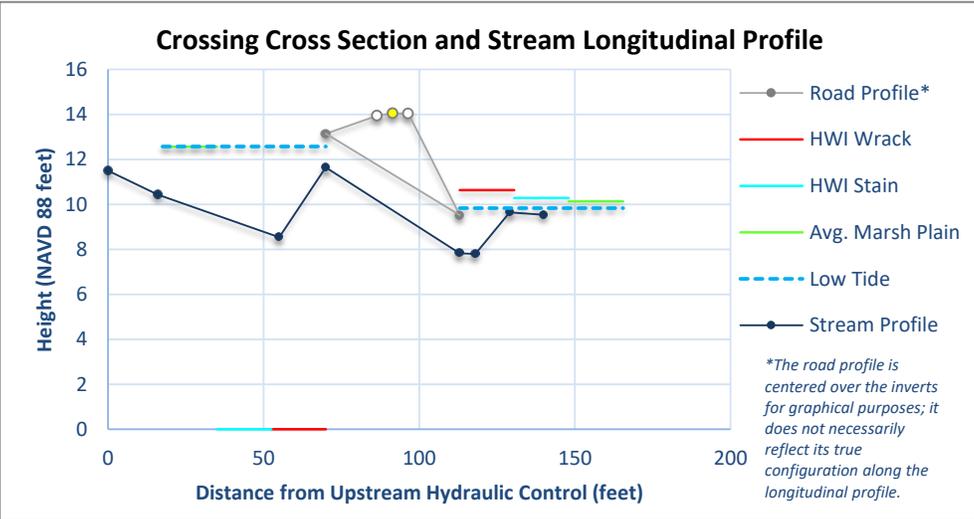
Long. Profile			
Dist.	Hght.	Feat.	Sub.
0	11.492	HC	C/S
16	10.432	CB	C/S
55	8.532	P	C/S
70	11.642	I	C/S
113	7.832	I	C
118	7.792	P	C
129	9.642	HC	G
140	9.542	CB	S

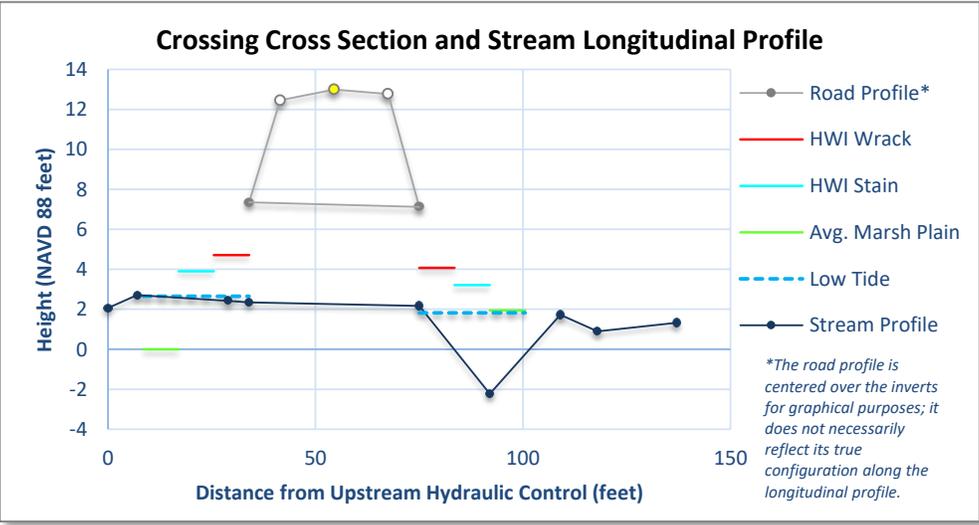
**Long. Profile**

Dist.	Hght.	Feat.	Sub.
0	2.0621	HC	C
7	2.7121	HC	C
29	2.4221	CB	G
34	2.3421	I	C
75	2.1721	I	C
92	-2.2279	P	C
109	1.7221	HC	G
118	0.9021	P	C
137	1.3221	HC	C

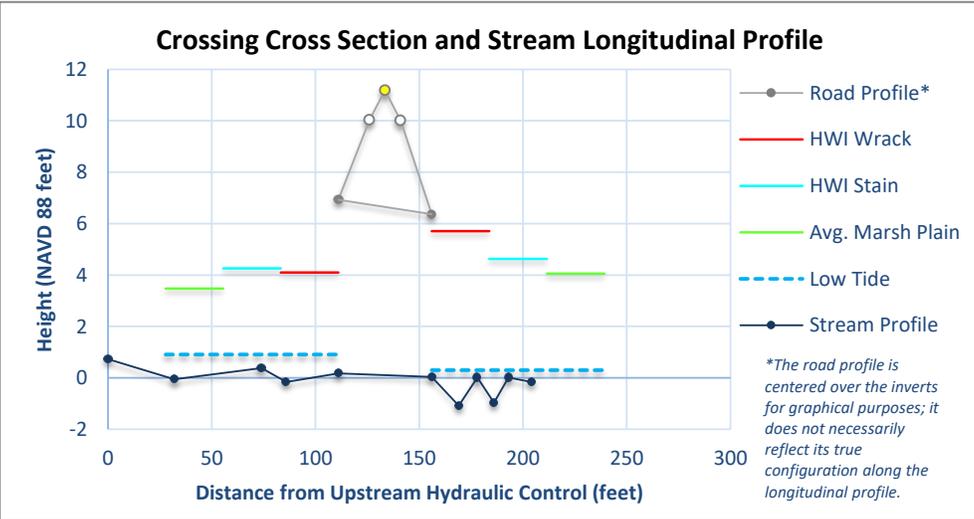
Long. Profile			
Dist.	Hght.	Feat.	Sub.
0	0.7277	HC	C/S
32	-0.0623	P	C/S
74	0.3777	HC	C/S
86	-0.1623	P	C/S
111	0.1777	I	C/S
156	0.0377	I	G
169	-1.0823	P	G
178	0.0077	HC	G
186	-0.9623	P	G
193	0.0177	HC	S
204	-0.1623	CB	C/S

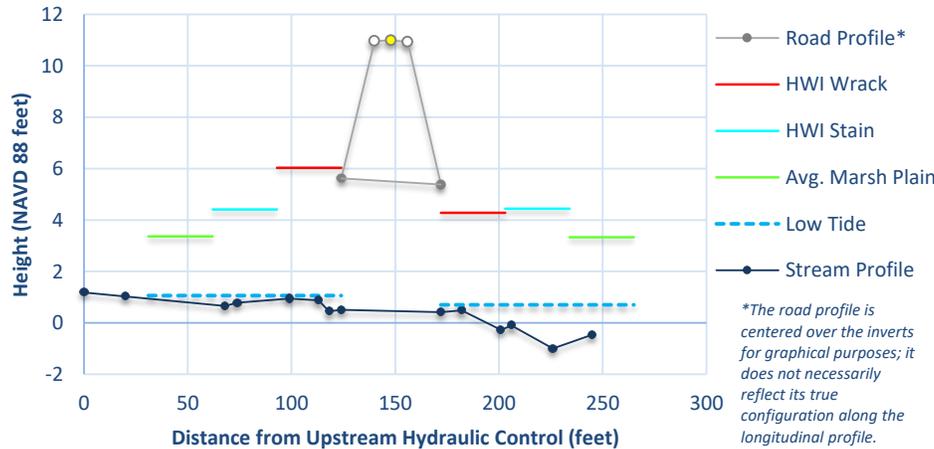
### Crossing Cross Section and Stream Longitudinal Profile

Dist.	Hght.	Feat.	Sub.
0	1.1808	HC	C/S
20	1.0208	HC	C/S
68	0.6608	P	C/S
74	0.7808	HC	C/S
99	0.9408	CB	S
113	0.8708	CB	C/S
118	0.4508	P	C/S
124	0.5108	I	G
172	0.4108	I	C
182	0.4808	GC	C
201	-0.2792	CB	C
206	-0.0992	HC	G
226	-0.9992	P	C/S
245	-0.4592	HC	C/S

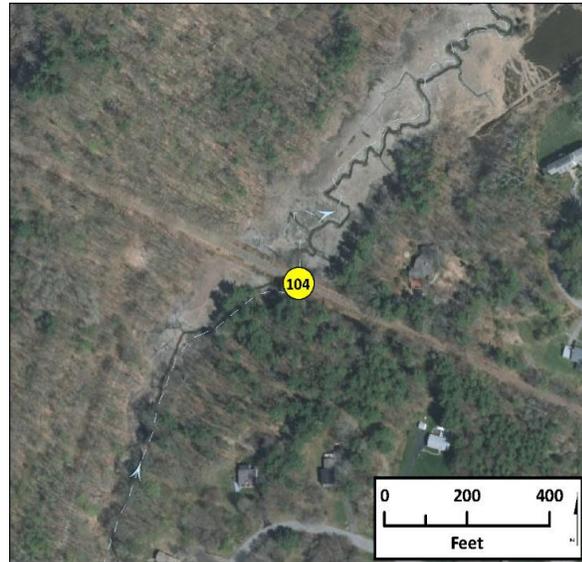
The railroad line that traverses the southeast corner of Great Bay crosses several small valleys of salt marsh (#103, 104, 106) and the Winnicut River (#105). This crossing is a granite culvert, about 1.5 feet wide and 5 feet tall, over a small tributary called Shaw Brook. With poor crossing condition, erosion and poor crossing ratio the overall combined score is 4, high priority for replacement.

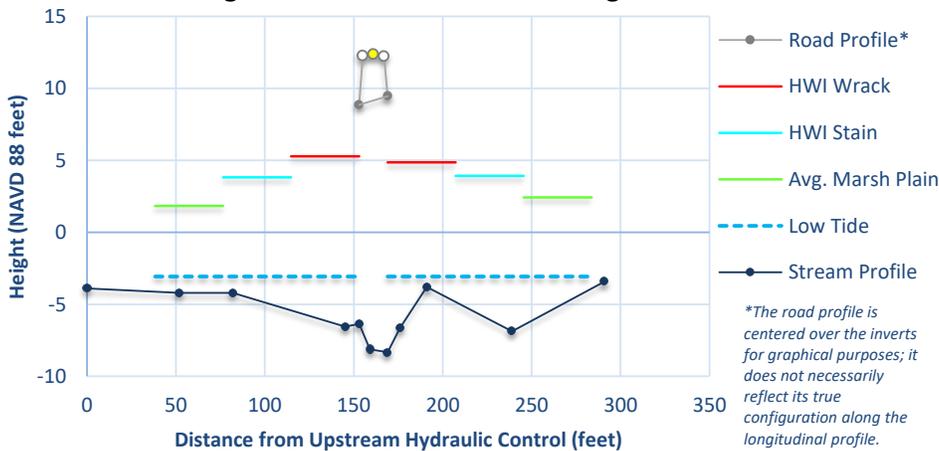
### Crossing Cross Section and Stream Longitudinal Profile

Dist.	Hght.	Feat.	Sub.
0	-3.8912	HC	S
52	-4.2012	P	C/S
82	-4.2012	HC	S
145	-6.5412	P	S
153	-6.3612	I	S
159	-8.1412	P	S
169	-8.3312	I	S
176	-6.6312	P	S
191	-3.8012	HC	C
239	-6.8712	P	C/S
291	-3.4212	HC	G

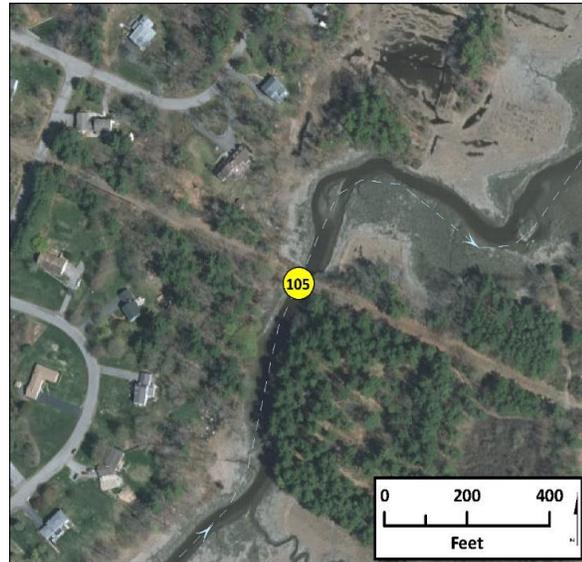
The railroad line that traverses the southeast corner of Great Bay crosses several small valleys of salt marsh (#103, 104, 106) and the Winnicut River (#105). The Winnicut River is bridged by the railroad (about 19 feet wide and 18 feet tall) with granite abutments. The crossing condition is poor and exhibits some erosion and minor tidal restriction. The vegetation upstream becomes brackish and is more shaded by large trees and the marsh plain was measured more than 0.5 foot lower, an indicator of peat subsidence. The overall combined score is 4, high priority for replacement.

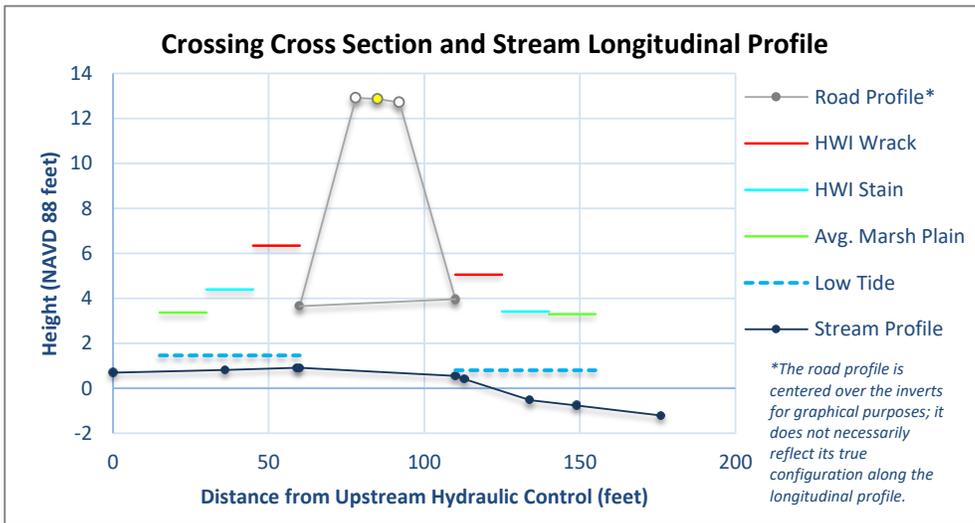
**Long. Profile**

Dist.	Hght.	Feat.	Sub.
0	0.6909	HC	S
36	0.8109	HC	B
59	0.9109	CB	B
60	0.9109	I	B
110	0.5509	I	C
113	0.4009	GC	C
134	-0.5291	HC	G
149	-0.7691	HC	G
176	-1.2091	CB	C/S

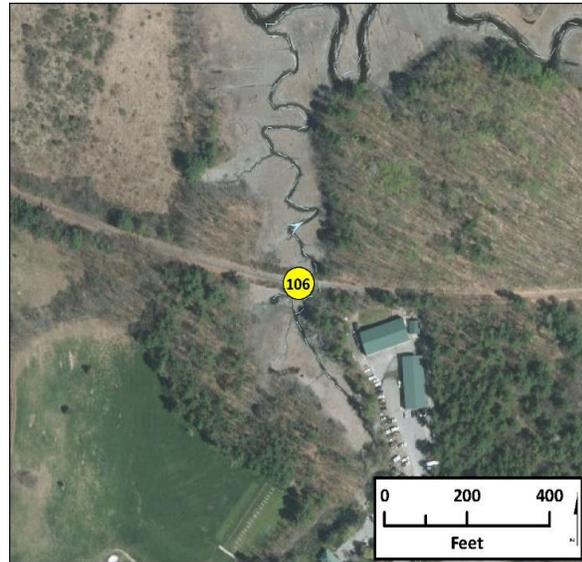
The railroad line that traverses the southeast corner of Great Bay crosses several small valleys of salt marsh (#103, 104, 106) and the Winnicut River (#105). This easternmost crossing is over a tributary to the Winnicut River, a 3 by 3 (approximately) granite culvert. The crossing condition is poor and moderate erosion was observed as well as a change in plant community. The culvert is slightly perched, and high tides often overtop the culvert. The overall combined score is 4, high priority for replacement.

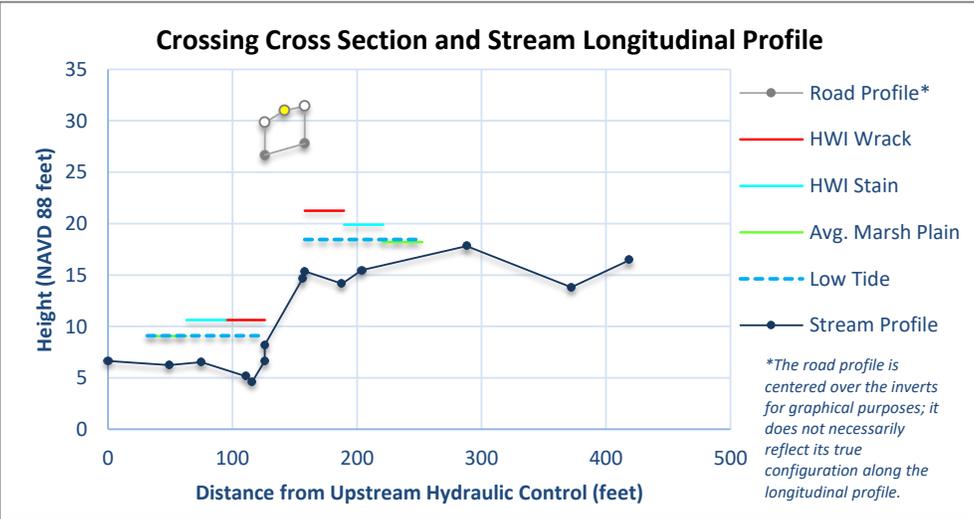
Long. Profile			
Dist.	Hght.	Feat.	Sub.
0	6.6339	HC	C/S
49	6.2339	P	C/S
75	6.5339	HC	C/S
111	5.1339	CB	G
116	4.6339	P	G
126	6.6339	CB	G
126	8.1839	I	G
156	14.614	CB	B
158	15.364	I	B
188	14.164	P	B
204	15.464	CB	B
288	17.814	HC	C
372	13.814	HC	C
419	16.464	HC	B

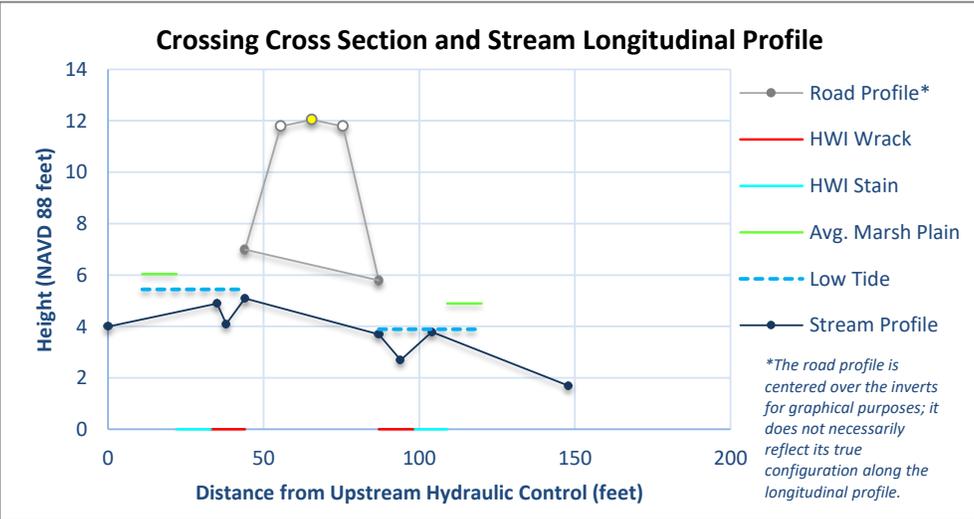
**Long. Profile**

<u>Dist.</u>	<u>Hght.</u>	<u>Feat.</u>	<u>Sub.</u>
0	3.9907	HC	C/S
35	4.8907	HC	C/S
38	4.0907	P	C/S
44	5.0907	I	C/S
87	3.6907	I	G
94	2.6907	P	G
104	3.7907	HC	C
148	1.6907	HC	S

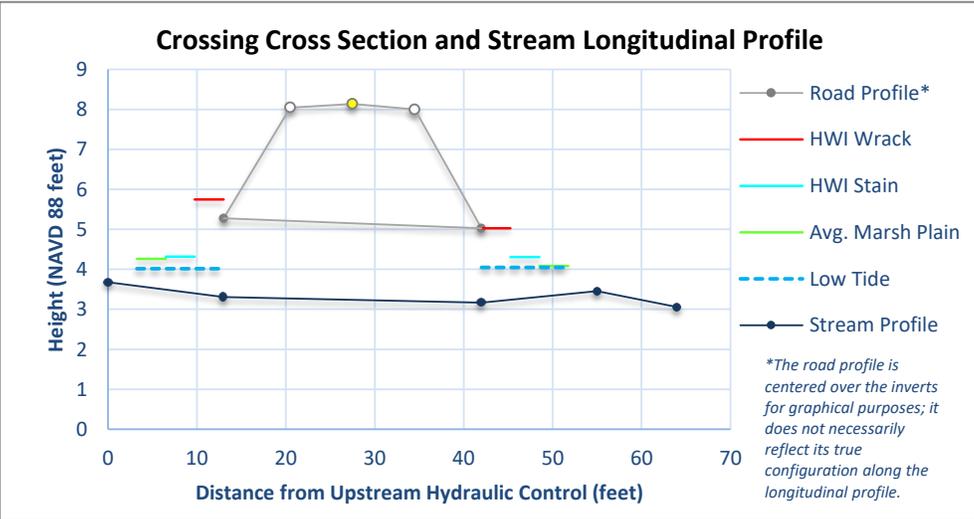
**Long. Profile**

Dist.	Hght.	Feat.	Sub.
0	3.6765	CB	C/S
13	3.3065	I	C/S
42	3.1665	I	G
55	3.4565	CB	C/S
64	3.0565	P	C/S

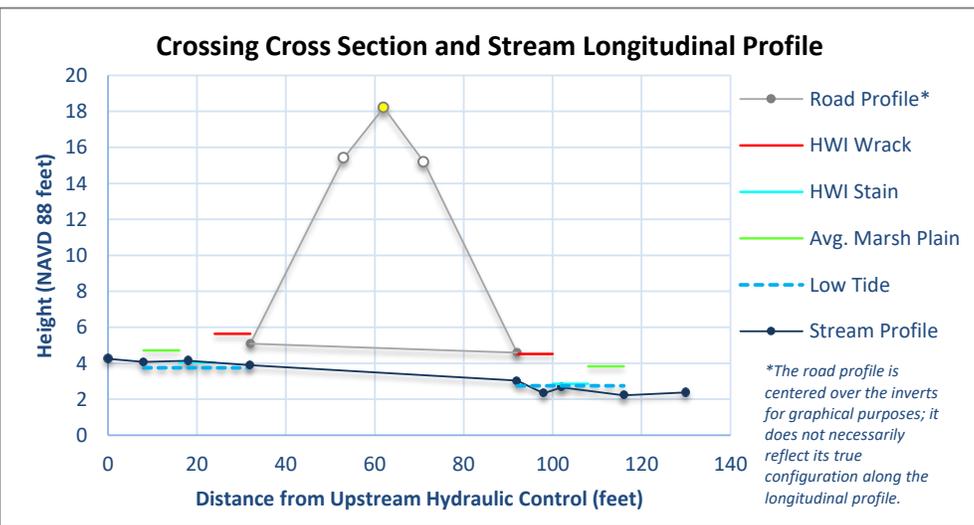
Long. Profile			
Dist.	Hght.	Feat.	Sub.
0	4.2487	HC	C/S
8	4.0687	P	C/S
18	4.1387	HC	C/S
32	3.8887	I	C
92	3.0387	I	G
98	2.3387	P	C
102	2.6687	HC	C
116	2.2187	P	S
130	2.3787	HC	C/S
