# Tidal Crossing Summary Sheet

## New Hampshire's Tidal Crossing Assessment Protocol

Crossing ID: 1

Observer(s) & Organization:	TS, JB (NHDES Coastal)
Municipality:	SEABROOK
Stream Name:	Blackwater River
Road Name:	Route 286

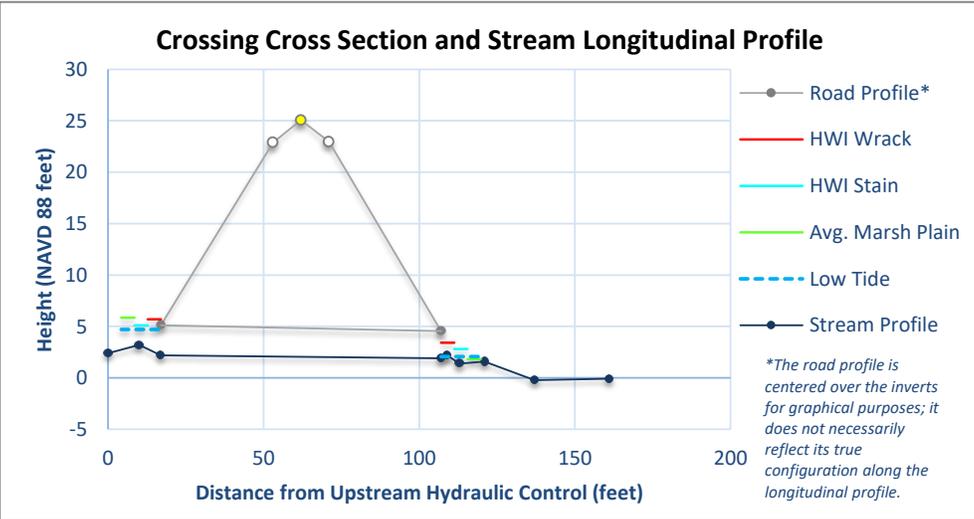
Long. Profile			
Dist.	Hght.	Feat.	Sub.
0	2.3856	P	C/S
10	3.2056	CB	C/S
17	2.1856	I	C/S
107	1.9156	I	B
109	2.1856	GC	B
113	1.3756	P	B
121	1.5856	HC	B
137	-0.2244	CB	S
161	-0.0944	HC	B

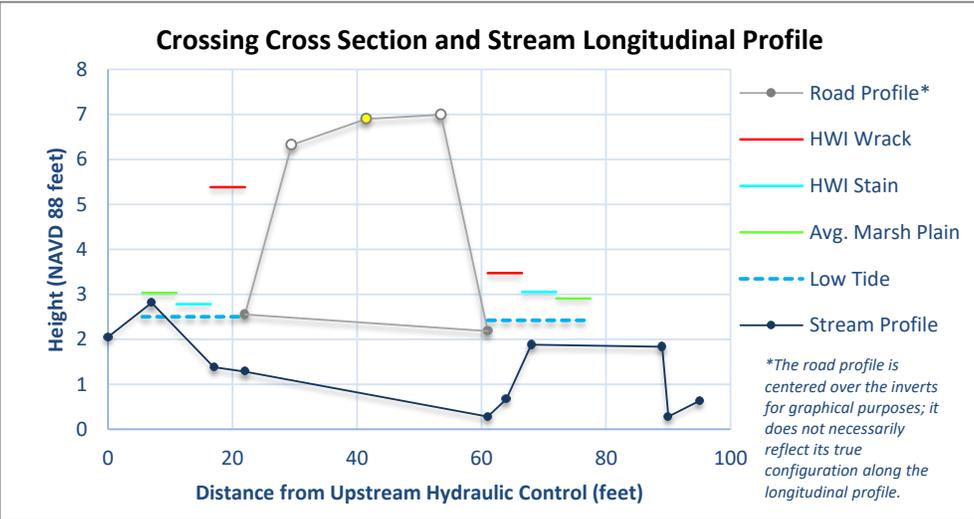
Long. Profile			
Dist.	Hght.	Feat.	Sub.
0	2.0516	HC	C/S
7	2.8116	HC	G
17	1.3816	CB	B
22	1.2816	I	B
61	0.2816	I	S
64	0.6716	P	S
68	1.8816	HC	C/S
89	1.8316	HC	C/S
90	0.2816	CB	C/S
95	0.6316	CB	C/S

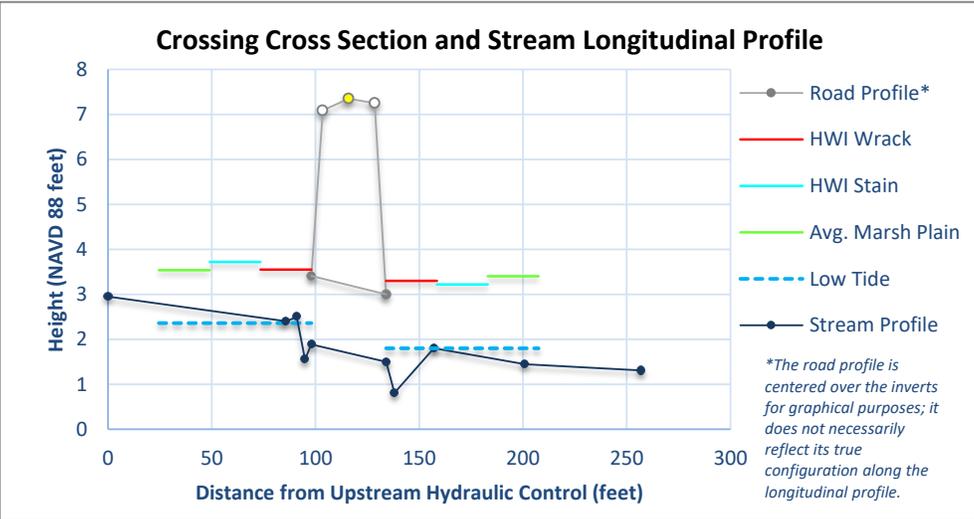
**Long. Profile**

Dist.	Hght.	Feat.	Sub.
0	2.9491	HC	C/S
86	2.3991	HC	G
91	2.4991	HC	G
95	1.5491	P	C/S
98	1.8891	I	C/S
134	1.4991	I	G
138	0.8091	P	C
157	1.7991	HC	G
201	1.4491	HC	G
257	1.3091	HC	G

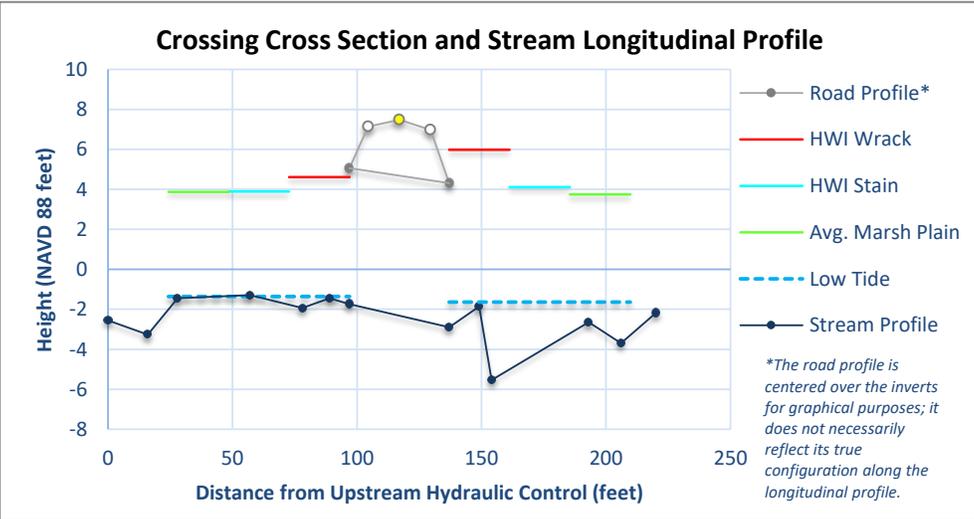
Long. Profile			
Dist.	Hght.	Feat.	Sub.
0	-2.5597	HC	G
16	-3.2597	P	G
28	-1.4397	HC	C/S
57	-1.2897	HC	G
78	-1.9397	P	G
89	-1.4397	GC	C
97	-1.7397	I	C
137	-2.8897	I	G
149	-1.8597	GC	C
154	-5.5397	P	C/S
193	-2.6397	HC	G
206	-3.6997	P	C/S
220	-2.1897	HC	G

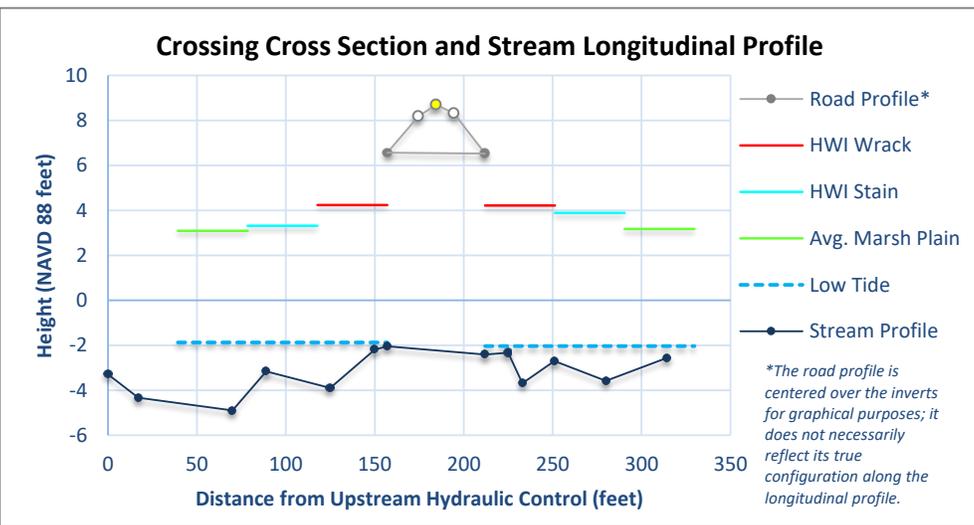
Long. Profile			
Dist.	Hght.	Feat.	Sub.
0	-3.2958	HC	C/S
17	-4.3358	P	C/S
70	-4.8958	CB	C/S
89	-3.1558	HC	C/S
125	-3.8958	P	C/S
150	-2.1858	GC	B
157	-2.0458	I	B
212	-2.4158	I	B
225	-2.3358	GC	B
233	-3.6858	P	G
251	-2.6958	HC	G
280	-3.5758	P	G
314	-2.5658	HC	G

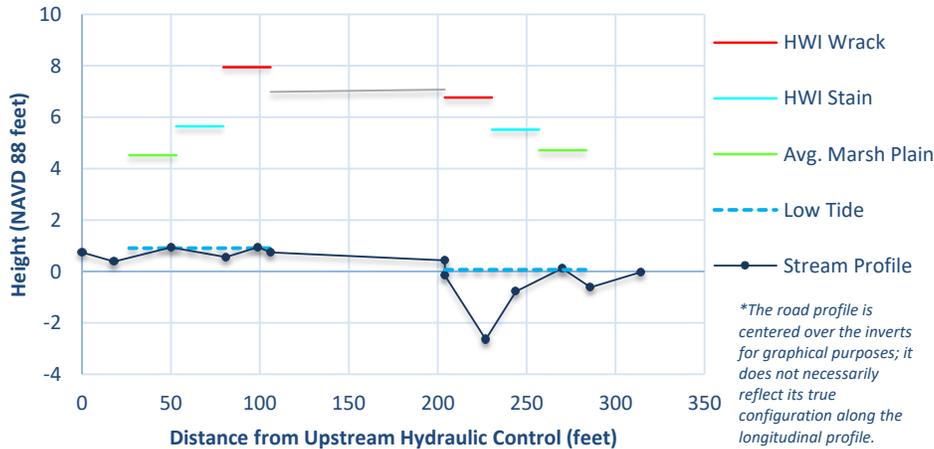
### Crossing Cross Section and Stream Longitudinal Profile

Dist.	Hght.	Feat.	Sub.
0	0.7453	HC	S
18	0.3853	P	S
50	0.9353	HC	S
81	0.5553	P	C/S
99	0.9453	HC	C
106	0.7353	I	C
204	0.4353	I	B
204	-0.1547	CB	B
227	-2.6447	P	S
244	-0.7747	CB	C/S
270	0.1153	HC	S
286	-0.6147	P	C/S
314	-0.0347	HC	S

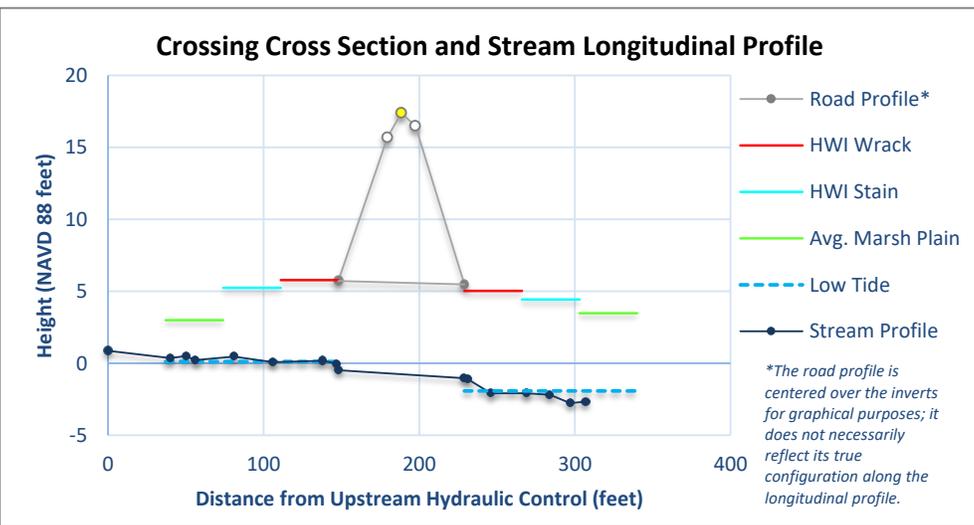
Long. Profile			
Dist.	Hght.	Feat.	Sub.
0	0.8685	HC	C
40	0.3585	P	C/S
50	0.5085	HC	G
56	0.2185	P	C/S
81	0.4685	HC	G
106	0.0785	CB	C/S
138	0.1685	HC	C
147	-0.0215	HC	C/S
148	-0.4815	I	C
229	-1.0415	I	B
231	-1.1015	GC	B
246	-2.0915	CB	S
269	-2.0915	HC	G
284	-2.1815	HC	G
297	-2.7715	P	G
307	-2.6515	HC	C/S

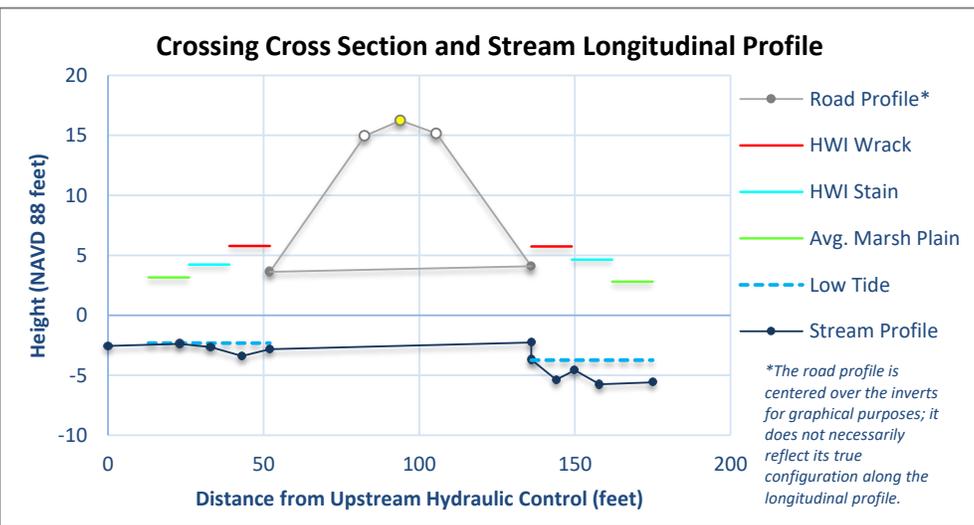
Long. Profile			
Dist.	Hght.	Feat.	Sub.
0	-2.5598	HC	C/S
23	-2.3798	HC	C/S
33	-2.6498	CB	S
43	-3.3998	P	C/S
52	-2.8298	I	C
136	-2.2698	I	G
136	-3.6798	CB	G
144	-5.3598	P	G
150	-4.5698	HC	B
158	-5.7498	P	G
175	-5.5898	CB	G

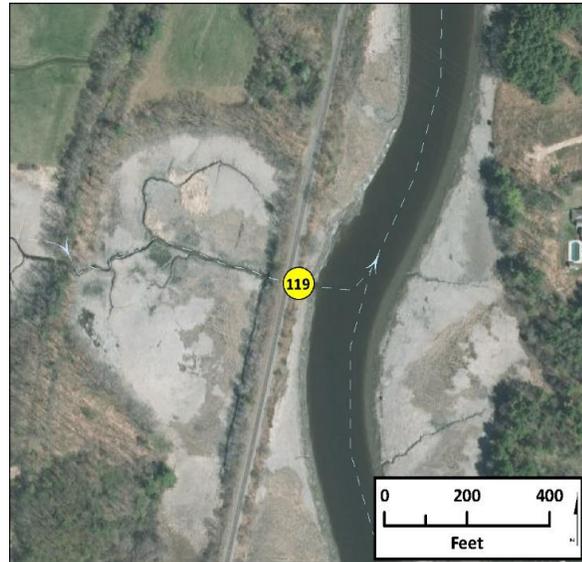
The railroad bed traveling north and south on the west side of Great Bay has several crossings of tidal marsh and creeks (117, 118, 119, 121). The granite culvert for this crossing is about 7 feet high by 4 feet wide and conducts water of an unnamed tidal creek to about 10 acres of tidal marsh. The crossing condition is poor, it constricts the channel width, restricts the tidal range and has a perch at low tide. The culvert fills during high tide on a regular basis. The overall combined score is 4, high priority for replacement.

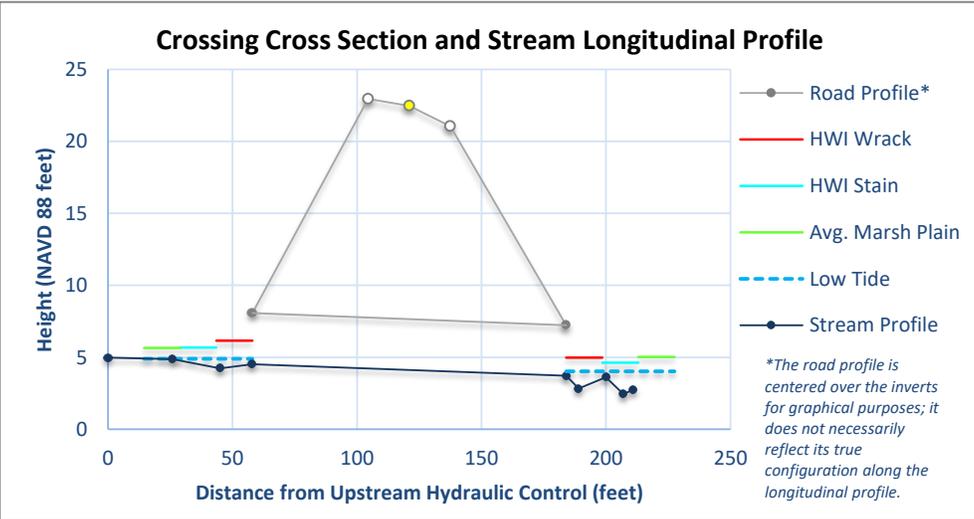
Long. Profile			
Dist.	Hght.	Feat.	Sub.
0	4.9738	HC	C/S
26	4.8738	HC	S
45	4.2338	P	C/S
58	4.5138	I	S
184	3.7238	I	C
189	2.8238	P	C
200	3.6238	HC	C
207	2.4438	P	C
211	2.7438	HC	C

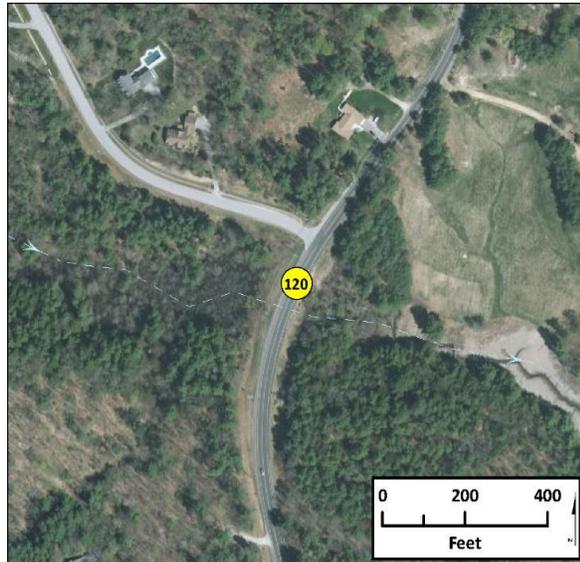
Newfield's Road crosses Rocky Hill Brook well above the railroad bed and the Brook runs through a 3.5-foot round metal pipe (although the upstream pipe exiting the road bed is partially crushed). The crossing condition is poor, with strong evidence of erosion and the culvert constricts the channel flow. The overall combined score is 4 for this culvert, indicating a high priority for replacement.

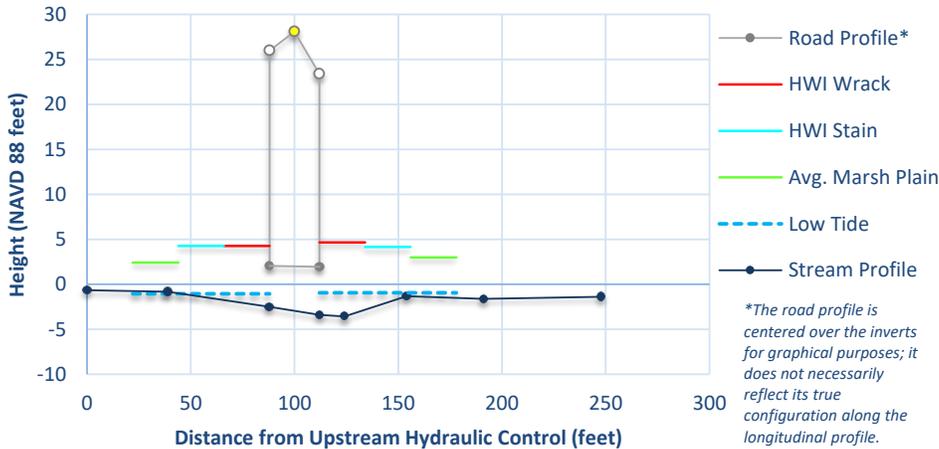
Crossing Cross Section and Stream Longitudinal Profile

Dist.	Hght.	Feat.	Sub.
0	-0.656	HC	S
39	-0.846	HC	S
88	-2.516	I	S
112	-3.406	I	C/S
124	-3.576	P	C/S
154	-1.316	HC	S
191	-1.606	P	S
248	-1.376	HC	S

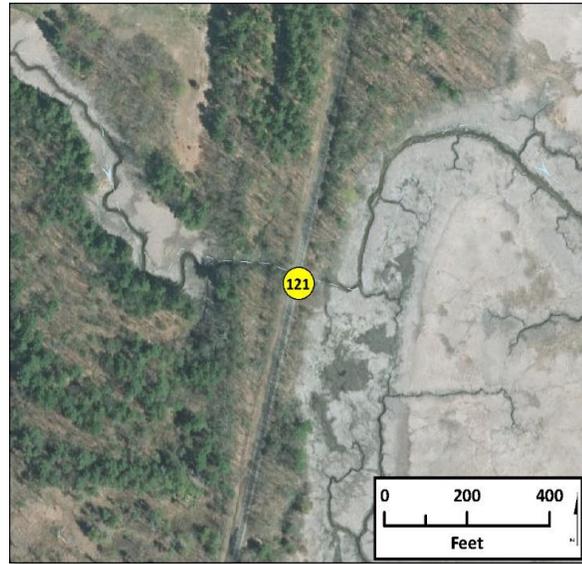
The railroad bed traveling north and south on the west side of Great Bay has several crossings of tidal marsh and creeks (117, 118, 119, 121). Rocky hill brook is tidal marsh where it crosses under the railroad through a 4-foot-wide and 5.5-foot-tall stone bridge. The crossing condition is poor showing channel constriction and severe erosion, with high tides overflowing the structure on a daily basis. The upstream marsh is more than 0.5 feet lower than the downstream marsh plain, indicating restriction has led to subsidence. The overall combined score is 4, high priority for replacement.

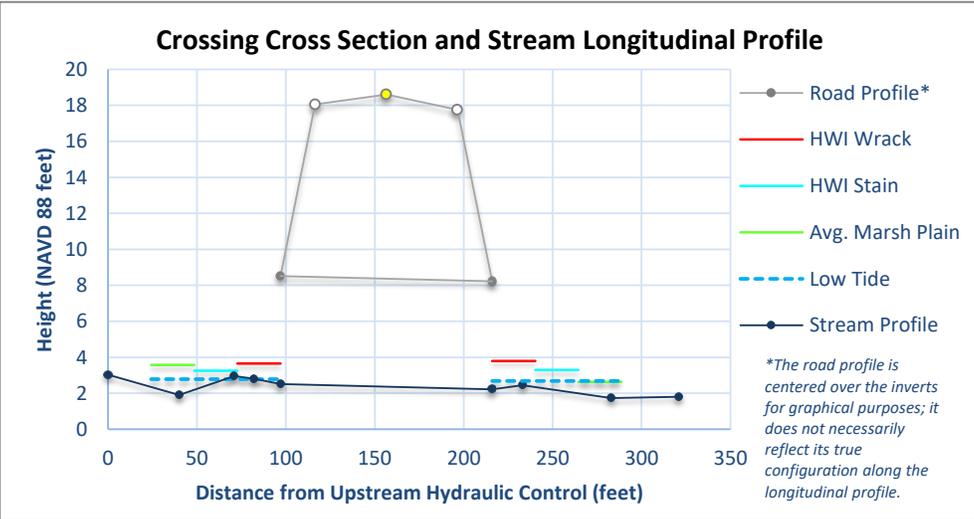
Long. Profile			
Dist.	Hght.	Feat.	Sub.
0	3.0324	HC	B
40	1.9024	P	C
71	2.9524	HC	C
82	2.8124	GC	C
97	2.5124	I	C
216	2.2224	I	C
233	2.4524	HC	C
283	1.7324	HC	C
321	1.8024	HC	C

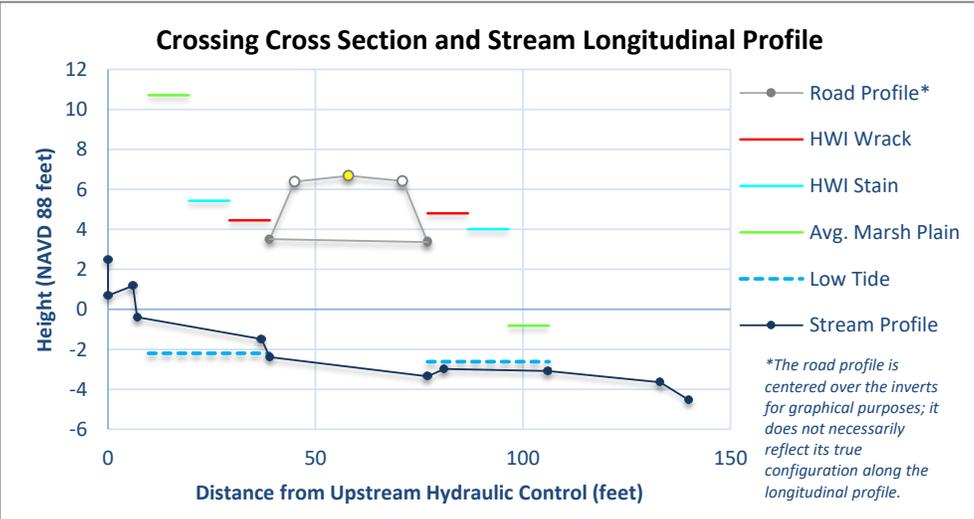
**Long. Profile**

Dist.	Hght.	Feat.	Sub.
0	2.4798	HC	N/A
0	0.6898	CB	B
6	1.1798	HC	B
7	-0.3902	HC	B
37	-1.4902	GC	B
39	-2.3902	I	B
77	-3.3502	I	C
81	-2.9902	GC	B
106	-3.0902	HC	C
133	-3.6502	HC	C
140	-4.5402	CB	C

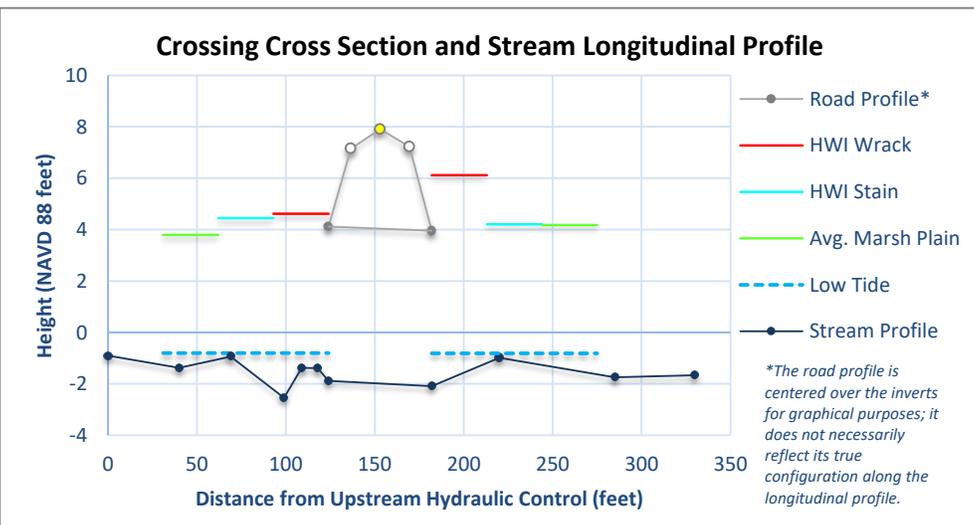
Long. Profile			
Dist.	Hght.	Feat.	Sub.
0	-0.9032	HC	G
40	-1.3832	P	G
69	-0.9432	HC	G
99	-2.5432	P	G
109	-1.3732	CB	G
118	-1.3932	GC	C
124	-1.8832	I	C
182	-2.0932	I	B
220	-0.9832	HC	G
285	-1.7432	HC	G
330	-1.6632	HC	G

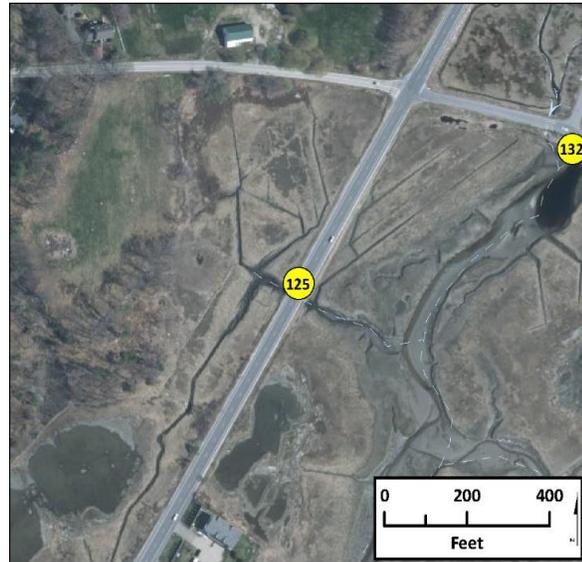
Route 1A crosses an extensive back-barrier salt marsh at Rye Harbor several times and this crossing provides tidal flow to a fragmented marsh that also receives flow through a crossing to the south (#46). Tidal waters are conducted through a 6 by 6-foot concrete culvert installed circa 1997 to restore tidal exchange and halt the spread of exotic *Phragmites* (common reed). The crossing condition is fair, the channel is constricted, and the high tide stain indicates that the culvert overfills regularly. The overall combined score is 4, high priority for replacement.

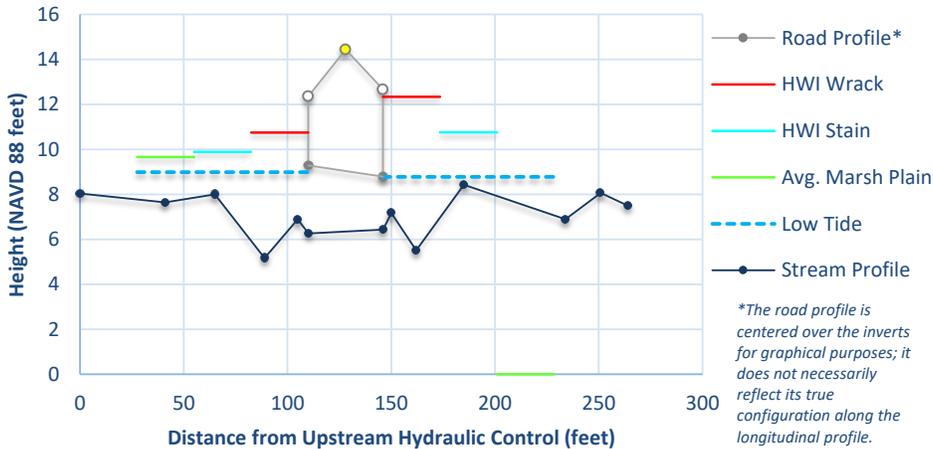
**Crossing Cross Section and Stream Longitudinal Profile**

Dist.	Hght.	Feat.	Sub.
0	8.0357	HC	C/S
41	7.6357	P	S
65	7.9957	HC	G
89	5.1657	P	C
105	6.8957	GC	B
110	6.2557	I	B
146	6.4257	I	B
150	7.1657	GC	B
162	5.5157	P	S
185	8.4257	HC	S
234	6.8857	P	G
251	8.0657	GC	C
264	7.4957	I	C

\*The road profile is centered over the inverts for graphical purposes; it does not necessarily reflect its true configuration along the longitudinal profile.

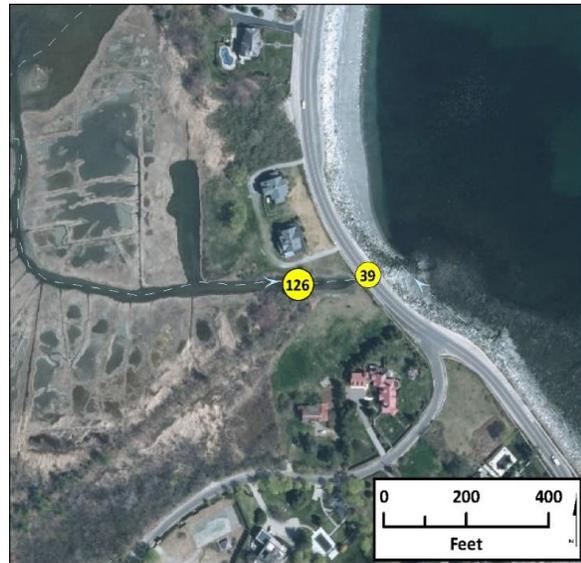
Tidal flow supporting the salt marsh at Philbrick’s Pond has been restricted by the trolley berm of the early 1900s as well as Route 1A (crossing #39). A recent investigation into the hydrodynamic flows and how they may be restored to rejuvenate the degraded salt marsh showed that the small clay pipe (2.5 feet in diameter) under the trolley berm was intact, but restricted tides, while the culvert under Route 1A was less restrictive (CMA Engineers 2018). The overall combined score of 5 indicates highest priority for replacement, but it will require landowner permission.

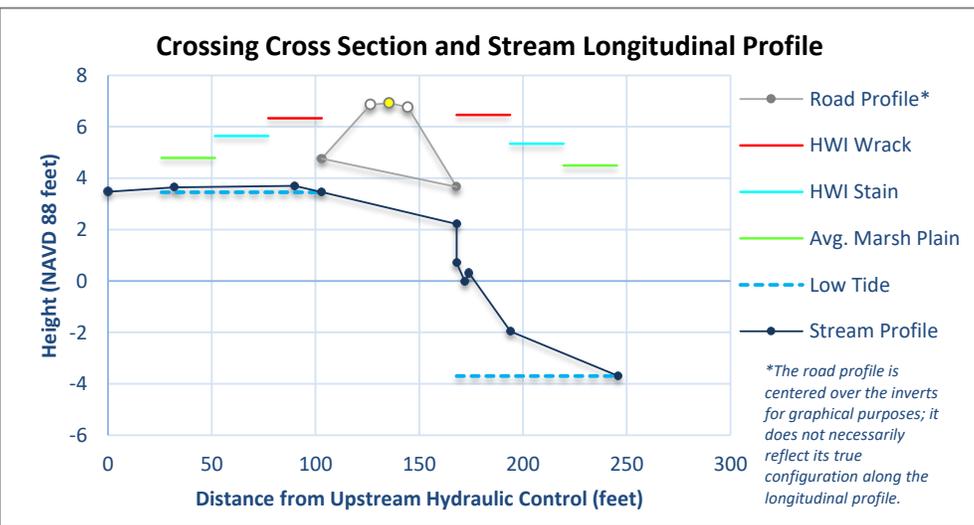
**Long. Profile**

Dist.	Hght.	Feat.	Sub.
0	3.4726	HC	C/S
32	3.6426	HC	C/S
90	3.7026	CB	C/S
103	3.4626	I	G
168	2.2126	I	C
168	0.7126	CB	C
172	-0.0274	P	G
174	0.3026	HC	G
194	-1.9574	CB	C
246	-3.6974	HC	S

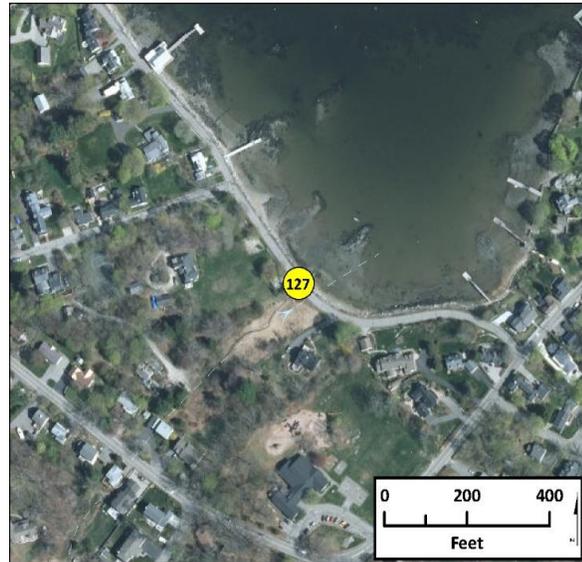
A small head of tide marsh on New Castle Island is crossed by River Road and a new 1.25-foot round pipe was installed in 2011 to improve tidal flow to the marsh, which was being invaded by weedy species such as a non-native form of common reed (Phragmites). The site has a history of flooding and continues to show signs of restriction. The overall combined score is 5: highest priority for replacement.

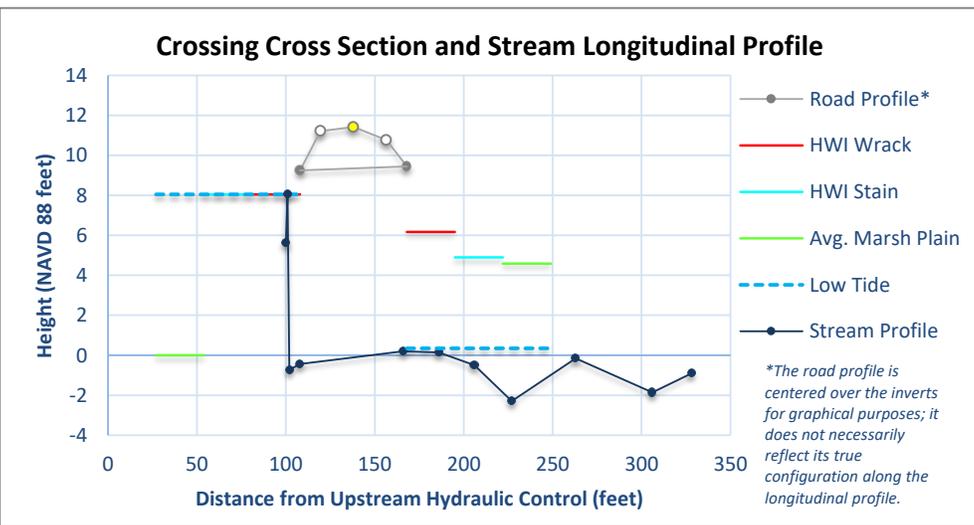
**Long. Profile**

Dist.	Hght.	Feat.	Sub.
100	5.5973	CB	C/S
101	8.0473	HC	N/A
102	-0.7327	CB	B
108	-0.4327	I	B
166	0.2073	I	B
186	0.1373	GC	B
206	-0.4927	CB	B
227	-2.2927	P	B
263	-0.1527	HC	S
306	-1.8527	P	B
328	-0.9127	HC	G

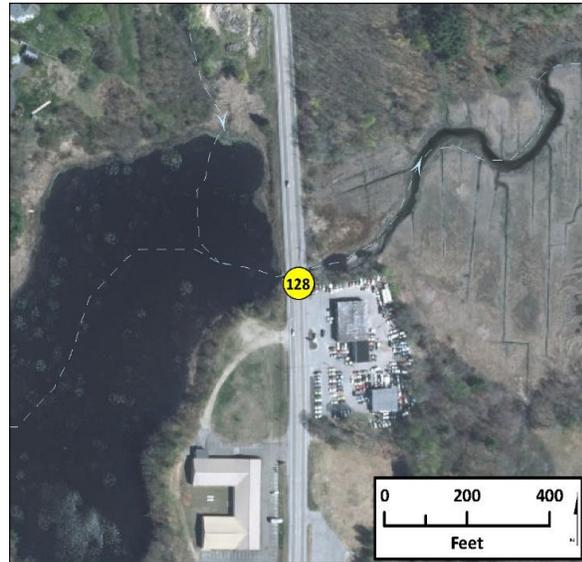
In Hampton Falls the head of tide for a narrow marsh ‘finger’ ends at the Dodge Ponds Dam just upstream of Route 1. The Route 1 cement culvert over the waterway is approximately 10 by 9 feet with wingwalls and fitted with slots for stoplogs (absent). The tide reaches about 5 feet above the culvert invert but is stopped by the dam, which impounds about 8 feet of water. The crossing condition is very good, but the dam restricts the tides completely, leading to an ecological score of 5 and an overall combined score of 5, highest priority for replacement.

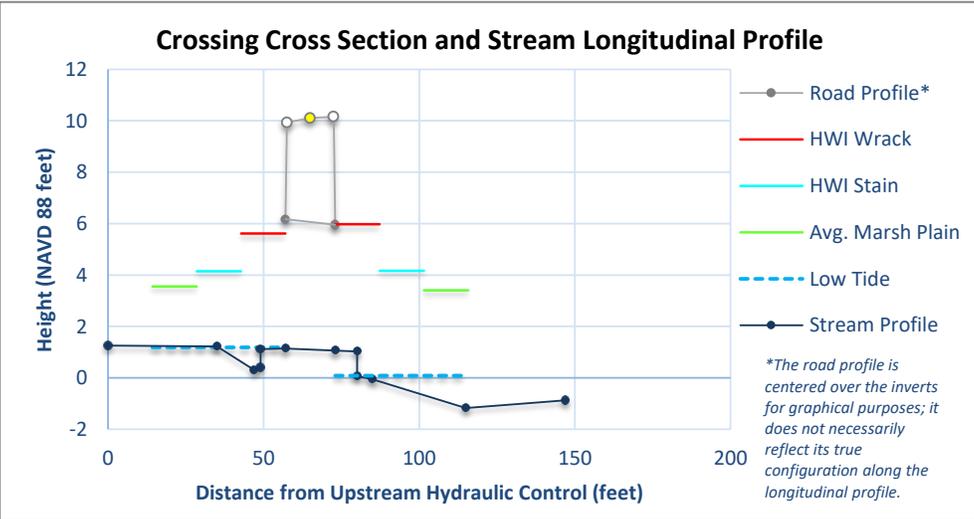
Long. Profile			
Dist.	Hght.	Feat.	Sub.
0	1.255	HC	G
35	1.225	HC	C
47	0.305	P	G
49	0.395	CB	G
49	1.115	GC	G
57	1.145	I	C
73	1.055	I	C
80	1.025	GC	C
80	0.075	CB	G
85	-0.055	HC	G
115	-1.175	CB	C/S
147	-0.875	HC	S

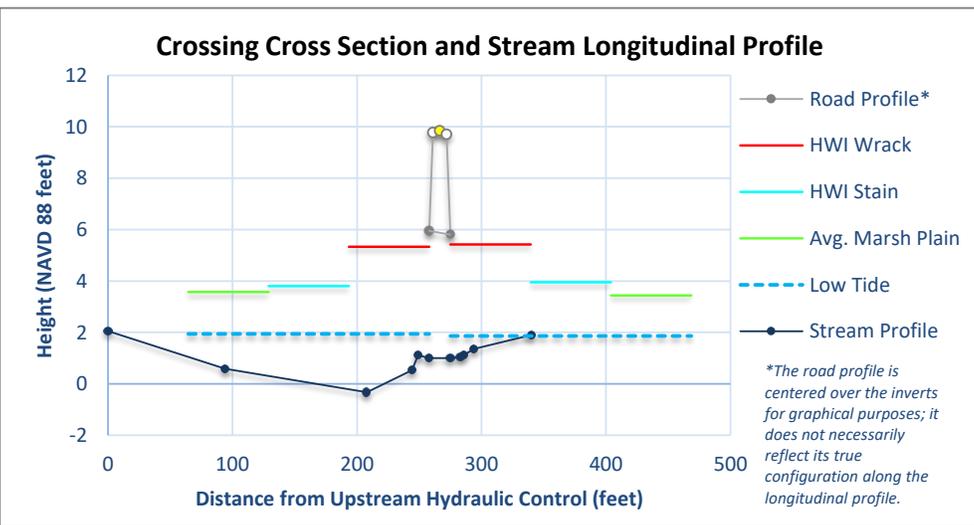
**Long. Profile**

Dist.	Hght.	Feat.	Sub.
0	2.0525	HC	B
94	0.5825	HC	B
208	-0.3275	P	C/S
244	0.5325	CB	C
249	1.1225	GC	C
258	1.0025	I	C
275	1.0025	I	G
283	1.0425	CB	C
286	1.1325	HC	C
294	1.3625	HC	G
340	1.9025	HC	C

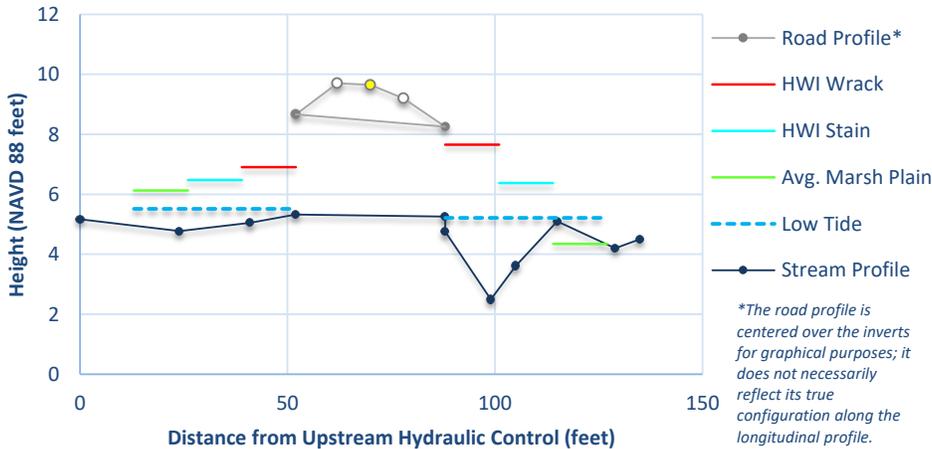
**Crossing Cross Section and Stream Longitudinal Profile**

Dist.	Hght.	Feat.	Sub.
0	5.1657	HC	C/S
24	4.7757	P	C/S
41	5.0457	HC	C/S
52	5.3257	I	C/S
88	5.2557	I	G
88	4.7557	CB	G
99	2.4957	P	C
105	3.6057	CB	G
115	5.0957	HC	C
129	4.2057	P	C/S
135	4.5057	HC	C

\*The road profile is centered over the inverts for graphical purposes; it does not necessarily reflect its true configuration along the longitudinal profile.

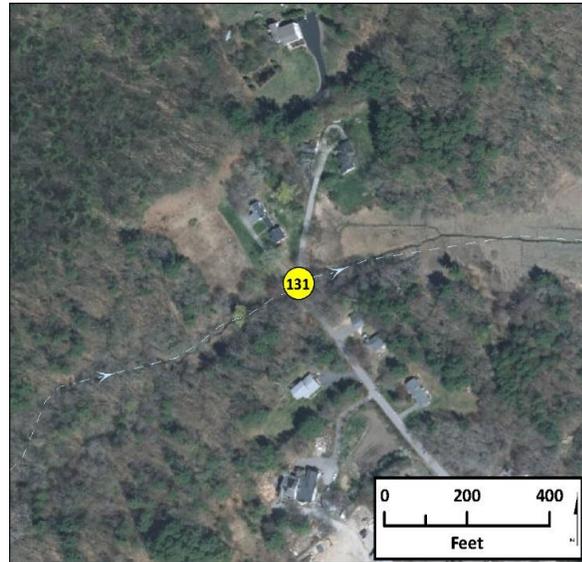
Marsh Lane crosses Kenney Brook in Hampton and conducts flow through a 3-foot round culvert. It is rated an overall combined score of 3, indicating a moderate priority for replacement due to high scour scores and relatively deep downstream pool. It sits at a high position in the landscape, but improvements may benefit fish passage, especially as sea levels rise.

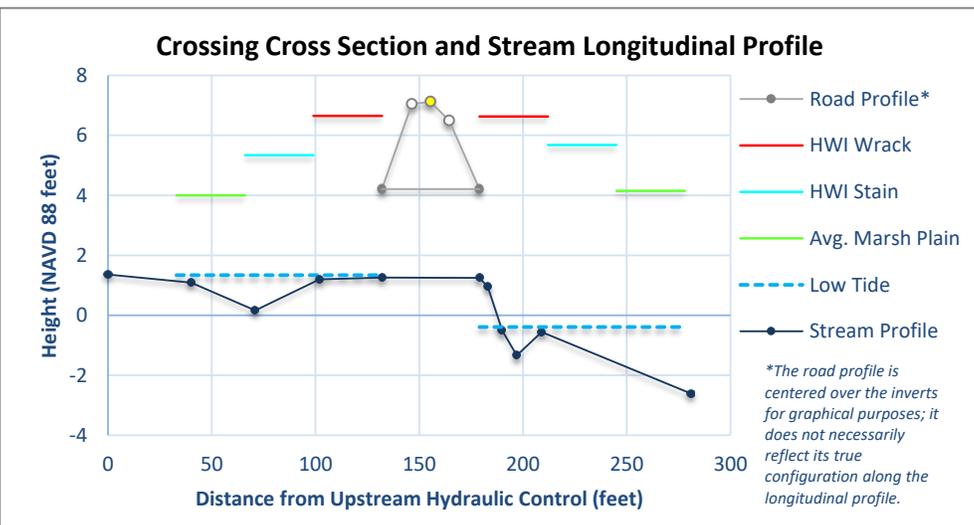
Long. Profile			
Dist.	Hght.	Feat.	Sub.
0	1.3594	HC	G
40	1.0894	CB	G
71	0.1594	P	C/S
102	1.1994	HC	C
132	1.2594	I	G
179	1.2494	I	B
183	0.9494	GC	B
190	-0.5106	CB	G
197	-1.3406	P	G
209	-0.5606	HC	G
281	-2.6106	HC	G

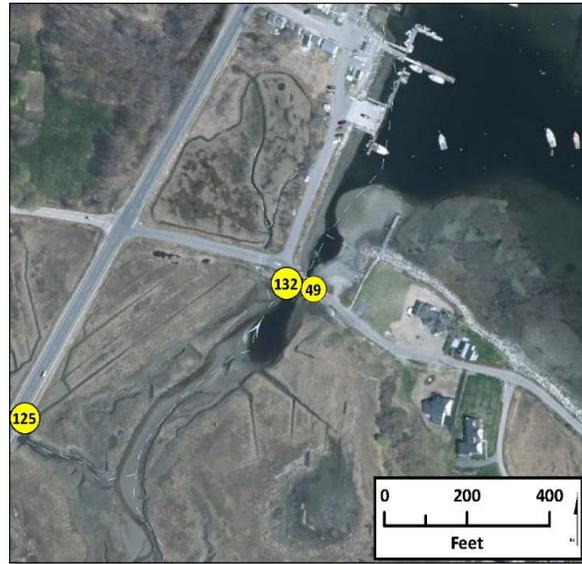
A small rectangular marsh surrounded by roads and cut off from tides during the development of Rye Harbor was restored to tidal exchange in 1998 by the addition of a 3 by 4-foot concrete culvert that runs under Harbor Road. Common reed covered wetland which had been partially filled with dredge spoil. Restoration included the new culvert and the area had the fill and a small tidal creek excavated. The crossing is in very good condition, but the culvert still restricts some of the tidal flow. It has an overall combined score of 3, a moderate priority for replacement.

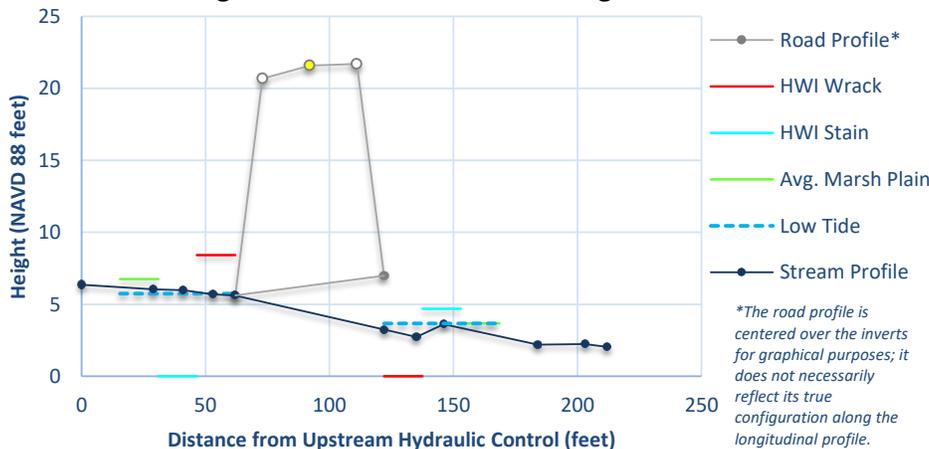
### Crossing Cross Section and Stream Longitudinal Profile

Dist.	Hght.	Feat.	Sub.
0	6.3579	HC	S
29	6.0379	CB	G
41	5.9779	HC	G
53	5.6979	CB	C
62	5.6179	I	S
122	3.2379	I	G
135	2.7379	P	C/S
146	3.6079	HC	C
184	2.1879	CB	S
203	2.2379	HC	C
212	2.0379	CB	S

\*The road profile is centered over the inverts for graphical purposes; it does not necessarily reflect its true configuration along the longitudinal profile.

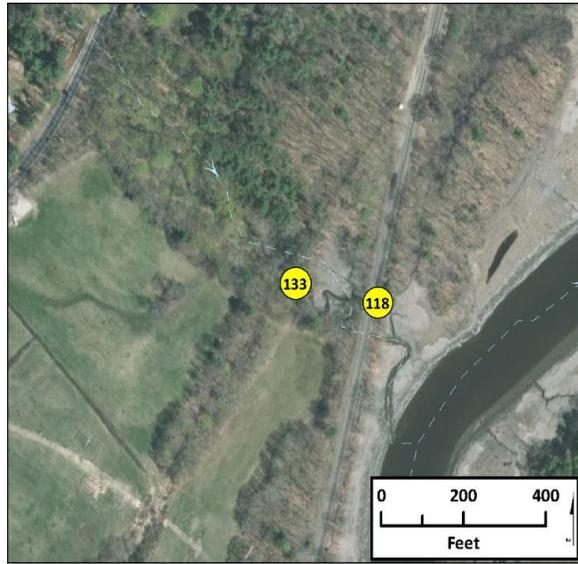
A small head of tide marsh that extends west from the Squamscott River in Newfields is crossed by an unnamed access road that conducts flow through a granite box culvert that may have been 4 by 4 feet in cross-section when installed. Currently, the upstream inlet appears to be collapsed and blocked by sediment. As might be expected, this culvert is not functional and is at risk for failure. The overall combined score is 4: high priority for replacement.

<b>Structure Condition Comments:</b>	Collapsed US, no structure to measure, see photo
--------------------------------------	--

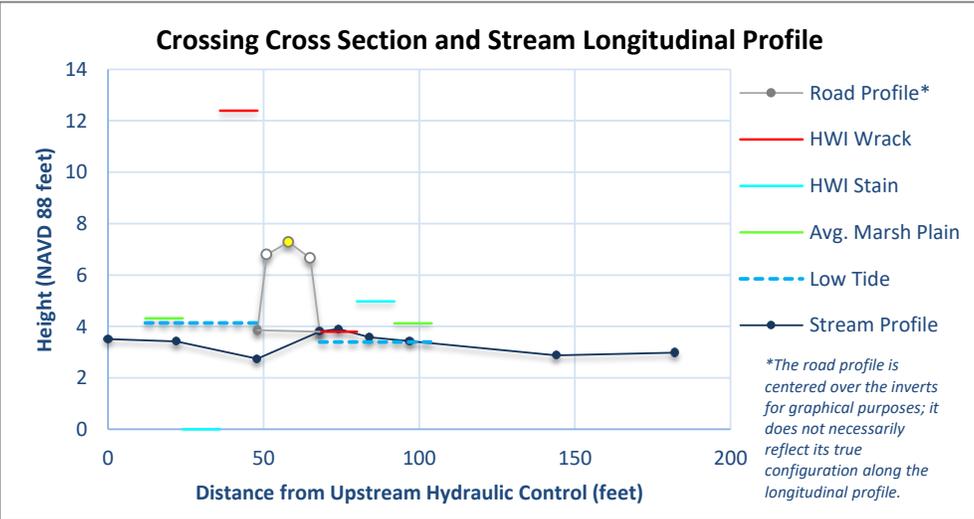
Long. Profile			
Dist.	Hght.	Feat.	Sub.
0	3.5135	HC	C/S
22	3.4135	CB	C/S
48	2.7435	I	C/S
68	3.7935	I	G
74	3.9035	HC	G
84	3.5835	CB	S
97	3.4335	P	S
144	2.8735	HC	C/S
182	2.9835	HC	C/S

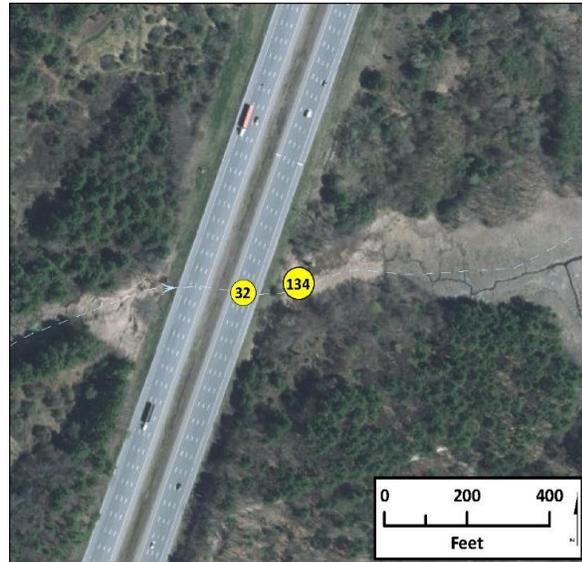
At the head of a tidal creek just south of the Taylor River is a berm barrier to 1-2 feet of tidal flow with a 1-foot metal pipe for drainage that is crushed at the downstream end. Current conditions are poor and prevent tidal flow leading to an overall combined score of 4: high priority for replacement. The culvert should be replaced unless the berm has no current use, in which case it should be removed.
